Aviation Investigation Final Report

Location:	Hillsville, Virginia	Accident Number:	ERA23FA131
Date & Time:	February 27, 2023, 16:56 Local	Registration:	N2991J
Aircraft:	Cessna 150G	Aircraft Damage:	Substantial
Defining Event:	VFR encounter with IMC	Injuries:	1 Fatal
Flight Conducted Under:	Part 91: General aviation - Personal

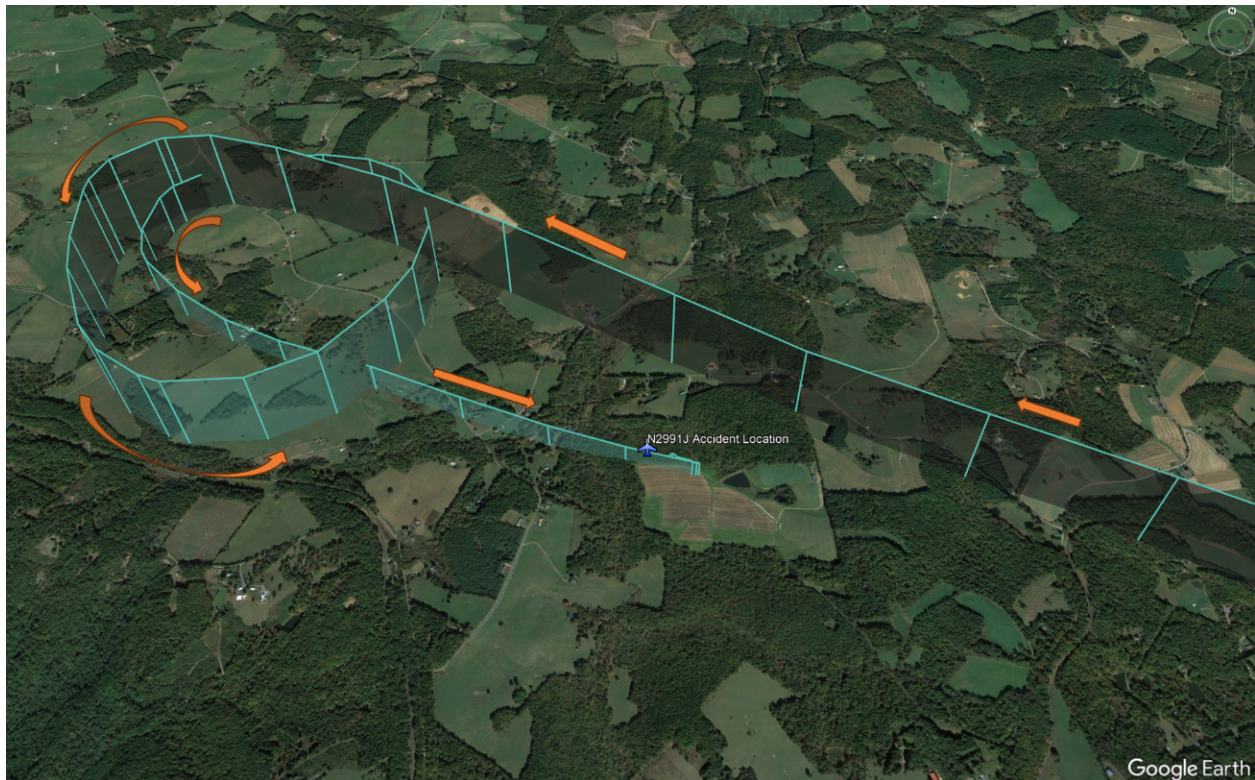
According to a GPS device that was downloaded at the National Transportation Safety Board Vehicle Recorders Laboratory, the airplane departed BUY at 1612. The pilot flew a nearly direct northwestern route towards HLX. About 15 miles from the destination, at 1653, the airplane began flying over mountainous terrain. Then, the airplane entered a descending left turn for 1 1/2 revolutions (540°) until the flight track straightened and reversed course on a southeasterly heading (figure 1). Examination of the GPS altitude data revealed that the airplane descended from about 3,250 ft to 3,000 ft, about 200 ft agl, during the final minute of flight. The final GPS data point was about 650 ft from where the main wreckage was located.

Figure 1. View of flight track for the final 4 minutes of flight. The blue track indicates the airplane flight track and the orange arrows indicate the direction of flight.
