Aviation Investigation Final Report

Location:	Coldspring, Texas	Accident Number:	CEN23LA172
Date & Time:	May 3, 2023, 13:29 Local	Registration:	N28HE
Aircraft:	Piper PA-34-200	Aircraft Damage:	Substantial
Defining Event:	Flight control sys malf/fail	Injuries:	2 Serious
Flight Conducted Under:	Part 91: General aviation - Instructional

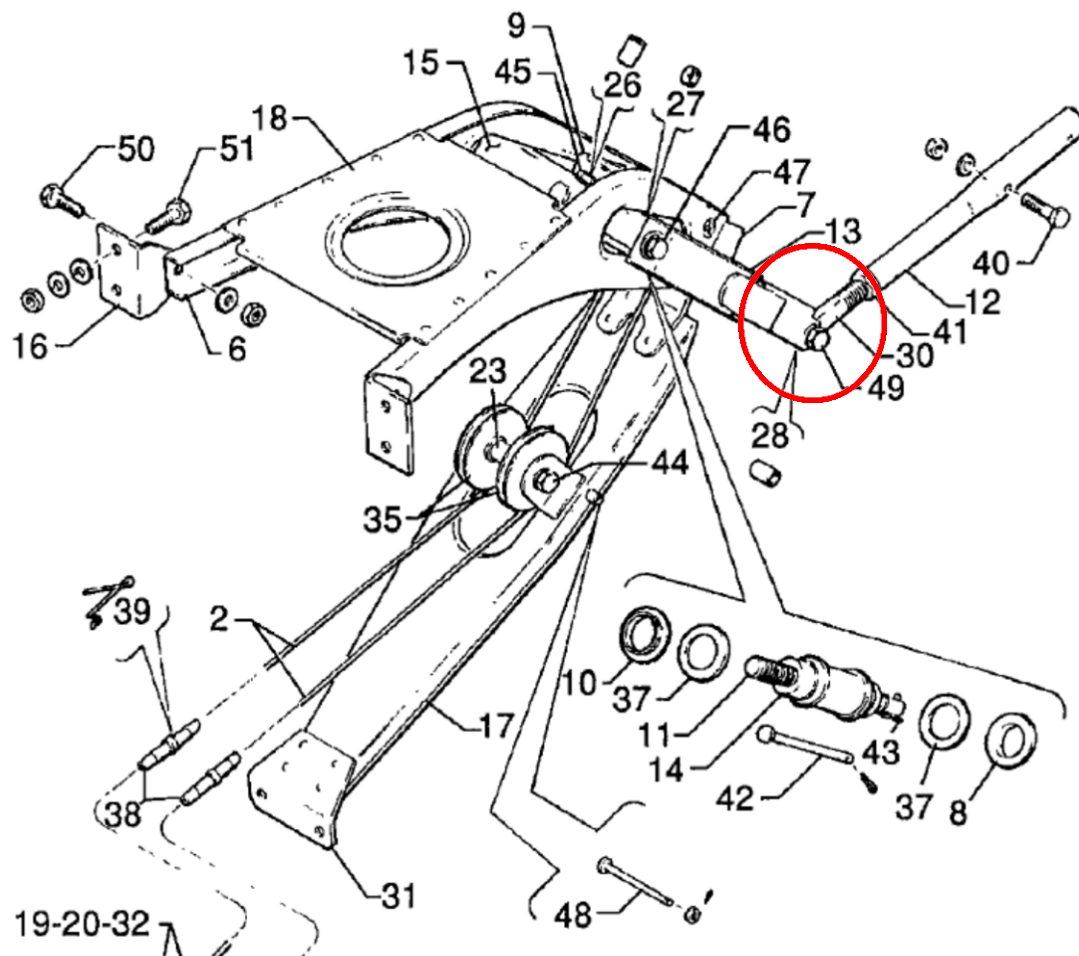
Figure 1. Illustrated Parts Catalog (Part Nos. 753-816)

A postaccident examination revealed that the bolt (item 49 in figure 1) which connects the stabilator trim rod assembly (item 12) to the stabilator link assembly (item 13) was missing. (Figure 2)
