Aviation Investigation Final Report

Location:	Fullerton, California	Accident Number:	WPR23LA317
Date & Time:	August 8, 2023, 15:00 Local	Registration:	N503JA
Aircraft:	Piper PA-24-260	Aircraft Damage:	Substantial
Defining Event:	Flight control sys malf/fail	Injuries:	1 Minor
Flight Conducted Under:	Part 91: General aviation - Personal

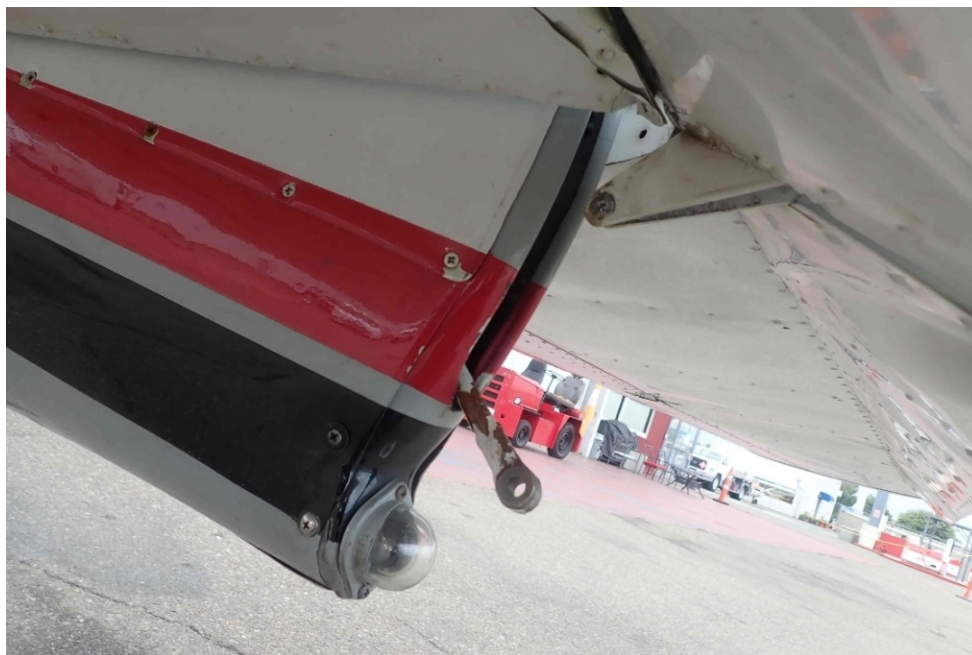
Circumferential scoring around the bolt hole within the tabs indicated that the bolt was likely loose for an undetermined period before failure. The nut had likely not been replaced since the airplane was manufactured almost 60 years before the accident, so its locking properties would have been significantly diminished.

The separation of the stabilator actuator from the stabilator tab, which resulted in pitch control surface flutter and structural damage.

The airplane sustained substantial damage to the stabilator structure and postaccident examination revealed that the stabilator tab actuator was disconnected from the control tab, and the bolt, nut, and washer that connected them were missing (figure 1).

Figure 1 - Stabilator tab disconnected from the actuator.

The tabs sustained extensive scratch and peening damage to both their inner and forward surfaces consistent with high frequency oscillations. The paint around the end of the tab actuator arm had chipped away, revealing similar peening damage to its steel surface.

Neither the bolt nor the nut that connected the tabs to the actuator were located, and there was circumferential scoring to the tabs around the bolt hole bore. Neither bolt hole appeared to be elongated. Likewise, the bushing within the actuator did not appear to be out of round.
