# Aviation Investigation Final Report

<b>Location:</b>	Prescott, Arizona	<b>Accident Number:</b>	WPR24LA061
<b>Date &amp; Time:</b>	December 26, 2023, 12:21 Local	<b>Registration:</b>	N29TT
<b>Aircraft:</b>	Glasair SH2	<b>Aircraft Damage:</b>	Substantial
<b>Defining Event:</b>	Sys/Comp malf/fail (non-power)	<b>Injuries:</b>	1 None
<b>Flight Conducted Under:</b>	Part 91: General aviation - Personal

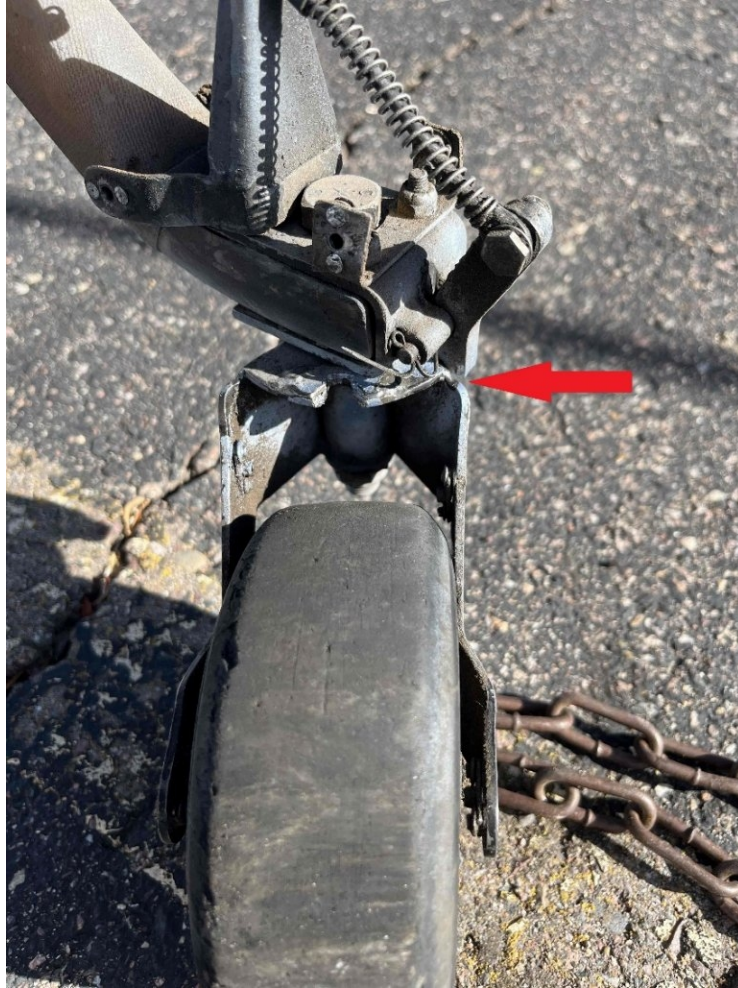
Further examination revealed that the tailwheel assembly locking mechanism was significantly worn and had been incorrectly constructed, so a positive lock was not possible. Under this condition, with light side loads as are often encountered during landing, the tailwheel could unlock and be pushed into an over center position. This resulted in the airplane aggressively swerving as observed.

Loss of directional control during landing due to an improperly constructed and maintained tailwheel locking assembly.

Postaccident examination revealed that both the cabin control and locking arm were in the locked position, but the tailwheel was jammed about the 45° to the left, rather than straight. Further examination revealed that the locking arm and associated plate slot were worn, and the locking spring had limited tension, such that with light force the tailwheel could be moved out of the straight position and jammed over center as the locking arm dropped down against the outer edges of the locking plate (see figure 1).

Figure 1. Tailwheel in the overcenter position. Arrow indicates where the locking arm has dropped down against the outer edges of the locking plate.

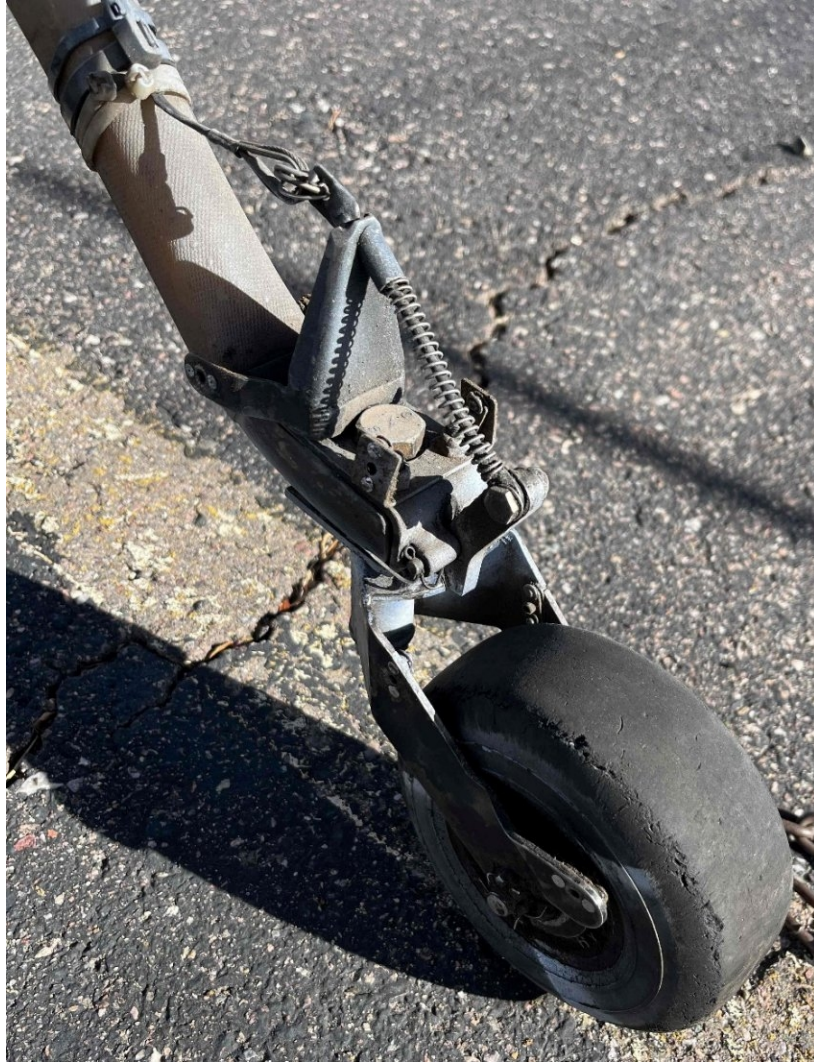
The construction plans specified that the control cable should be routed directly from the locking arm to a phenolic guide in the vertical fin shear web. However, the cable was routed from the locking arm down to a set of four cable ties mounted to the tailwheel strut (see figure 2).

Figure 2. Tailwheel in the straight position; note the cable ties in top left restricting free movement of the locking cable.
