Aviation Investigation Final Report

Location:	Hillsborough Township, New Jersey	Accident Number:	ERA23LA225
Date & Time:	May 6, 2023, 12:55 Local	Registration:	N262MK
Aircraft:	MOONEY AIRCRAFT CORP. M20K	Aircraft Damage:	Substantial
Defining Event:	Loss of engine power (partial)	Injuries:	1 Minor
Flight Conducted Under:	Part 91: General aviation - Personal

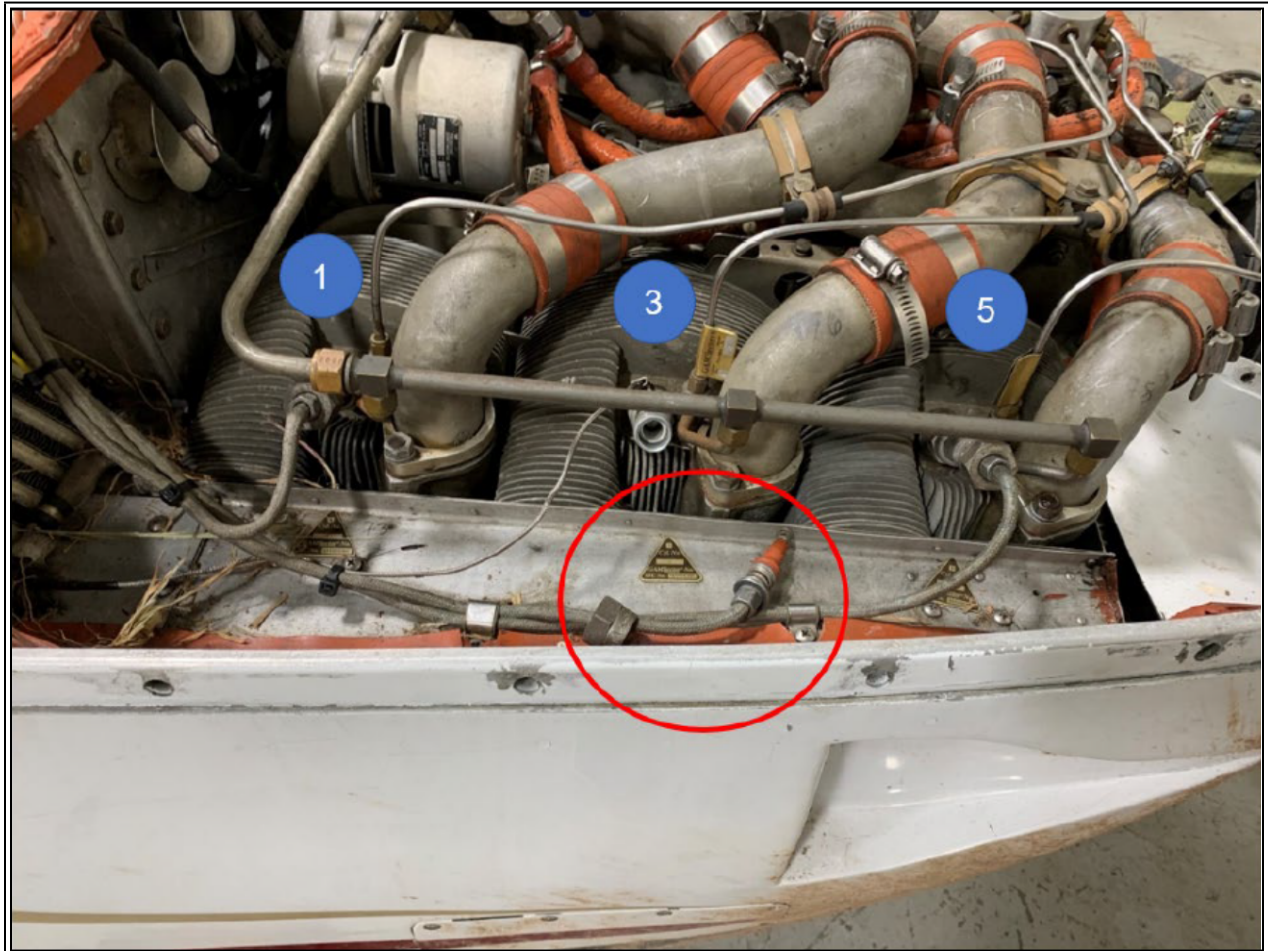
Postaccident examination of engine found that the Nos. 1 and 5 cylinder top spark plug ignition harnesses were loose to their respective sparkplugs. The No. 3 top spark plug ignition harness was found completely unscrewed, detached, and lying next to the spark plug on top of the cylinder shroud. There were no other anomalies discovered with the engine. Based on this information, it is likely that the reduction in engine power the pilot reported during the takeoff was due to this ignition system anomaly.

The airplane had undergone maintenance and had been flown for 1.5 hours since the last inspection. The mechanic who performed that maintenance could not recall servicing any spark plugs, nor did he recall removing any ignition harnesses. Although the mechanic may not have loosened or removed the ignition harness, it is likely that he, or other maintenance personnel performing maintenance tasks at some other point, did not ensure the ignition harnesses were properly tightened before returning the airplane to service.

The partial loss of engine power due to maintenance personnel’s failure to ensure that the ignition harnesses were properly secured and the pilot’s inappropriate pitch control inputs, which resulted in the airplane exceeding its critical angle of attack and subsequently entering an aerodynamic stall.

The Nos. 1 and 5 cylinder top spark plug ignition harnesses were found loose to their respective sparkplugs when touched by hand. The No. 3 top spark plug ignition harness was found completely unscrewed, detached, and lying next to the spark plug on top of the cylinder shroud. Figure 1 provides an overview of how the ignition harnesses were found when the airplane was examined at the recovery facility.

Figure 1: View of the Nos. 1, 3, and 5 cylinders and ignition harnesses as found at the recovery facility. The No. 3 ignition harness was found lying next to its attachment area. The No. 1 and 5 ignition harnesses were loose to the touch.
