Aviation Investigation Final Report

Location:	Willows, California	Accident Number:	WPR23FA122
Date & Time:	March 7, 2023, 16:11 Local	Registration:	N8424V
Aircraft:	ROCKWELL INTERNATIONAL S-2R	Aircraft Damage:	Substantial
Defining Event:	Low altitude operation/event	Injuries:	1 Fatal
Flight Conducted Under:	Part 137: Agricultural

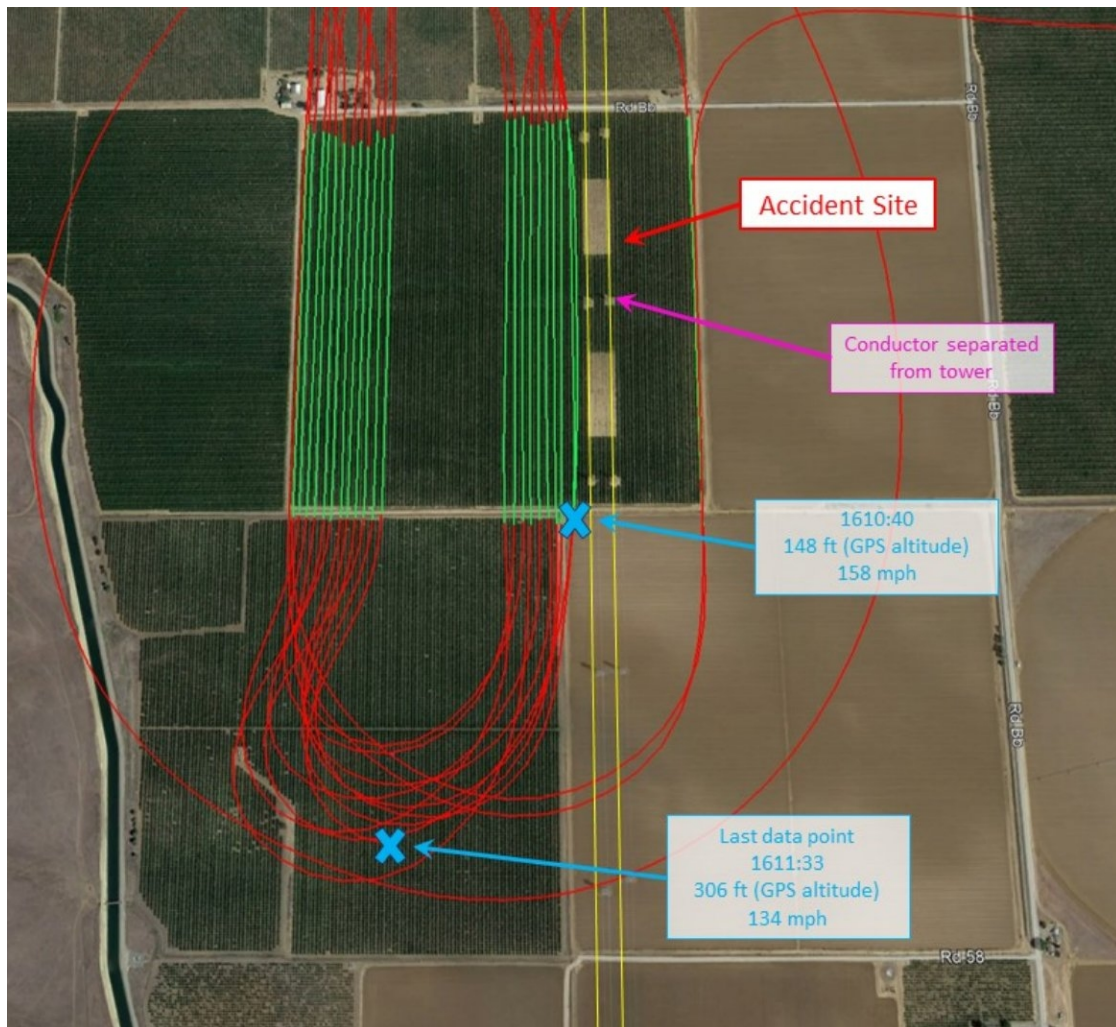
The pilot flew the same racetrack pattern as he had previously. The pilot's 2 final northerly passes over the field took place at 1609:30 and 1610:39 about 100 ft west of the bank of the powerlines at an altitude of 131 ft agl. The flight track ceased at 1611:33 about 0.6 nautical miles (nm) southwest of the accident site. A witness located about 0.5 nm northwest of the accident site reported that he observed the airplane make several passes in a racetrack pattern on a north/south heading directly over him about 25 minutes before the accident. The airplane left the area and then returned about 1610 and made additional passes. He heard a loud noise about 2 minutes after the last pass.

Figure 1. GPS flight track with annotations and last data point before accident

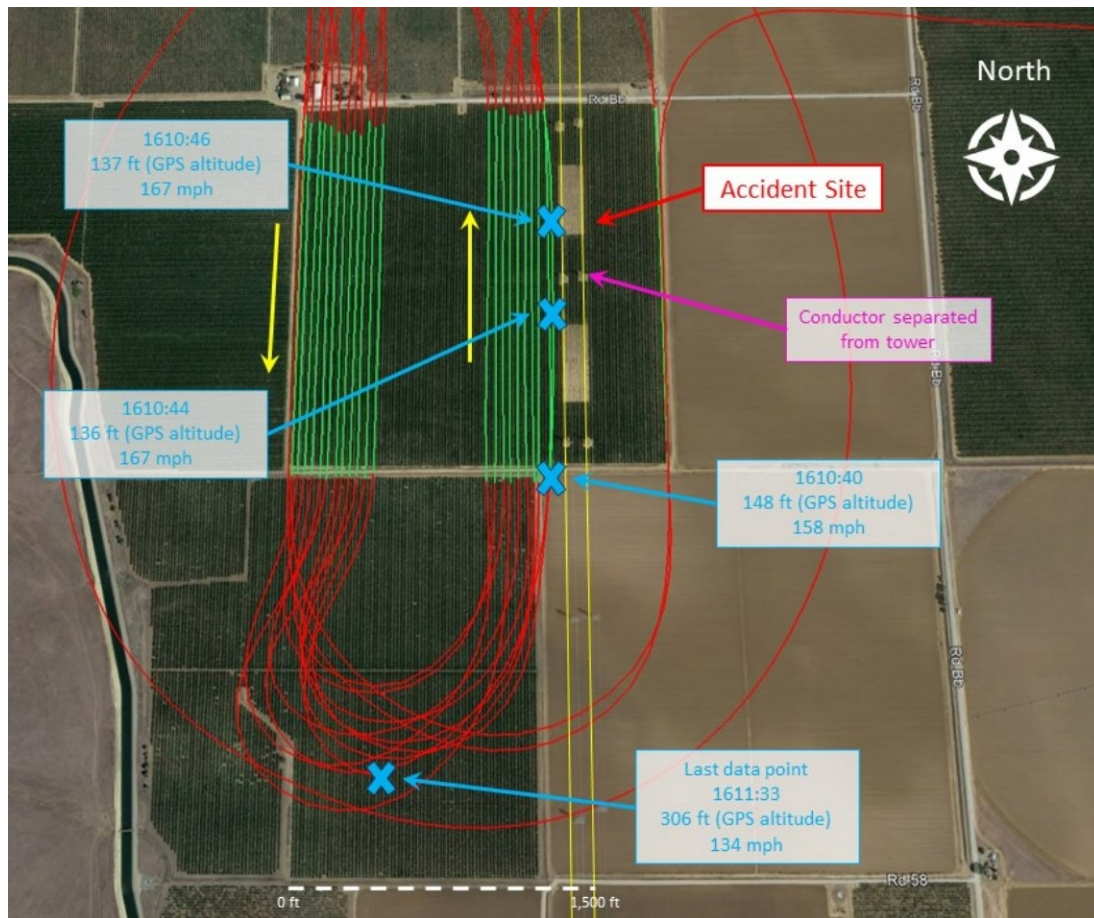
Figure 2. Diagram of parallel passes about 100 ft west of powerlines

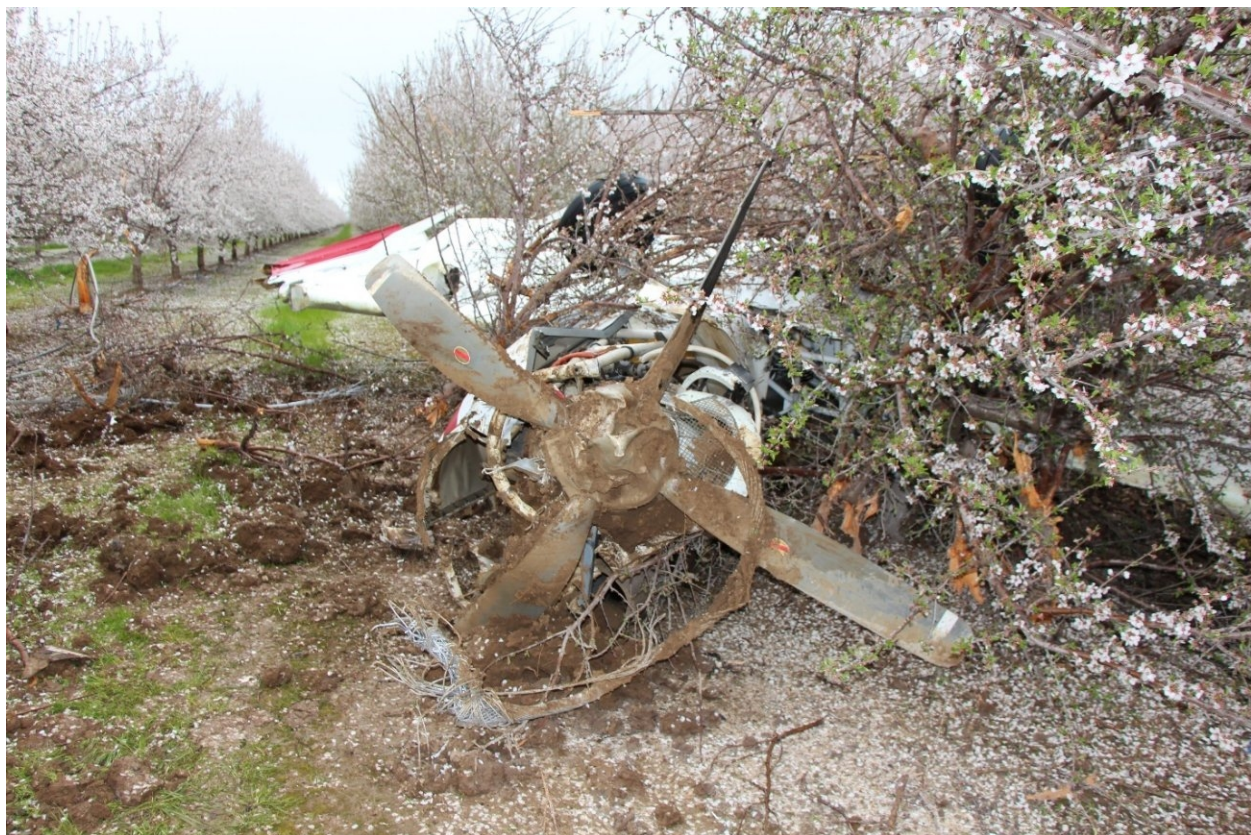
Figure 3. View of airplane at accident site from front with cable wrapped around propeller

The propeller spinner dome exhibited braided scoring and cable notches in three of the propeller blade leading edges. Propeller blade 2 displayed a gouge in the trailing edge consistent with cable wrap damage.

The propeller also exhibited rotational scoring and leading edge notches/cuts, consistent with an inflight impact of a cable as the propeller rotated. An impact signature noted on the internal surface of the piston corresponded to a 17.7° blade angle, consistent with a power condition in flight. The two dowel pin holes on the mounting flange appeared deformed in the direction of rotation. A counterweight impact mark in the spinner dome was measured at 17.4° , which corresponded with a blade angle of about 4° closer to flight idle and consistent with a lower power signature at the time of impact with terrain.

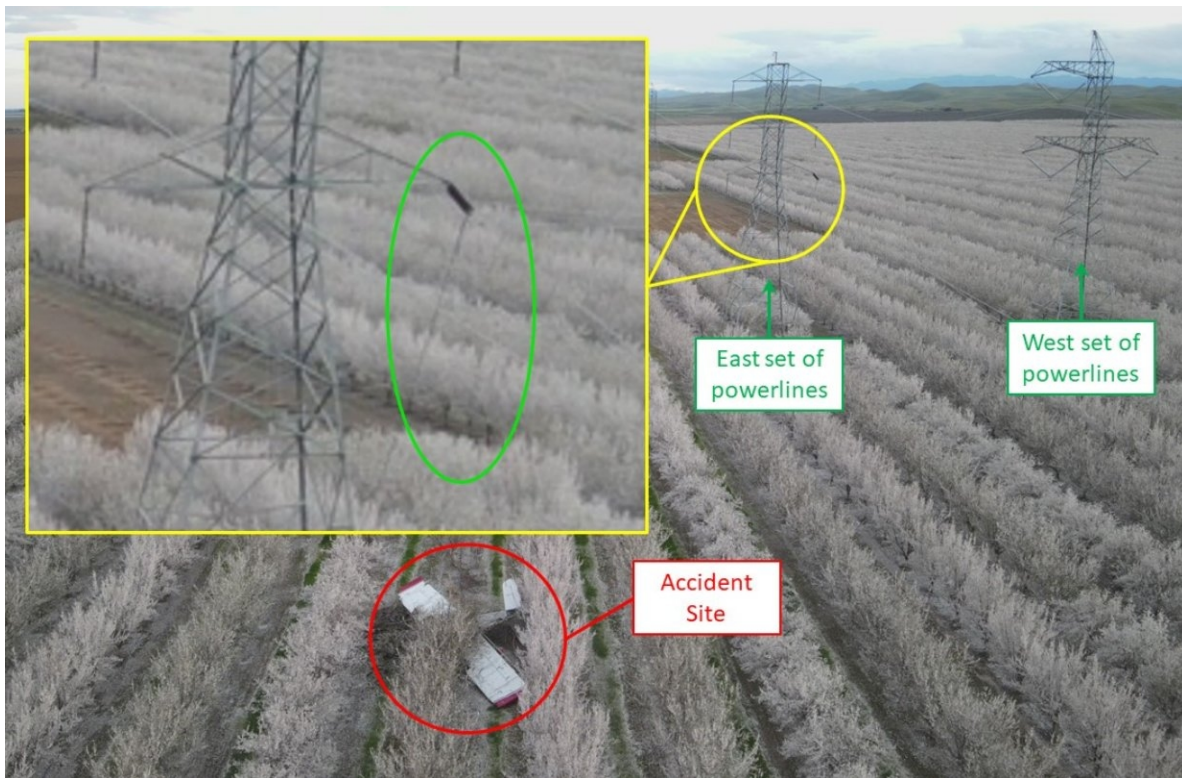
The airplane came to rest inverted in an almond orchard about 500 ft northeast of a powerline tower and was oriented on a heading of 038° magnetic and adjacent to a severed lower conductor (powerline). All the major structural components of the airplane were accounted for at the accident site. The debris field was marked by several broken tree branches about 50 ft southeast of the accident site. A ground scar about 5 ft in diameter was collocated with the main wreckage. Both ailerons and flaps remained attached to their respective wings, which were both attached to the fuselage. The right wing displayed a depression about 3 ft in diameter with accordion style deformation and tree remnants several feet outboard of the wing root. The left wing leading edge exhibited a depression about 10 ft from the wing root. A section of conductor, about 2 inches in diameter, was wrapped around the propeller hub (see Figure 3). The conductor line was traced through the left wing depression to the trees southeast of the accident site.

The airplane's first point of impact was the west inboard powerline about midspan between 2 towers about 500 ft southwest of the accident site. (See annotation on Figure 4, "East set of powerlines".) According to the operator of the powerlines, the lowest conductor at the towers that held the powerline that was severed was about 75 ft agl at the tower and sagged down to 36 ft agl midspan. The powerlines were in a north-south configuration and were held by 130 ft tall towers that supported multiple powerlines at various heights. An identical set of powerlines, also in a north-south configuration, was located about 115 ft west of the first impact point.

Figure 4. Powerlines and accident site facing south
