Aviation Investigation Final Report

Location:	Indianapolis, Indiana	Accident Number:	CEN23LA093
Date & Time:	January 24, 2023, 15:39 Local	Registration:	N99EC
Aircraft:	CIRRUS DESIGN CORP SR20	Aircraft Damage:	Destroyed
Defining Event:	Collision with terr/obj (non-CFIT)	Injuries:	1 Fatal
Flight Conducted Under:	Part 91: General aviation - Personal

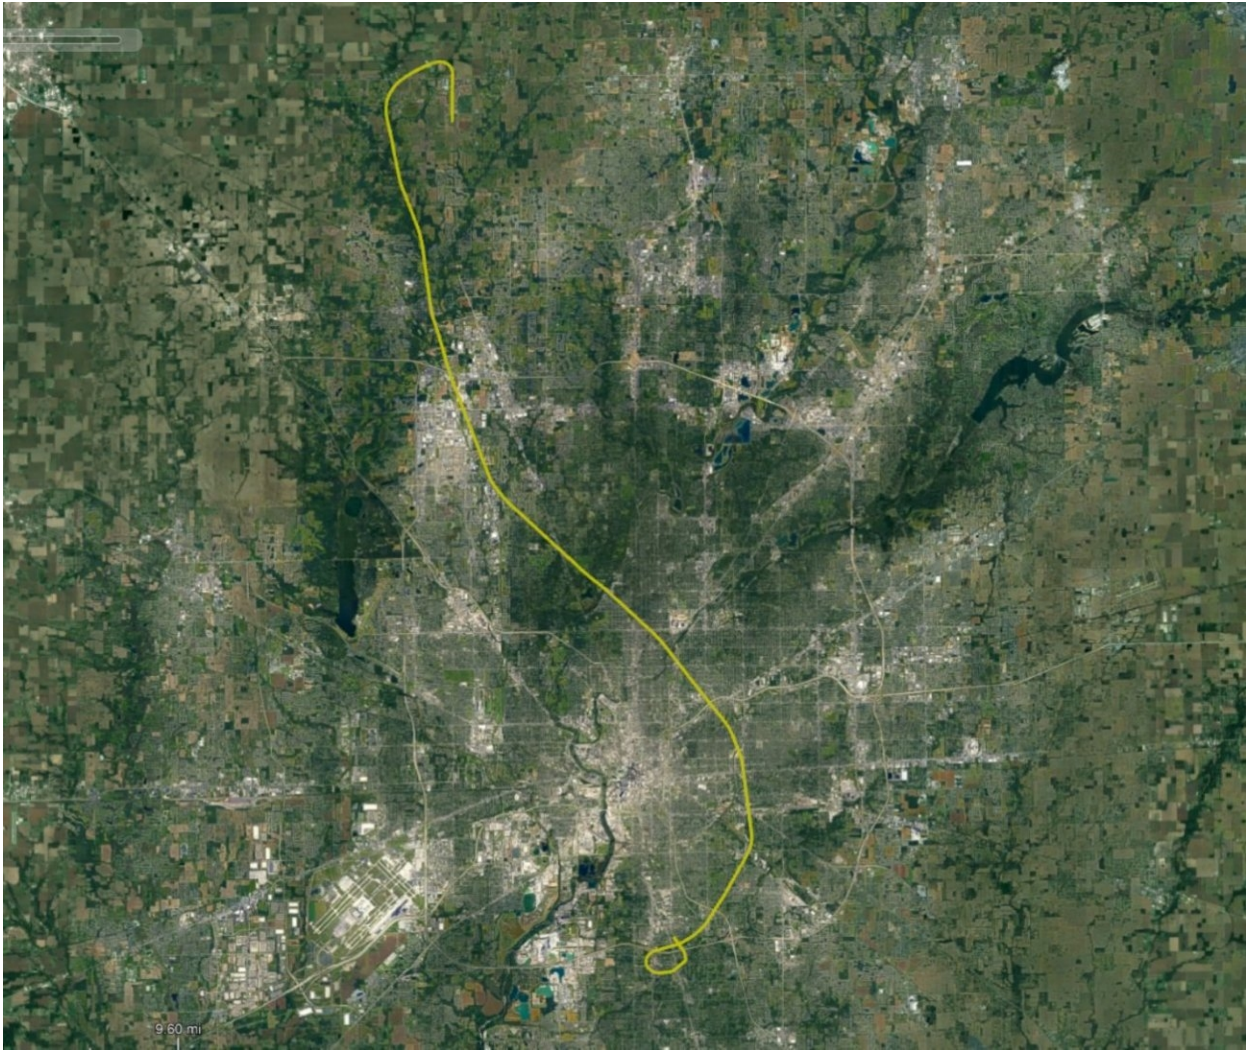
According to automatic dependent surveillance-broadcast data (ADS-B), the airplane departed the Indianapolis Executive Airport, Indianapolis, Indiana, about 1526. After takeoff, the airplane turned left, climbed to about 1,000 ft above ground level, and continued to the southeast past downtown Indianapolis. South of downtown and near the end of the data, the airplane made a 360° left turn and began a rapid descent (see Figure 1.). A residential surveillance camera captured the impact sequence and showed the airplane impact in a nose and right-wing low attitude. There were no witnesses to the accident.

1. Airplane's ADS-B flight track
