# Aviation Investigation Final Report

<b>Location:</b>	Shreveport, Louisiana	<b>Accident Number:</b>	CEN23LA087
<b>Date &amp; Time:</b>	January 20, 2023, 16:34 Local	<b>Registration:</b>	N71SN
<b>Aircraft:</b>	WORLD AIRCRAFT CO WA-3	<b>Aircraft Damage:</b>	Substantial
<b>Defining Event:</b>	Fuel related	<b>Injuries:</b>	1 None
<b>Flight Conducted Under:</b>	Part 91: General aviation - Personal

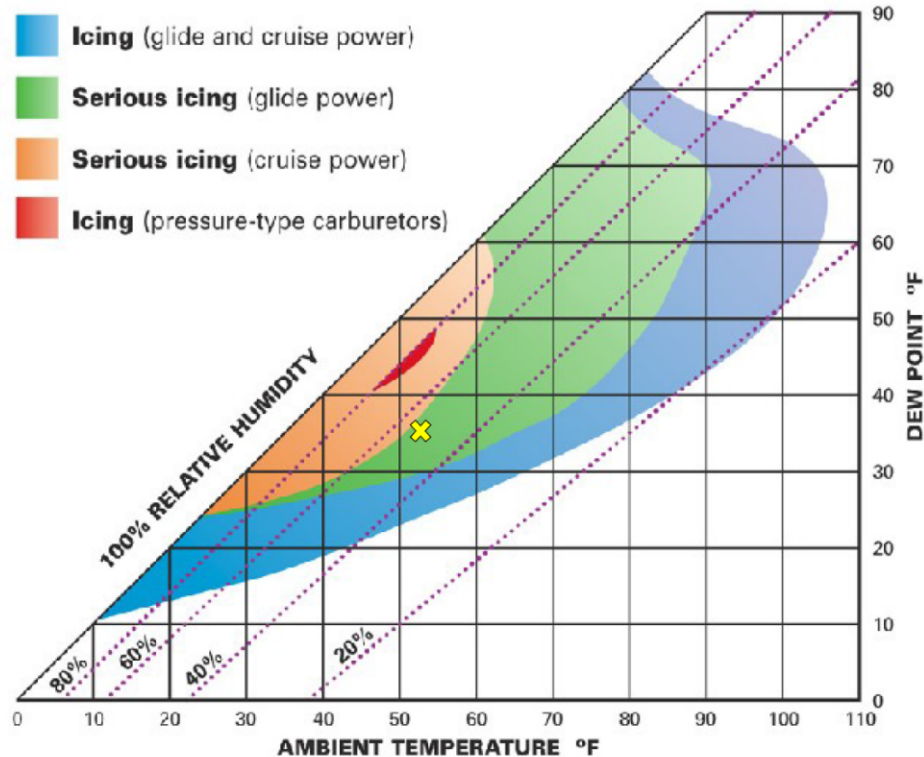
Figure 1. Carburetor Icing Probability Chart

A review of the Carburetor Icing Probability Chart located in the FAA’s Special Airworthiness Information Bulletin CE-09-35, *Carburetor Icing Prevention*, dated June 30, 2009, found that the airplane was operating in an area conducive to the formation of serious icing at glide power settings and close to the area of serious icing at cruise power. The airplane was fueled with 93-octane automotive fuel which, as noted below, could make carburetor icing more likely. Additionally, the airplane was not equipped with a carburetor temperature gauge or a carburetor heat control, nor was it required to be by the FAA.

According to Transport Canada TP 10737 (Use of Automotive Gasoline [Mogas] in Aviation), Mogas is generally higher in volatility than Avgas and will thus absorb more heat from the mixing air when vaporizing, resulting in ice accumulation at higher ambient temperatures. It goes on to say that “the likelihood of carb icing while flying on Mogas is higher,” and advises that, “[a]lthough the severity of the carb icing and the methods to deal with it are similar for both Avgas and Mogas, its ONSET is likely to occur at HIGHER AMBIENT TEMPERATURES and at LOWER HUMIDITY with Mogas. In other words, conditions under which a pilot may feel there is only a slight risk for carb icing on Avgas may in fact be ideal for the formation of ice while using more volatile Mogas. This will result in the need to select ‘carb heat on’ in less severe icing conditions and for a longer duration while using Mogas.”
