Aviation Investigation Final Report

Location:	Scott City, Kansas	Accident Number:	CEN23LA264
Date & Time:	June 24, 2023, 11:30 Local	Registration:	N9721Q
Aircraft:	Beech B19	Aircraft Damage:	Substantial
Defining Event:	Fuel starvation	Injuries:	1 None
Flight Conducted Under:	Part 91: General aviation - Personal

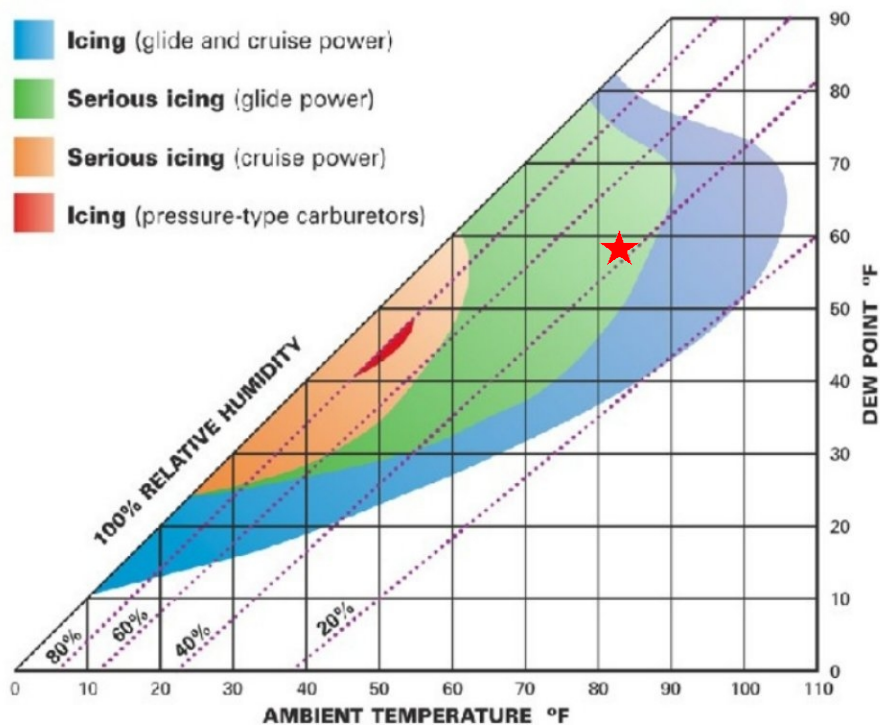
Figure 1: Carburetor Icing Probability Chart. Reference: Special Airworthiness Information Bulletin CE-09-35

When the temperature and dewpoint at the time of the accident were plotted on a carburetor icing probability chart, it was revealed that the airplane was operating in an environment conducive for serious carburetor icing at a glide power setting. The pilot stated that he checked the carburetor heat before departure. After the carburetor heat check, it is likely that ice began to form in the carburetor’s venturi during the extended ground operation before departure, which, in turn, limited the engine rpm at 2,200.

A partial loss of engine power as a result of carburetor icing that formed while the engine was operating at a low power setting for an extended period before departure.

The reported weather conditions about 15 minutes before the accident included a temperature of 82°F and dewpoint of 59°F. When plotted on a carburetor icing probability chart, the airplane was operating in an environment conducive for serious carburetor icing at a glide power setting. (See Figure 1)
