Aviation Investigation Final Report

Location:	Boston, Massachusetts	Incident Number:	DCA23LA192
Date & Time:	February 27, 2023, 18:54 Local	Registration:	N280LJ (A1); N179JB (A2)
Aircraft:	LEARJET INC 60 (A1); Embraer ERJ 190-100 IGW (A2)	Aircraft Damage:	None (A1); None (A2)
Defining Event:	Runway incursion veh/AC/person	Injuries:	N/A (A1); N/A (A2)
Flight Conducted Under:	Part 91: General aviation - Positioning (A1); Part 121: Air carrier - Scheduled (A2)

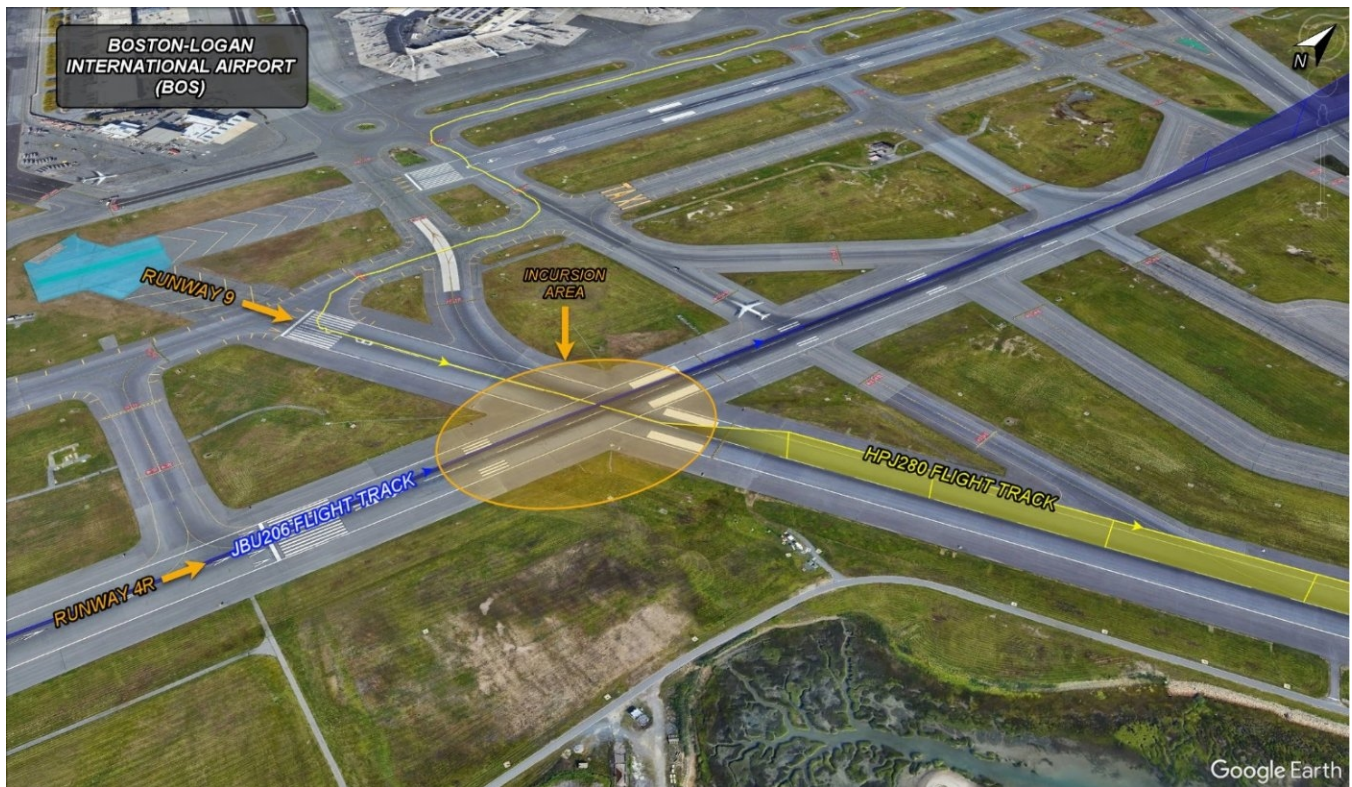
JBU206's flight crew initiated a go-around while over runway 04R, prior to reaching the intersection with runway 09. The closest proximity between both airplanes occurred when JBU206 was about 30ft AGL during the landing flare, close to the point where both runways intersected, see figure 1. A video file taken by the occupant of the flight deck observer seat was provided to the NTSB and a screen capture from the video is shown in figure 2.

Figure 1. Flight tracks of both JetBlue (JBU206) and Hop-a-Jet (HPJ280) with yellow circle indicating incursion area.

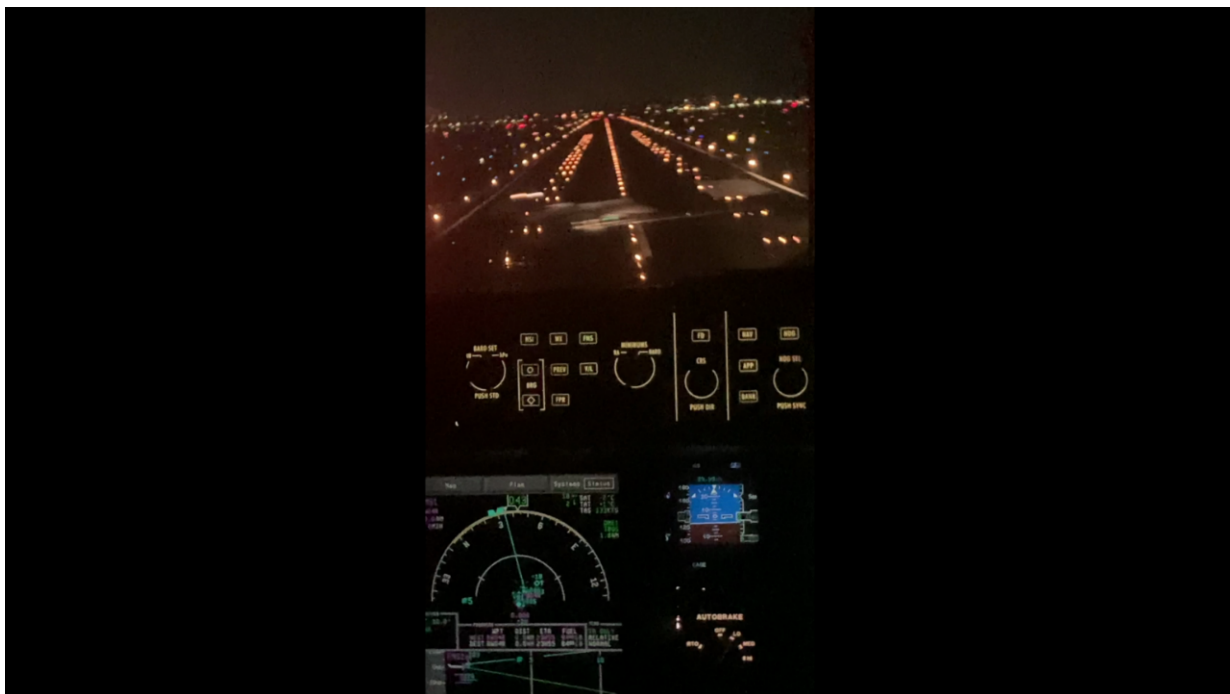
Figure 2: Screen capture from jump-seat occupant's video recording showing Lear 60 crossing runway centerline.

The Hop-a-Jet flight crew taking off without a takeoff clearance which resulted in a conflict with a JetBlue flight that had been cleared to land on an intersecting runway.
