# Aviation Investigation Final Report

| <b>Location:</b> | Udall, Kansas | <b>Accident Number:</b> | CEN23LA169 |
| <b>Aircraft:</b> | Zenith STOL CH750 | <b>Aircraft Damage:</b> | Substantial |

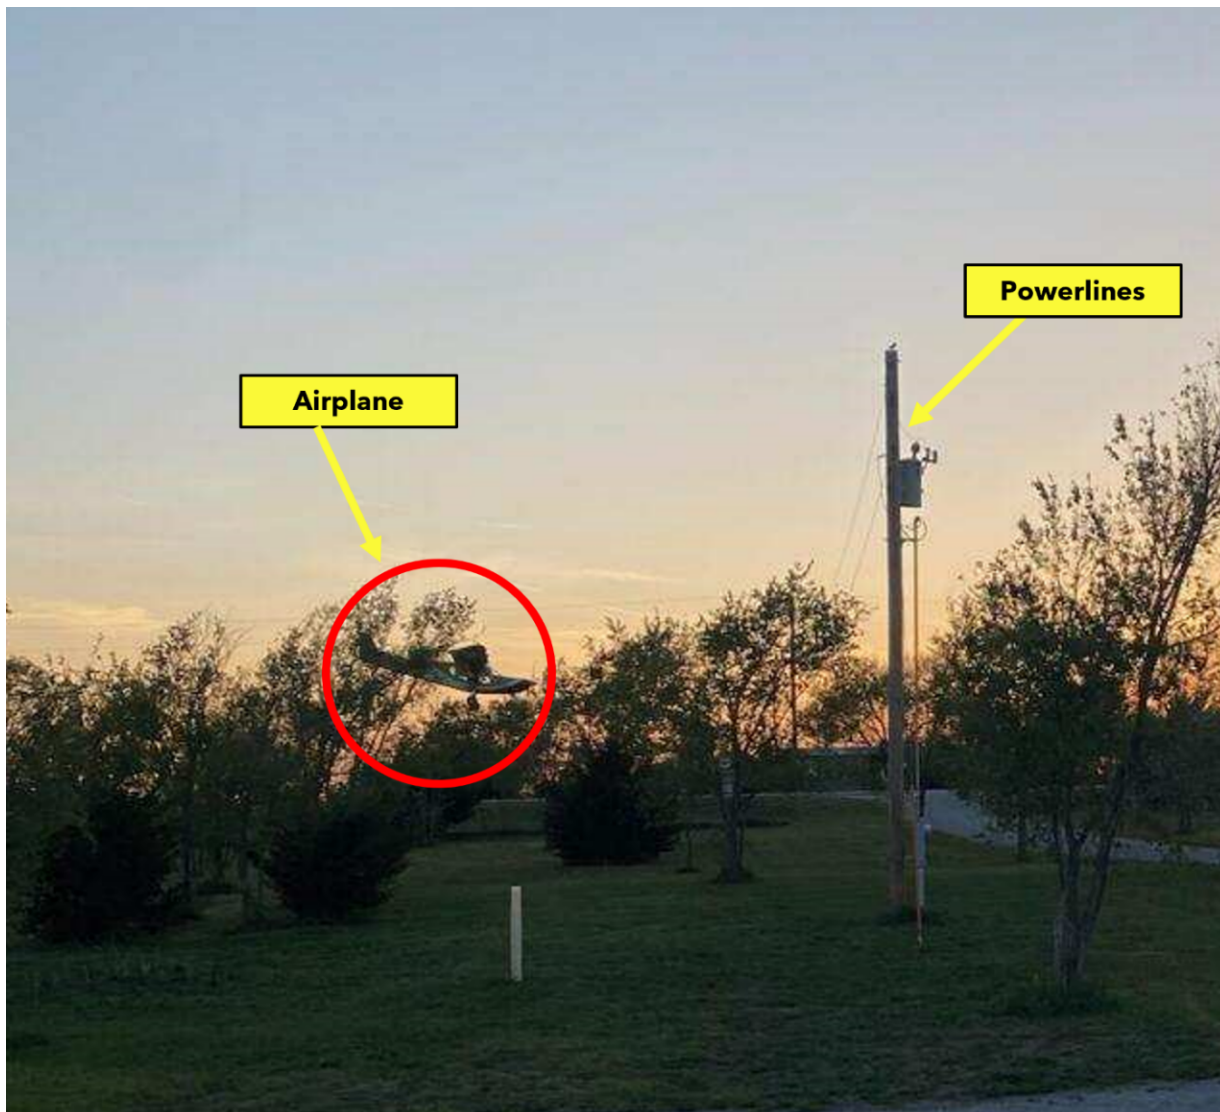
A witness reported seeing the airplane flying low towards his house. He provided a photo of the airplane in flight, right before it struck the power line (see Figure 1). He stated that he saw the airplane fly under power lines, heard a noise, and then saw the power lines moving. He stated that he heard engine noise and that there was no indication of a rough running engine. After striking the power lines, the airplane climbed and flew to the northwest at “treetop height.”

*Figure 1. A witness photo that shows the accident airplane right before it struck the power line. The airplane is circled in red and the power lines are labeled in yellow.*
