# Aviation Investigation Final Report

<b>Location:</b>	McKinney, Texas	<b>Accident Number:</b>	CEN24LA037
<b>Date &amp; Time:</b>	November 11, 2023, 12:41 Local	<b>Registration:</b>	N751HP
<b>Aircraft:</b>	Charles L. Hayes Lancair IVP Turbine	<b>Aircraft Damage:</b>	Substantial
<b>Defining Event:</b>	Landing area overshoot	<b>Injuries:</b>	1 Minor, 2 None
<b>Flight Conducted Under:</b>	Part 91: General aviation - Personal

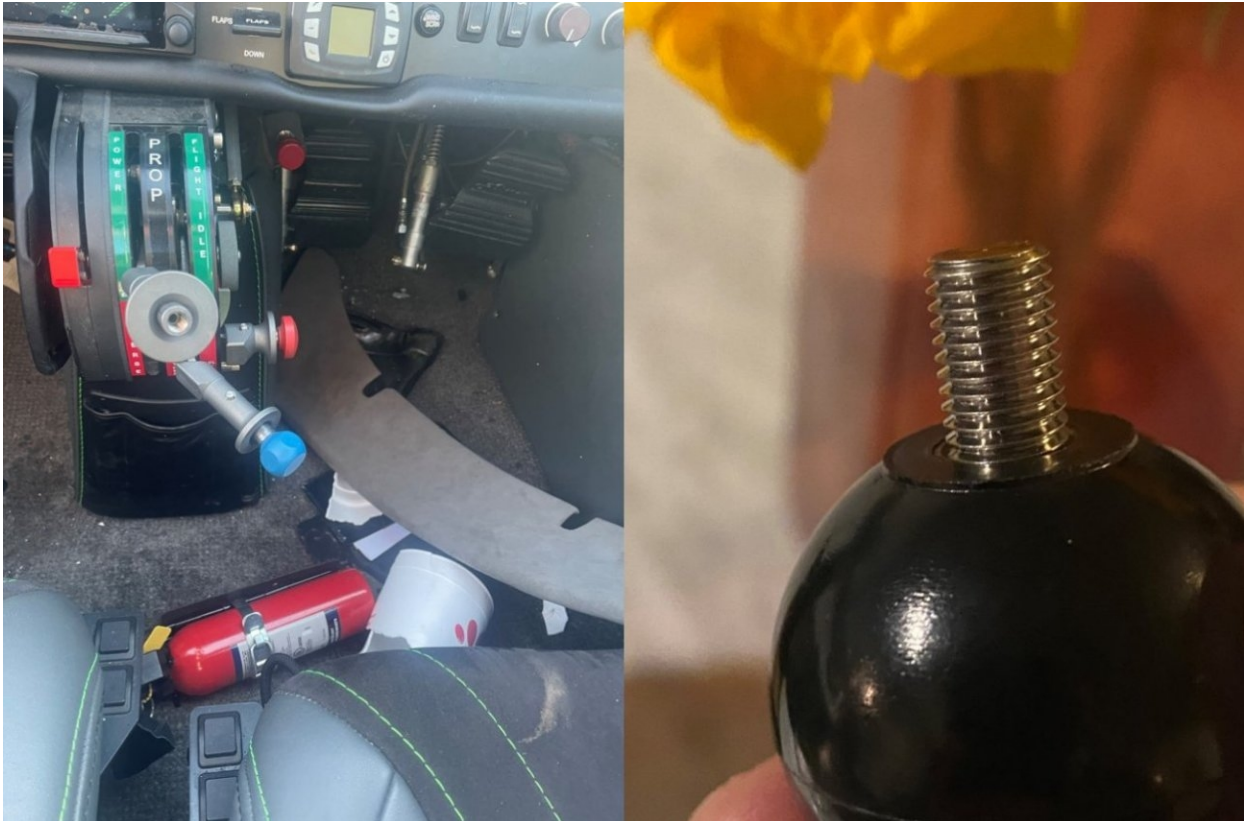
Postaccident examination of the airplane revealed no evidence of any preimpact mechanical malfunctions or failures that would have precluded a normal landing. Although the power lever

ball top unscrewed, the power lever functioned normally between full power and reverse settings.

The pilot reported he had not previously landed at T31 and performed a touch and go landing on runway 17 “to see the field.” The pilot climbed the airplane to the traffic pattern altitude and flew a normal traffic pattern to land on runway 17. During the downwind leg, the pilot pulled back the power lever and the ball on top of the lever (see Figure 1) came off in his hand. The pilot handed the ball to the passenger and continued the landing at the flight idle power position.

Figure 1. Cockpit power lever and ball.

Postaccident examination of the airplane revealed cable continuity from the cockpit power lever to the propeller governor. The cockpit control lever, without the ball top, was actuated between full power and the reverse positions with no anomalies noted. The cockpit door seal was intact, and no damage was noted to the seal adhesive or materials.
