# Aviation Investigation Final Report

<b>Location:</b>	Baytown, Texas	<b>Accident Number:</b>	CEN23LA259
<b>Date &amp; Time:</b>	June 23, 2023, 14:58 Local	<b>Registration:</b>	N8446B
<b>Aircraft:</b>	Piper PA-28RT-201T	<b>Aircraft Damage:</b>	Substantial
<b>Defining Event:</b>	Unknown or undetermined	<b>Injuries:</b>	1 Minor
<b>Flight Conducted Under:</b>	Part 91: General aviation - Personal

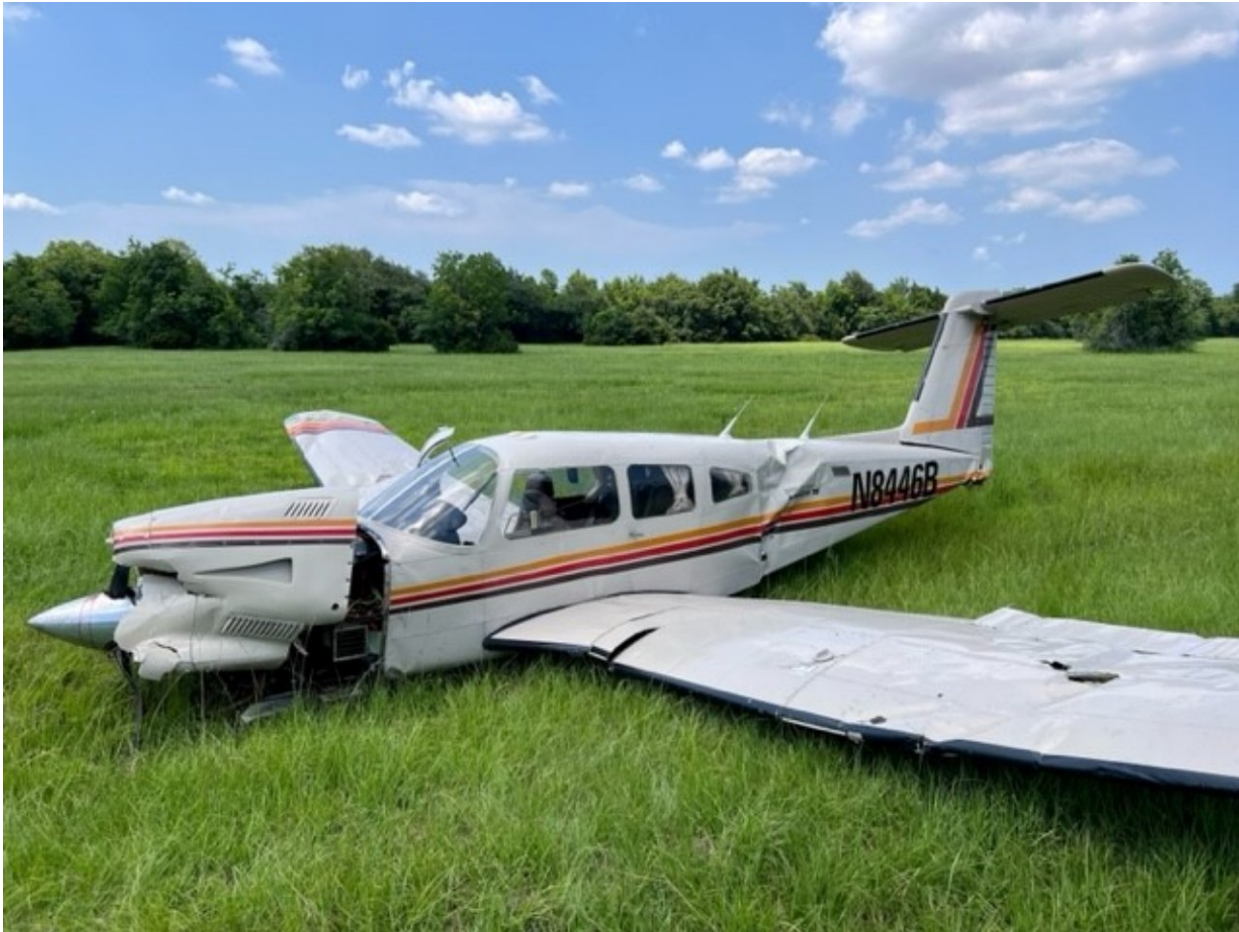
A postaccident examination of the airframe and engine revealed no mechanical malfunctions or failures that would have precluded normal operation. Due to impact related damage, the engine could not be functionally tested and the reason for the total loss of engine power was not determined.

According to the pilot, he planned to locally practice some instrument flight maneuvers in preparation for an upcoming instrument flight rules check ride. After about 30 minutes of flight time, while 5 to 7 miles east of the airport, the engine began to run rough. The pilot leaned the fuel mixture and the engine returned to a normal operating condition. A few minutes later the engine began to run rough again. The pilot enriched the fuel mixture, turned on the auxiliary fuel pump to the low position, and the engine returned to a normal operating condition. The pilot returned to the airport, entered a left downwind, and elected to fly a normal traffic pattern. When the airplane was on the final leg of the traffic pattern and about about 1/2 to 1 mile from the airport, the engine lost total power. The pilot was unable to make the airport and executed a forced landing to an adjacent field. During the forced landing, the landing gear collapsed and the airplane came to rest upright. The airplane sustained substantial damage to both wings and the fuselage (see Figure 1).The pilot estimated the airplane contained about 50 gallons of fuel before takeoff.

Figure 1. Accident airplane (Source: Pilot/owner of the airplane)
