# Aviation Investigation Final Report

<b>Location:</b>	Gordonville, Texas	<b>Accident Number:</b>	WPR23LA130
<b>Date &amp; Time:</b>	March 18, 2023, 10:00 Local	<b>Registration:</b>	N4064X
<b>Aircraft:</b>	Aero Commander 100-180	<b>Aircraft Damage:</b>	Substantial
<b>Defining Event:</b>	Sys/Comp malf/fail (non-power)	<b>Injuries:</b>	1 Minor, 1 None
<b>Flight Conducted Under:</b>	Part 91: General aviation - Personal

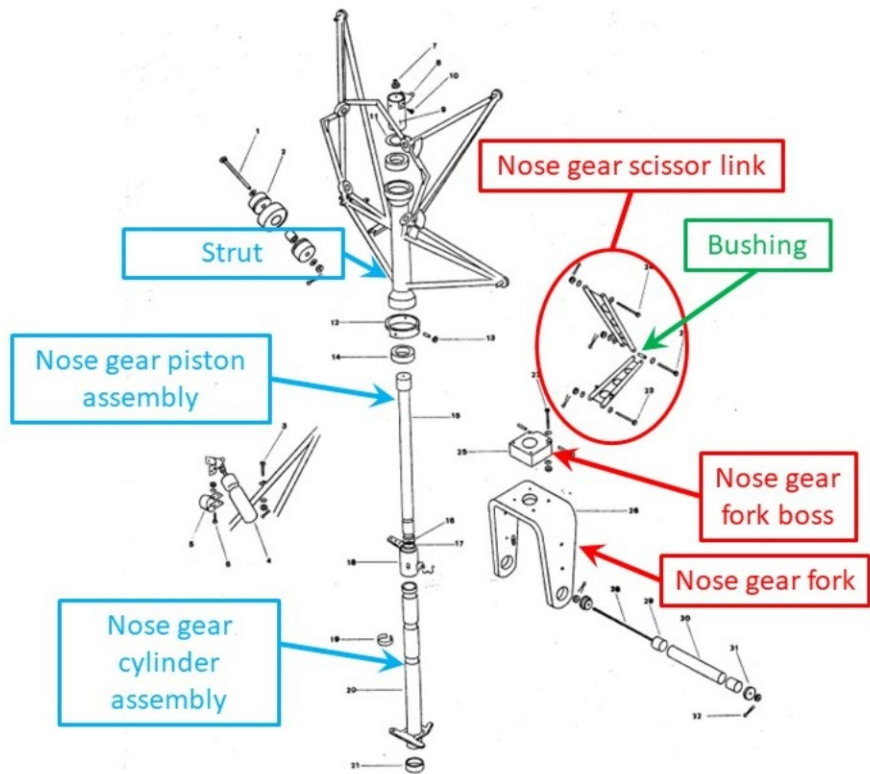
Figure 1. Nose gear assembly from illustrated parts catalogue

A National Transportation Safety Board Materials Laboratory examination revealed evidence of fatigue on the left side of the upper scissor link at the fracture face. There was insufficient evidence to determine the source of the fatigue crack.

The aircraft logbooks showed that on March 15, 2022, a "new torque link upper attachment bushing was installed on the nose strut." According to the illustrated parts catalogue, there is a bushing installed at the bottom of the upper scissor link adjacent to the area that fractured at the ears. However, the bushing and its associated hardware remained attached and secure at the upper torque link.
