Aviation Investigation Final Report

Location:	Indianola, Mississippi	Accident Number:	CEN23LA194
Date & Time:	May 18, 2023, 08:17 Local	Registration:	N63B
Aircraft:	Beech 35-C33A	Aircraft Damage:	Destroyed
Defining Event:	Fire/smoke (non-impact)	Injuries:	1 None
Flight Conducted Under:	Part 91: General aviation - Personal

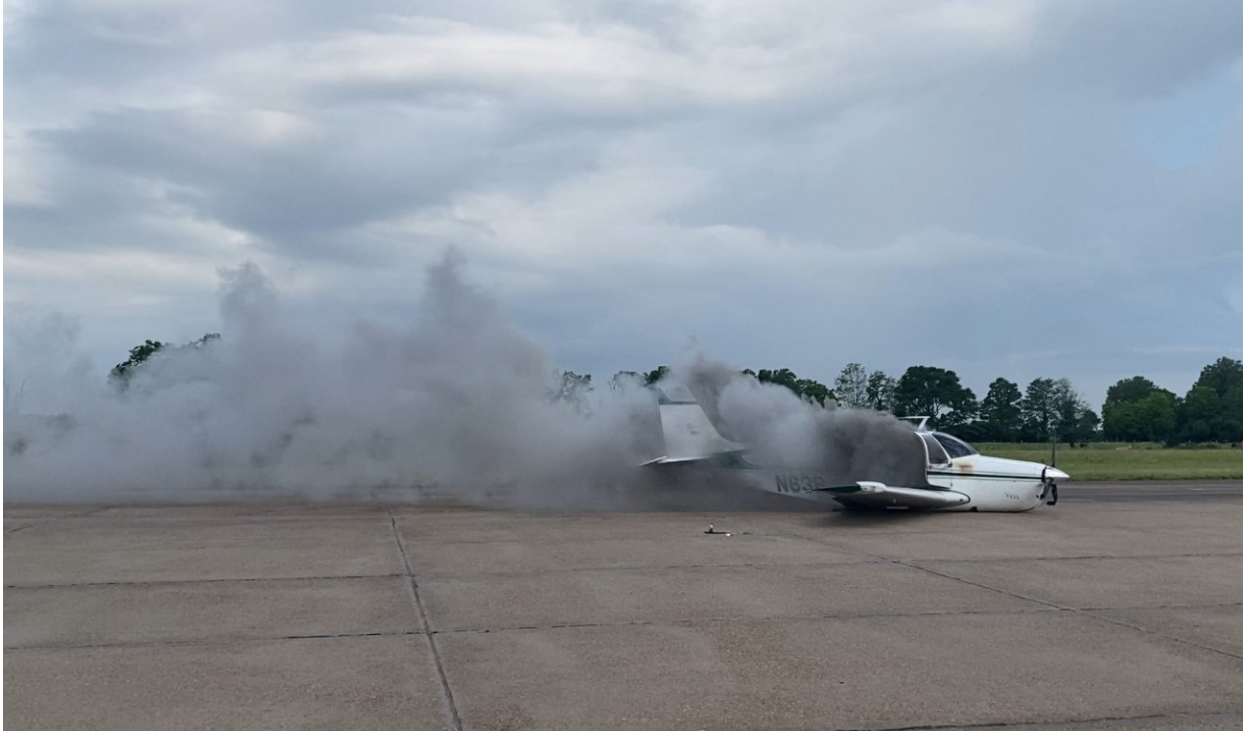
The postaccident examination was unable to determine the source of the fire due to the extensive fire damage.

Figure 1. The airplane on the runway with dark smoke in the cabin and heat discoloration below the front right windscreen, near the battery box.

After the accident, the responding Federal Aviation Administration inspector examined the wreckage and stated it appeared that the fire had started below the battery box. He could not tell if it originated on the engine side or the cockpit side of the firewall. He removed the end cap from the starter and the internal components did not reveal any anomalies. All of the electrical wiring in the cabin area was burned down to bare copper wire. Also, he found no compromised fuel lines on the engine side of the firewall. He identified one melted fuel line on the cockpit side of the firewall, which was behind the pilot's (left) side of the instrument panel. Portions of the fuel line had melted around an adjacent avionics wire, which exhibited damage to the outer shielding. Due to the significant fire damage, the inspector was unable to determine the source of the fire.
