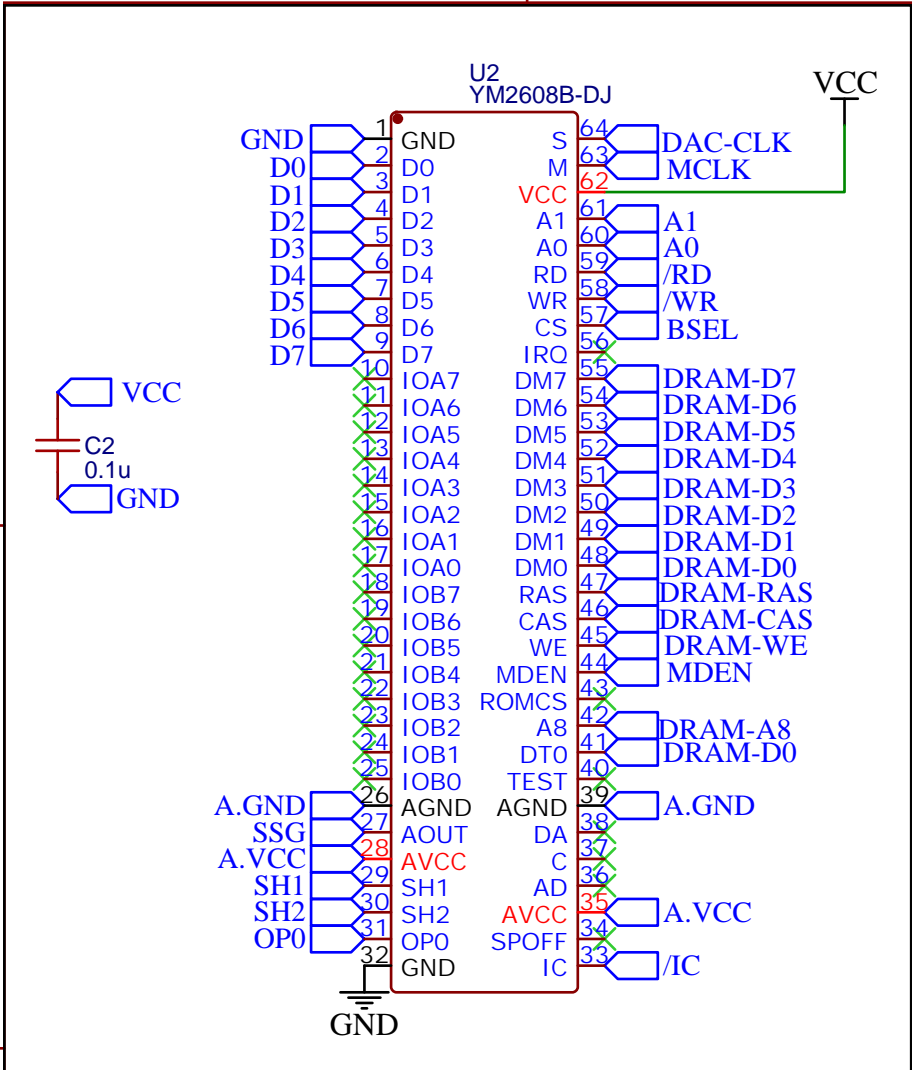
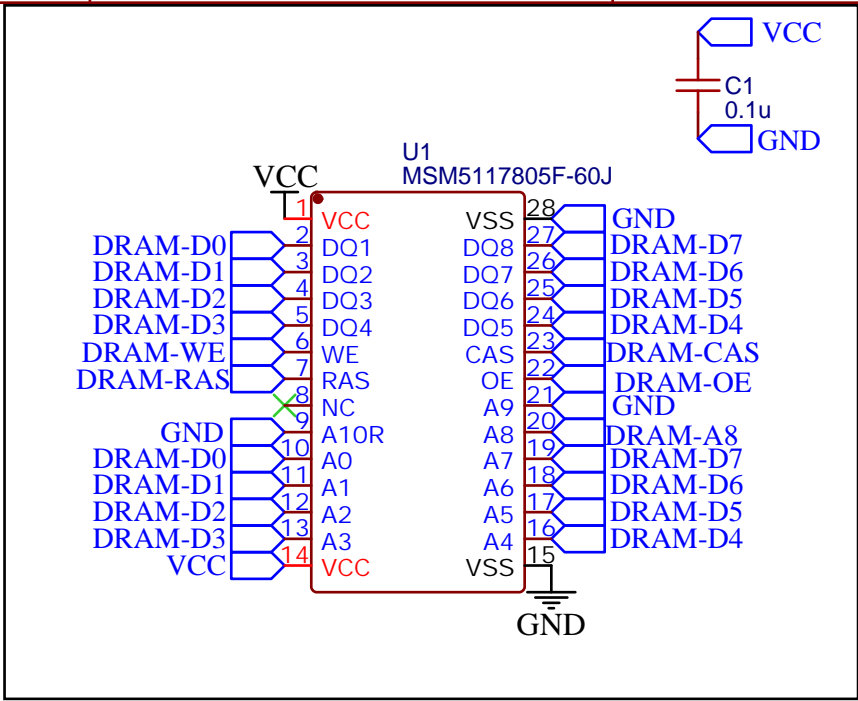
1n电容位置放置错误  
60TK焊盘间距过大  
2023.12.21  
1.焊盘间距已修复，需要再次测量实物  
2.Vbias已添加  
3.滤波电容已更换

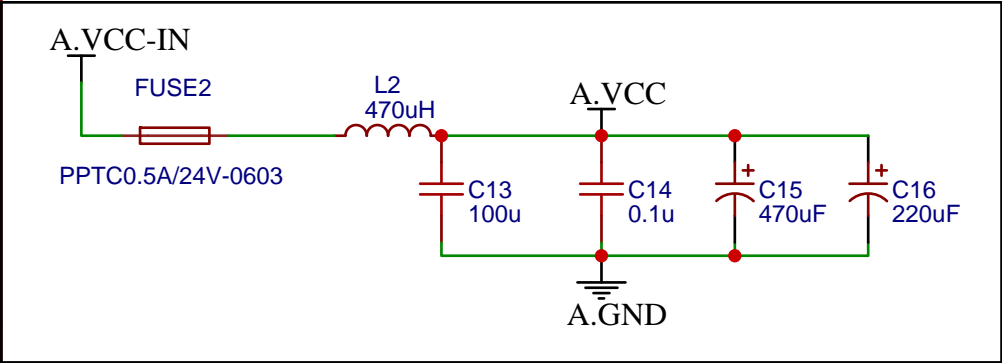
去掉二极管，那个会引起压降
