Very Real Site Report for testing

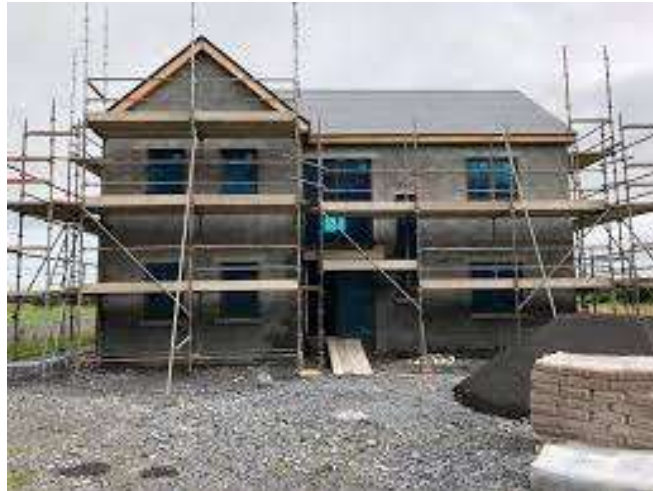
House A is progressing well

Roof is up.

Walls are Ready for external render.

Windows are installed.

Current access to the house is unsafe.

Scaffolding is not tied properly in in some parts.

Missing some windowsills need more.

A new safer ramp should be installed.
