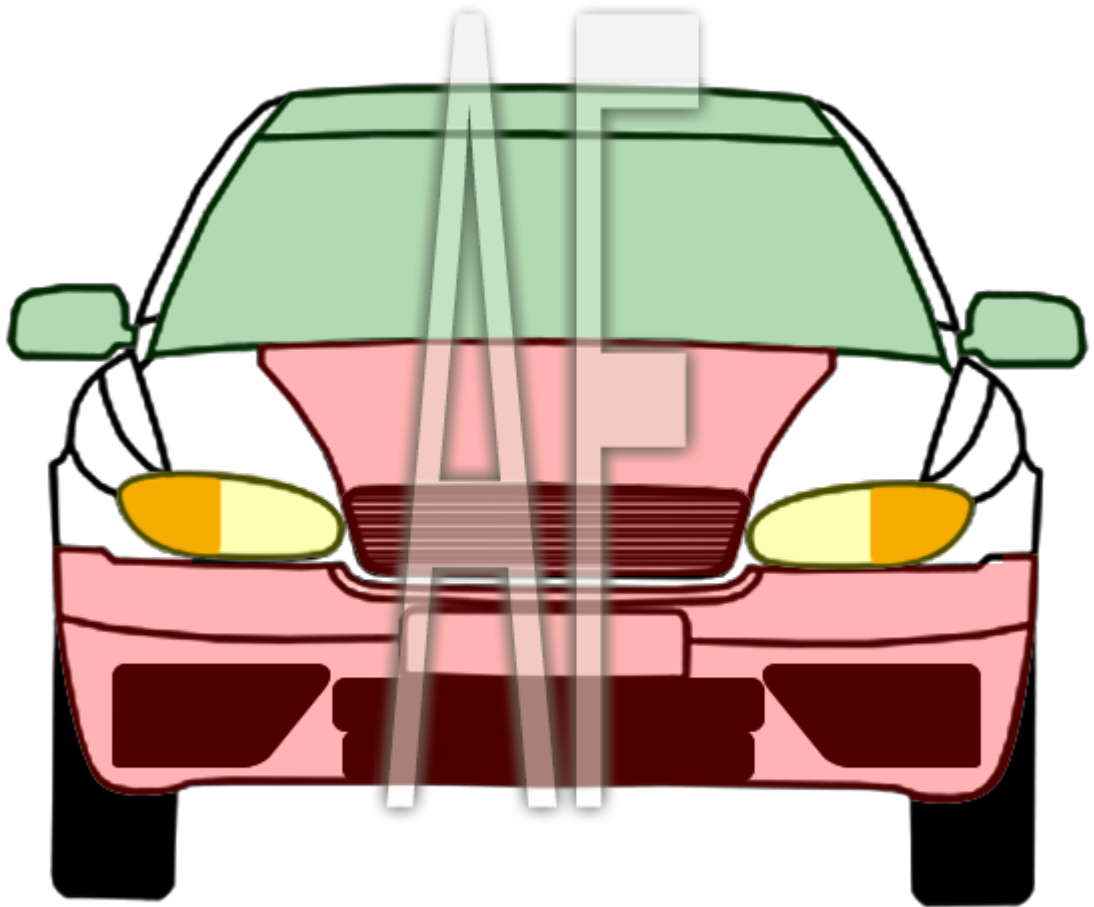
Front side

Roof Condition: Seems OK

Windshield Condition: Seems OK

Hood Condition: Major damage

Grill Condition: Major damage

Front Bumper Condition: Major damage

Mirrors Condition: Seems OK

Front Lights Condition: Minor damage

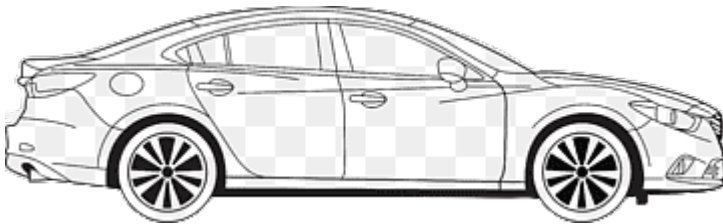
Right side

Right Rear Quarter Condition: Seems OK

Right Rear Door Condition: Seems OK

Right Front Door Condition: Seems OK

Right Fender Condition: Seems OK
