December 20, 2022

Insured:	Harry Silverglide
Address:	15771 Waite Island Drive Fort Myers, Florida 33908
D/O/L:	9/28/2022
Your File No.:	80134492
FCNA File No.:	105783

The purpose of the site investigation and this report was to provide an opinion on: (a) the cause, origin, duration, and extent of the reported damage to the exterior, interior, and roof, (b) whether this damage was a result of wind or flood associated with Hurricane Ian, and (c) the repairability of the roof.

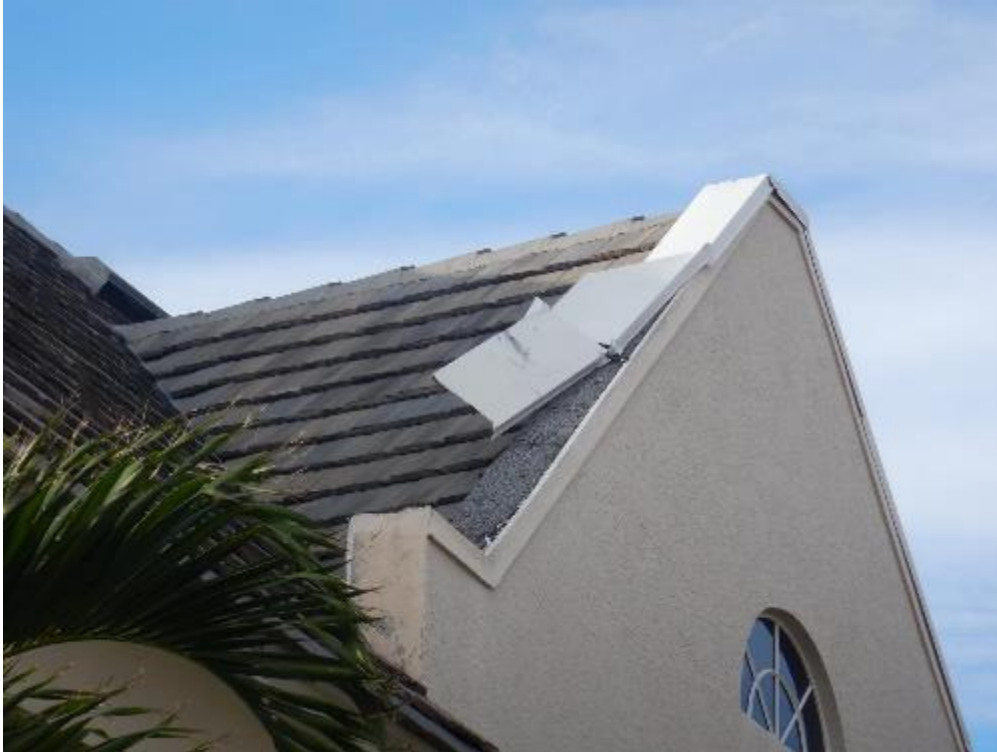
Photograph #8 – Approximately three (3) fascia boards along the left side of the residence were loose, fractured, separated, and missing.

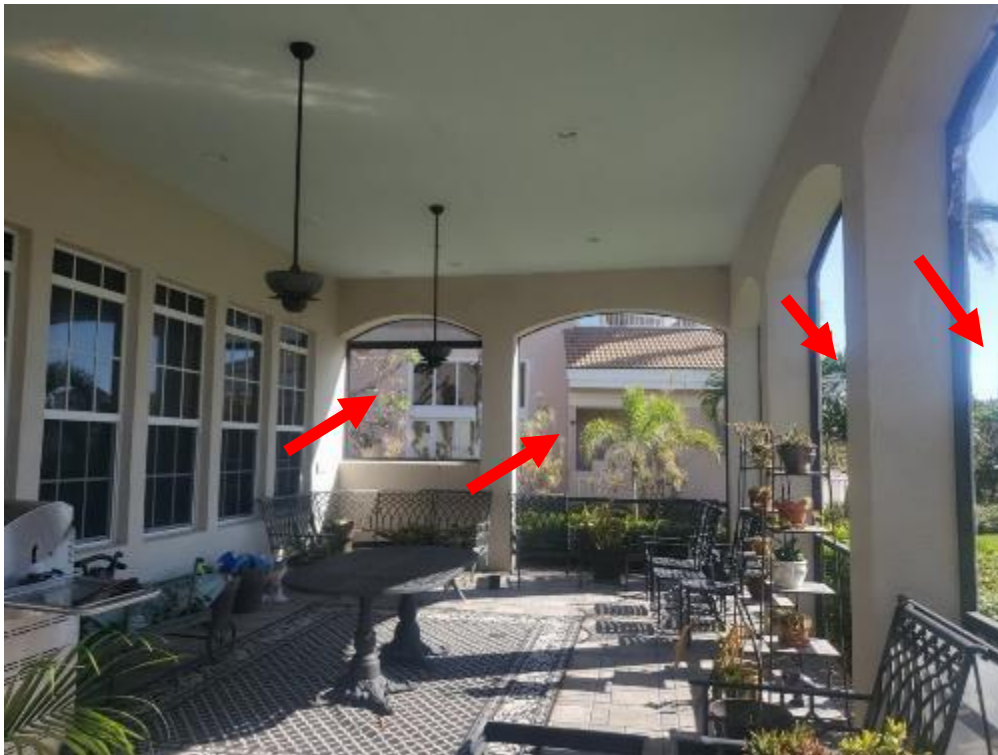
Photograph #13 – Approximately fifty-five (55) pool and patio enclosure screens along the rear side of the residence were loose, torn, separated, and/or missing (representative condition).

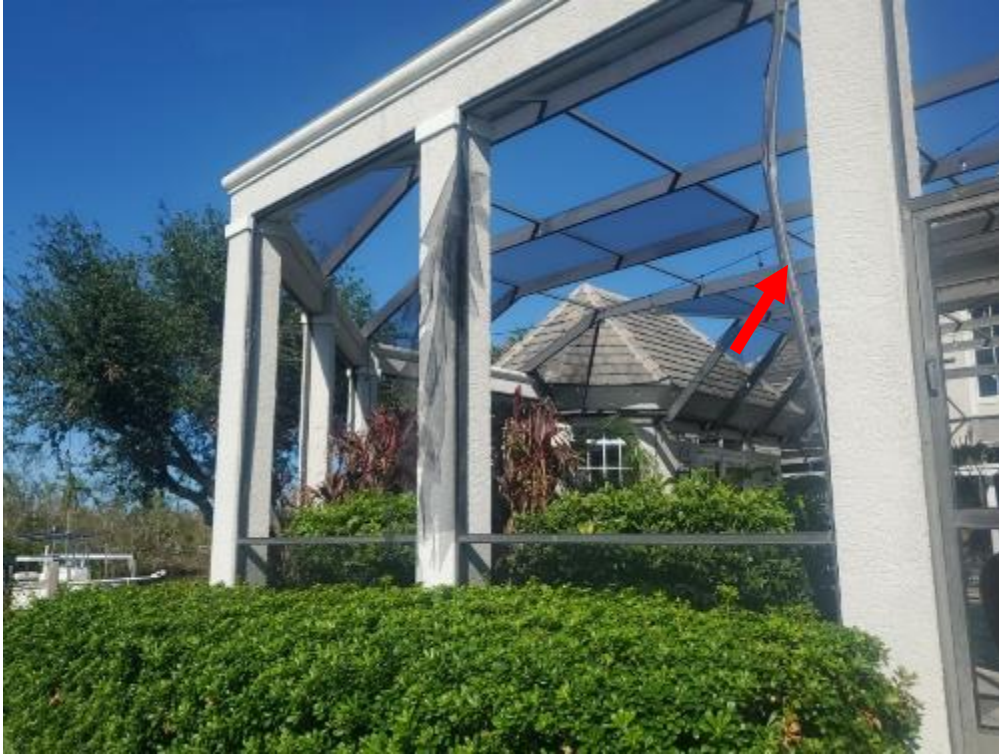
Photograph #14 – The patio enclosure screens along the rear side of the residence were loose, torn, separated, and/or missing (representative condition).

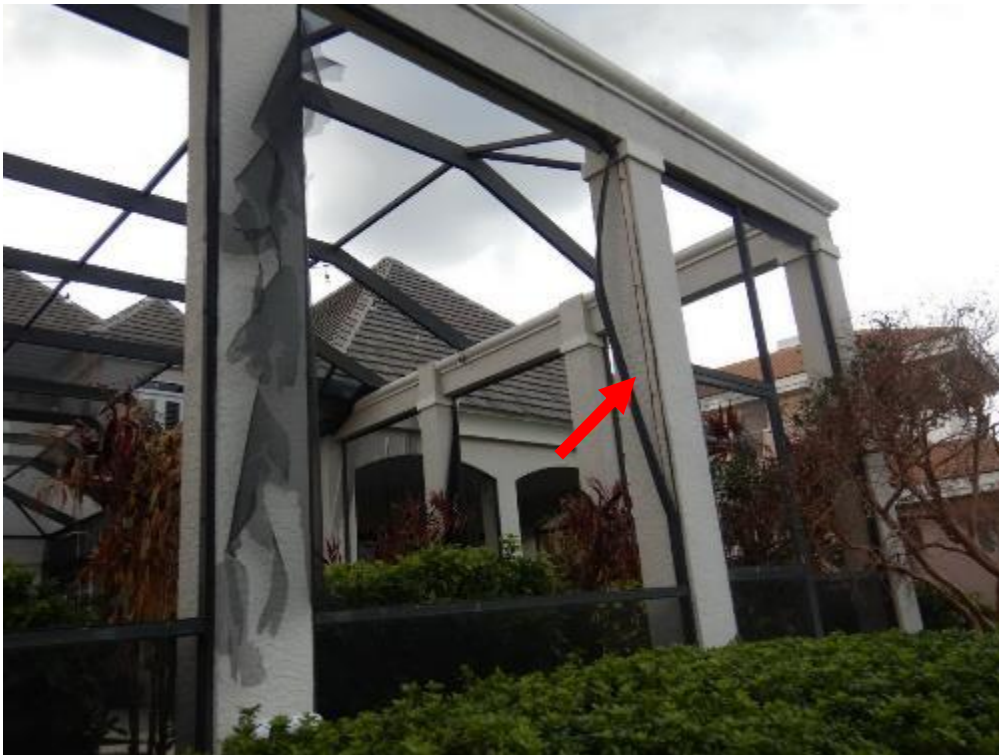
Photograph #15 – Approximately nine (9) pool enclosure framing members were bent, twisted, warped, fractured, or separated (representative condition).

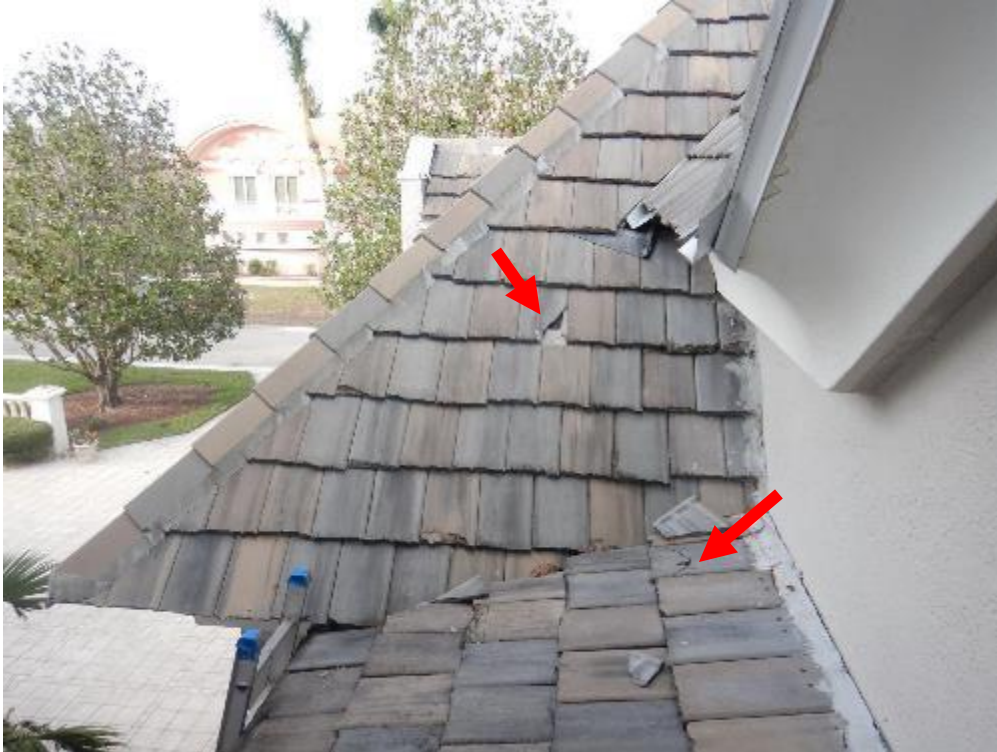
Photograph #36 – One (1) randomly fractured, scattered, and/or missing tile was on the front-facing facet.

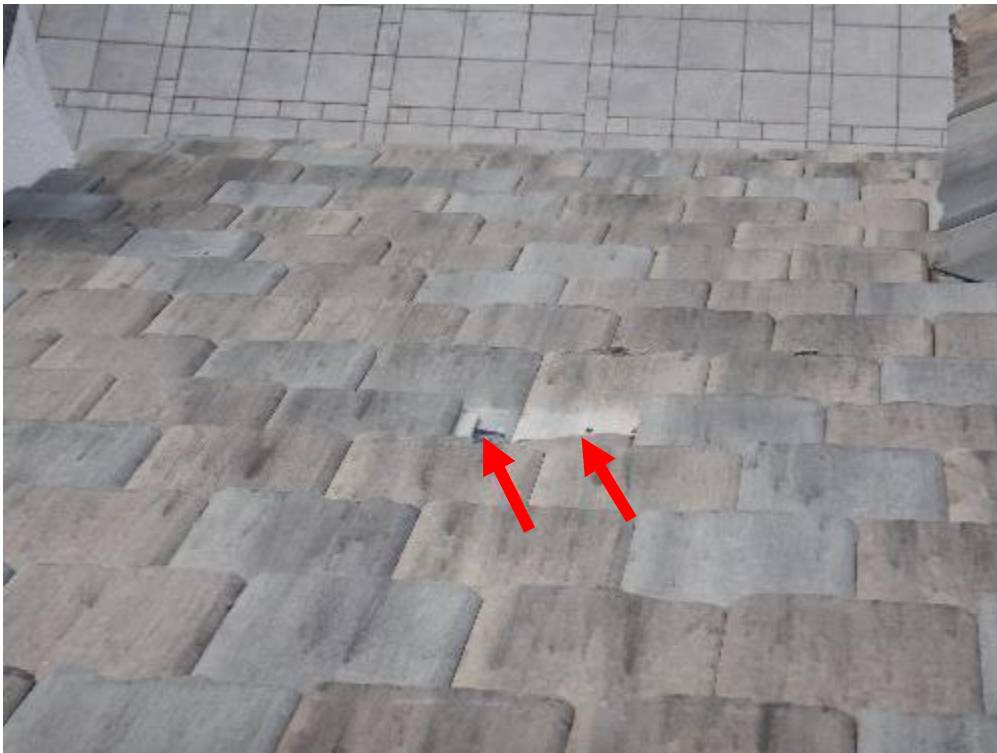
Photograph #37 – Two (2) randomly fractured, scattered, and/or missing tiles were on the front-facing facet.

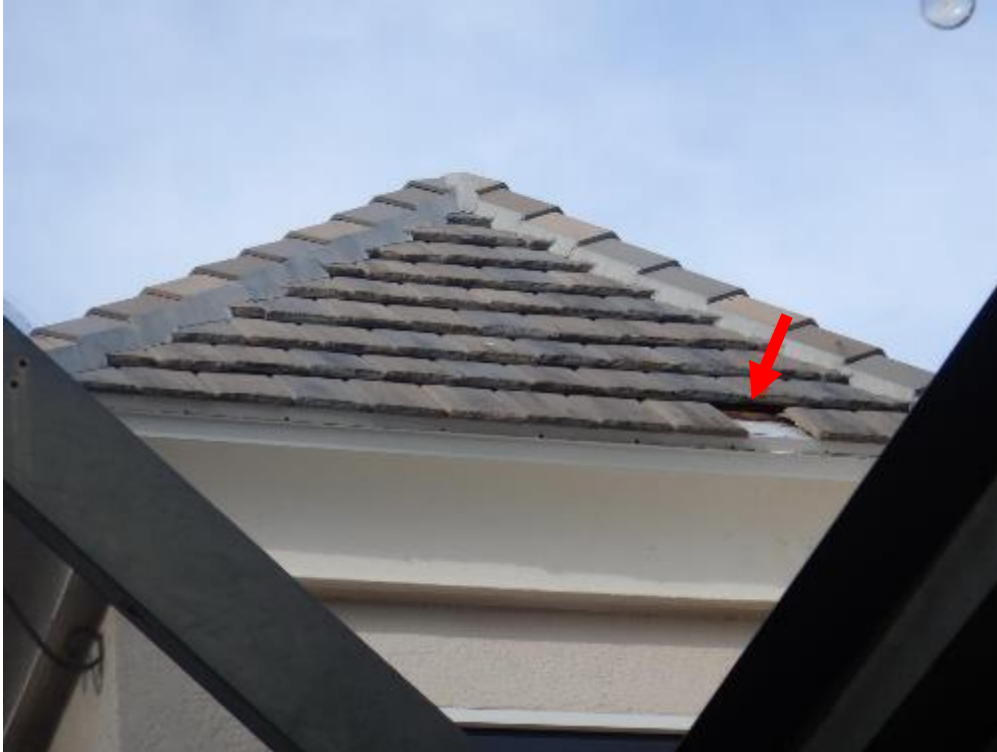
Photograph #40 – Three (3) randomly fractured, scattered, and/or missing tiles were on the right-facing facet.

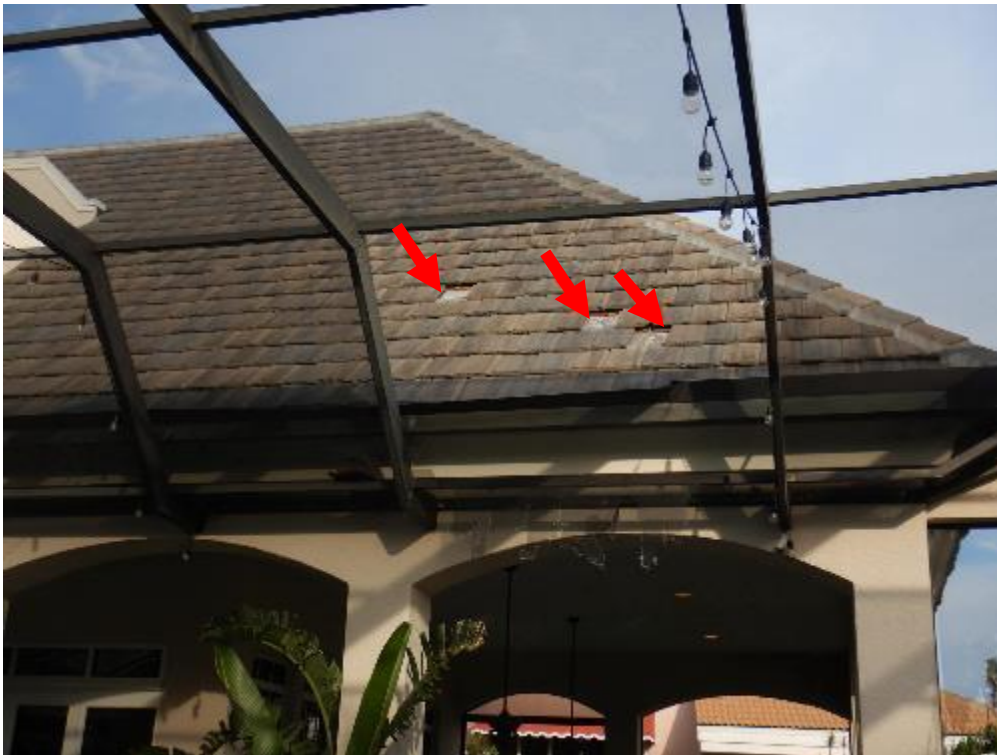
Photograph #41 – One (1) randomly fractured, scattered, and/or missing tile was on the rear-facing facet.

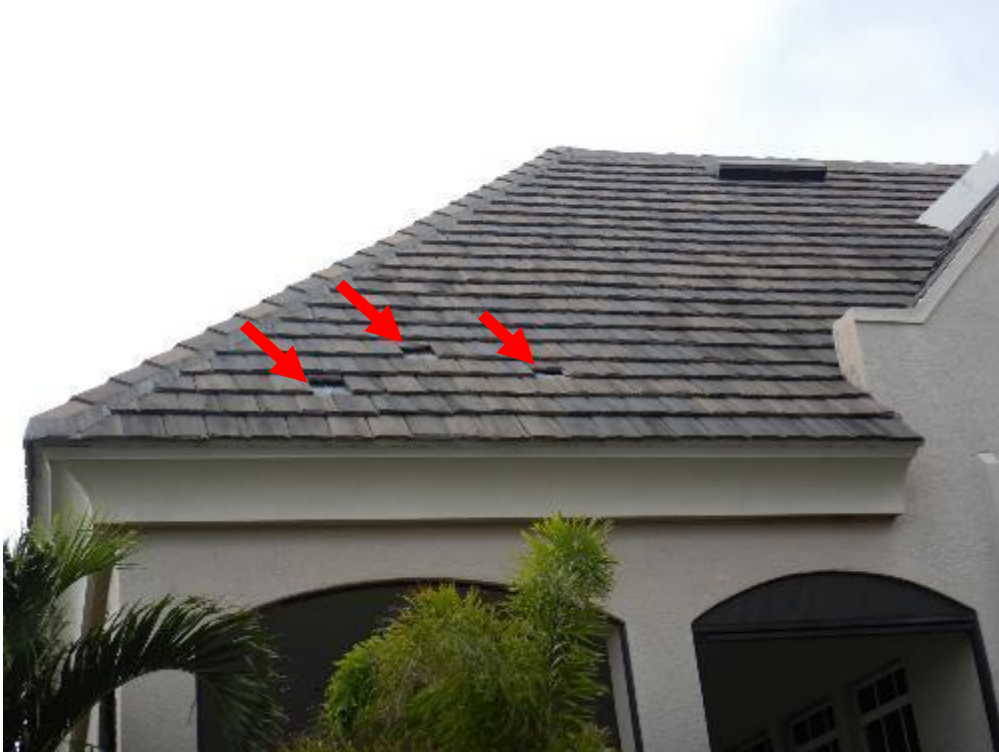
Photograph #42 – Three (3) randomly fractured, scattered, and/or missing tiles were on the rear-facing facet.

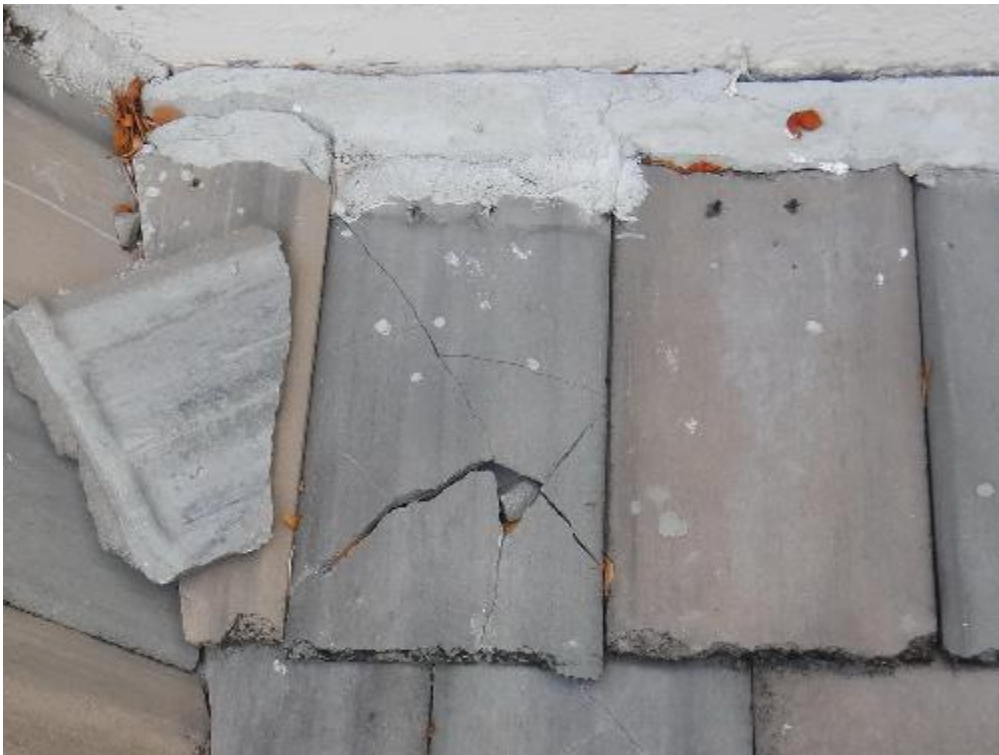
Photograph #43 – Three (3) randomly fractured, scattered, and/or missing tiles were on the left-facing facet.

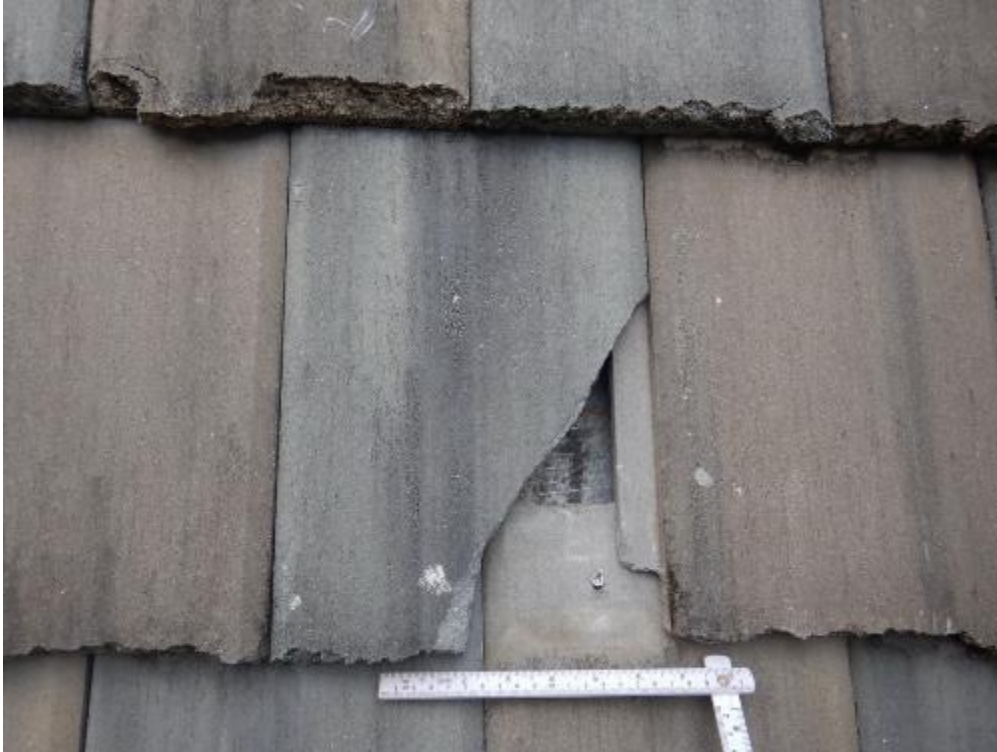
Photograph #44 – A randomly fractured tile was on the front-facing facet (representative condition).

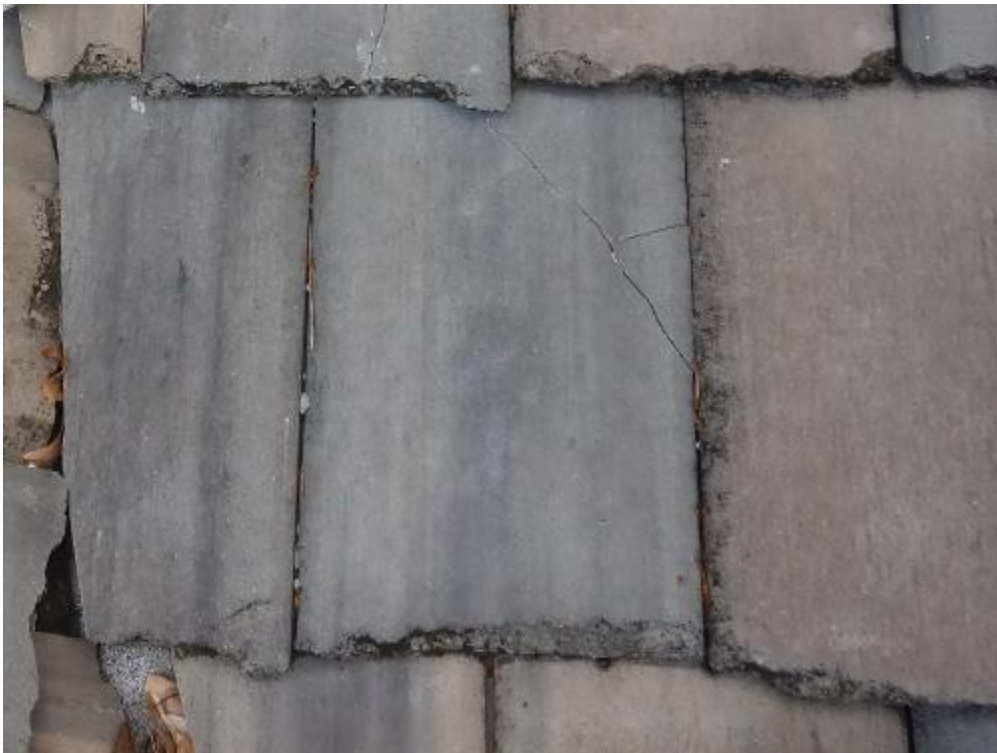
Photograph #45 – Diagonal fractures were in several field tiles (representative condition shown here). No abrasion (impact) marks were on the tiles.

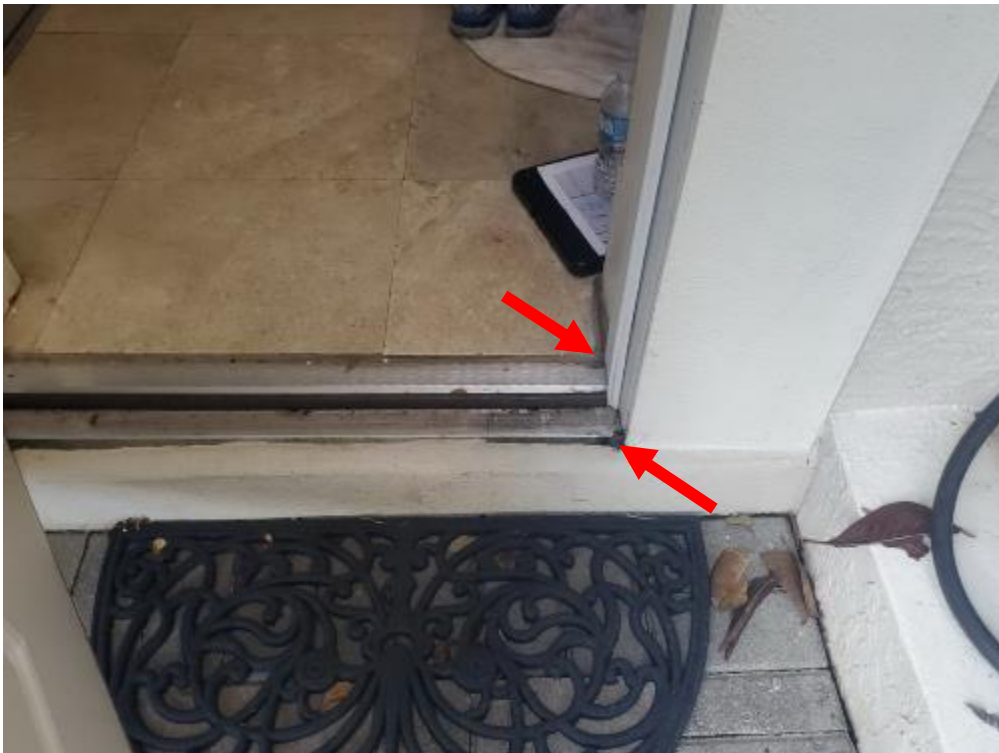
Photograph #51 – Dark brown stains, cracks, and/or peeled texture were on the baseboard and the floor adjacent to the garage door.

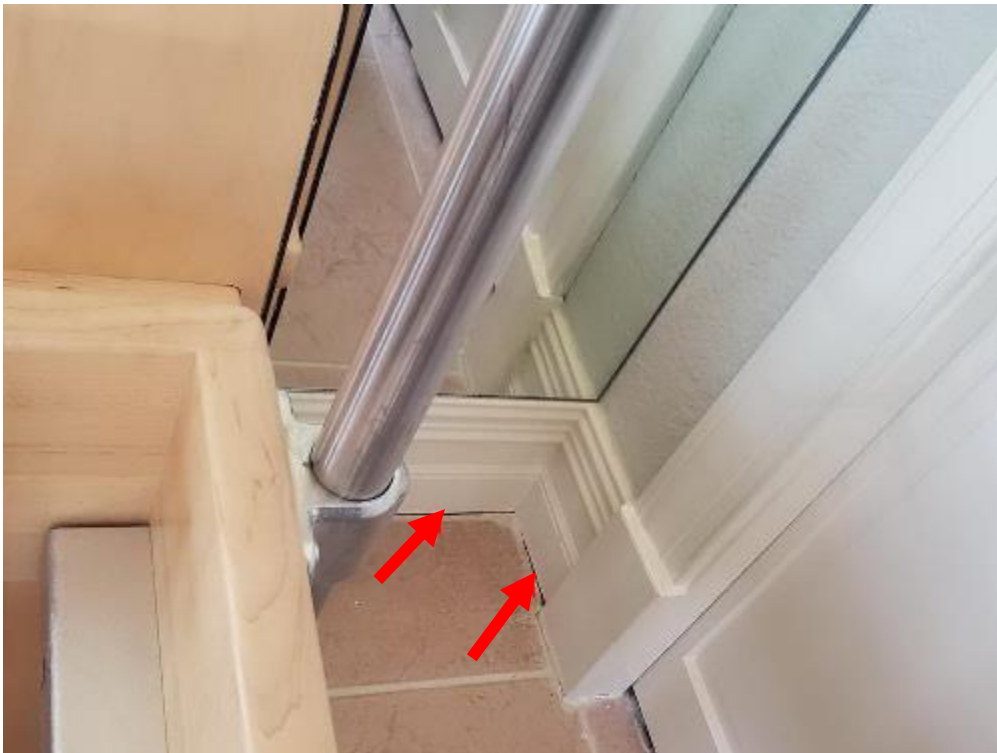
Photograph #53 – Cracks/separations up to 1/8-inch wide were between the floor and baseboard interface of the detached studio of the residence (representative condition shown here).

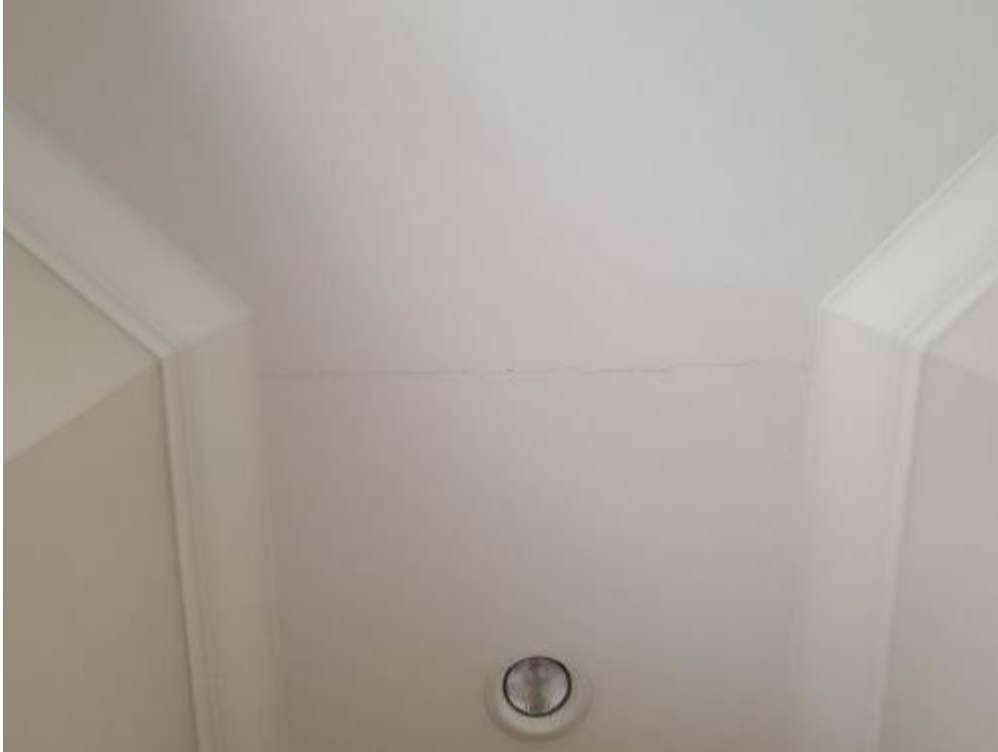
Photograph #56 – Cracks up to 1/16-inch wide without discoloration were on the first story hallway ceiling (representative condition shown here).

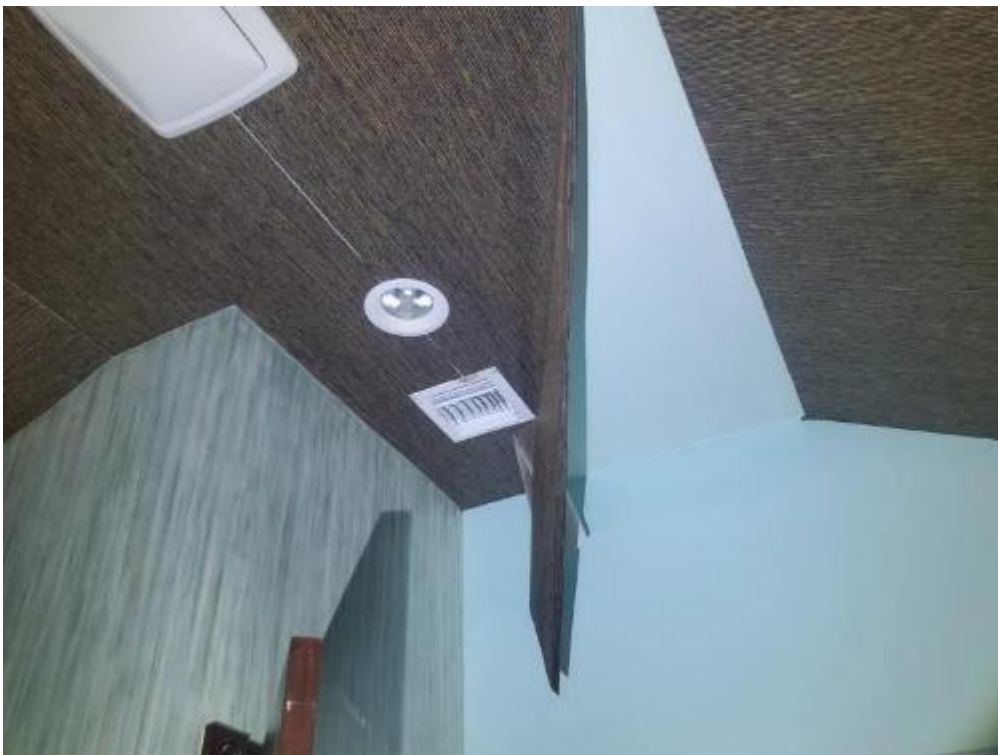
Photograph #57 – Cracks up to 1/16-inch wide were on the first story hallway ceiling (representative condition).

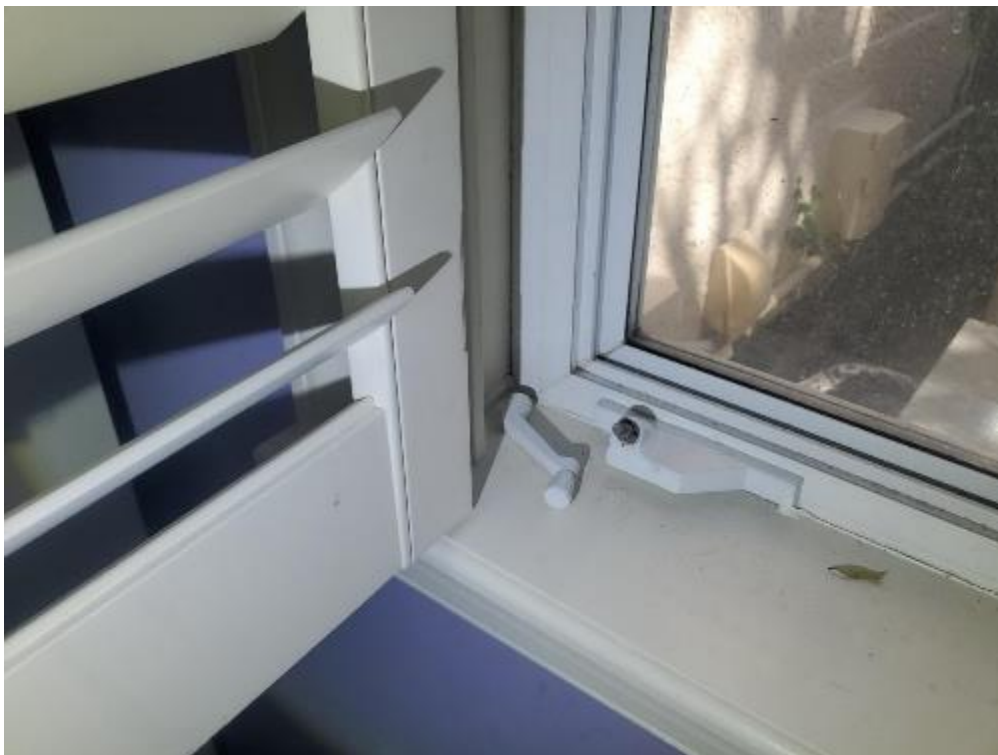
Photograph #59 – Light brown stains and cracks up to 1/8-inch wide were in the sealant and/or paint at the interface of the wood-framed windows and interior trim of the laundry room window (representative).

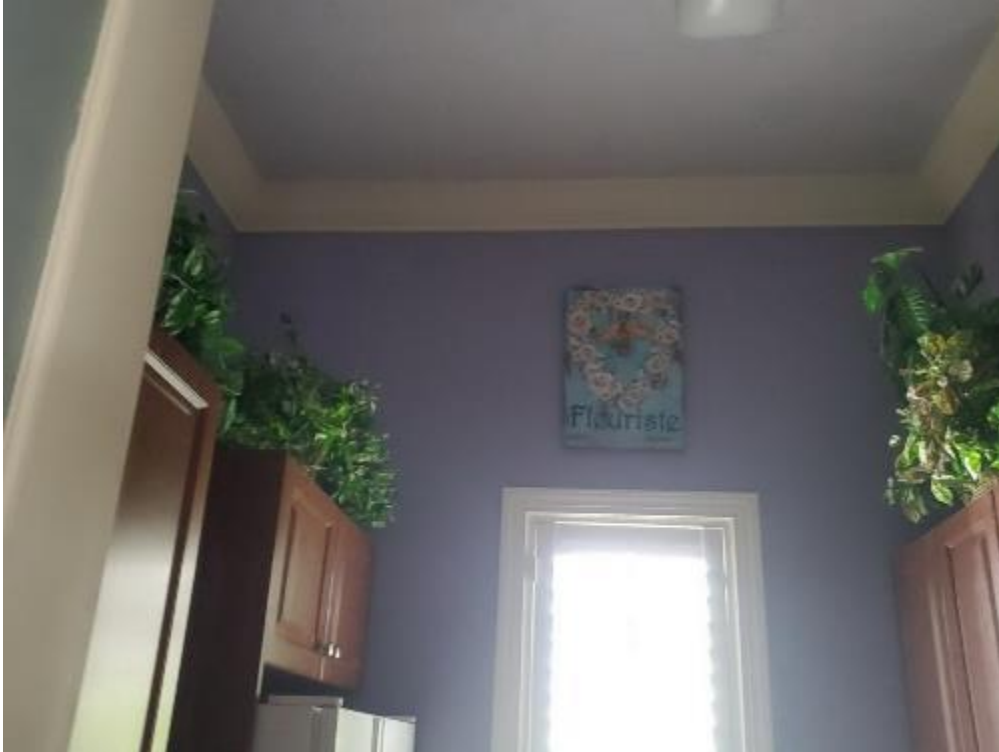
Photograph #60 – Light brown stains and cracks up to 1/8-inch wide were in the sealant and/or paint at the interface of the wood-framed windows and interior trim of the laundry room window (representative).

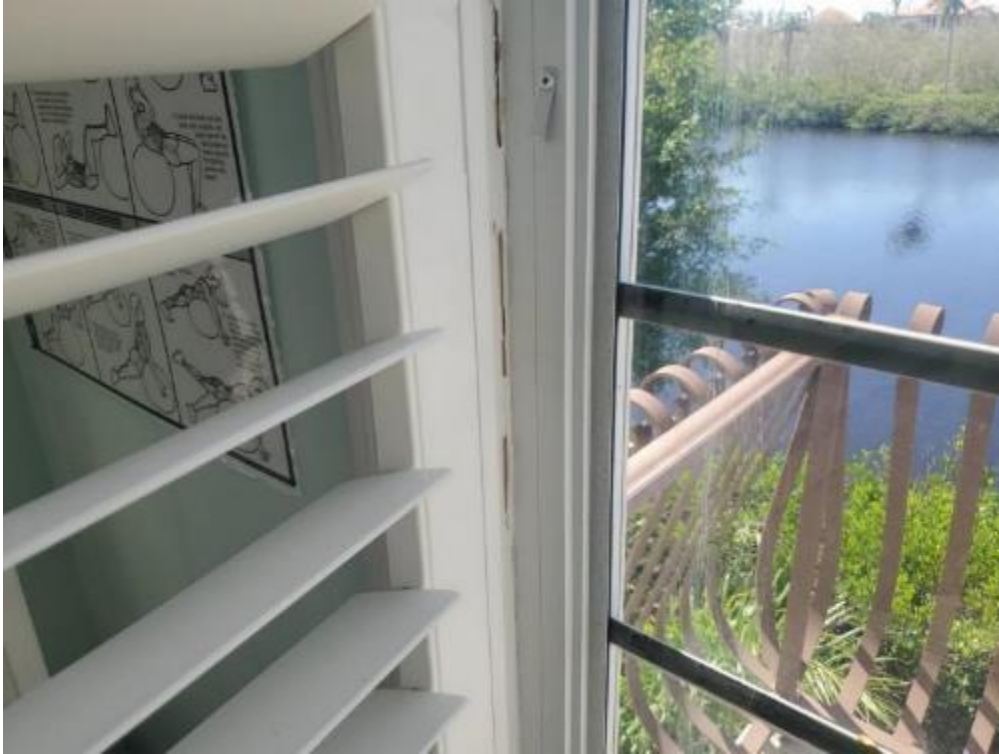
Photograph #64 – Light brown stains and cracks were around the second story gym window (representative condition shown here).

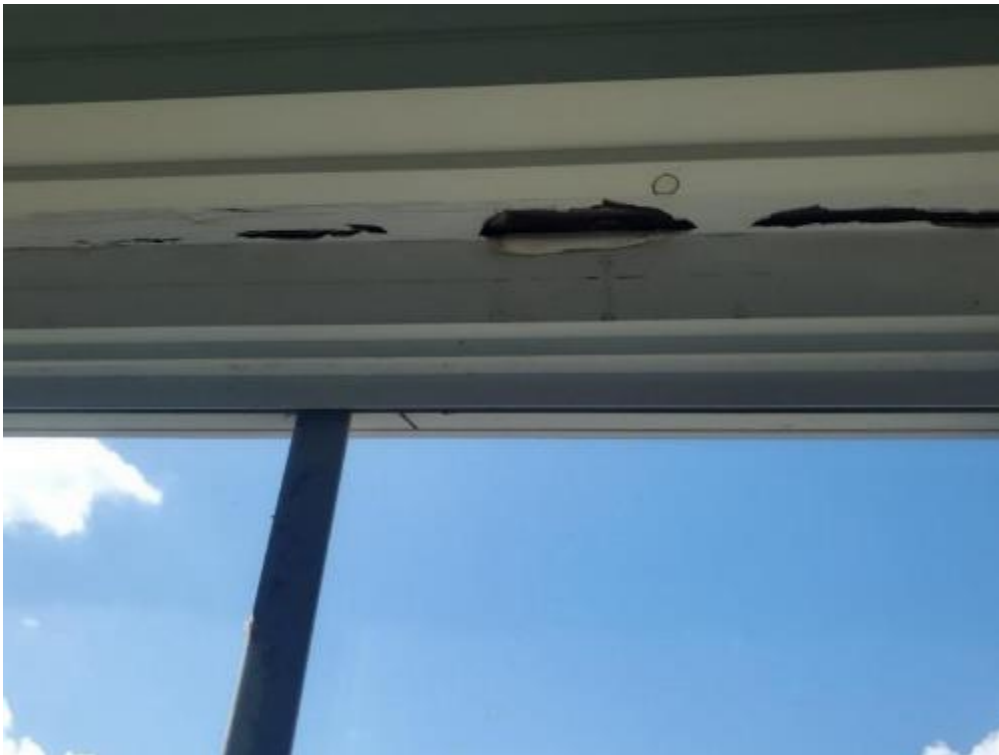
Photograph #65 – Gaps up to 2 inches long were between the ends of the weather stripping seals and frames of the second story gym window (representative condition shown here).

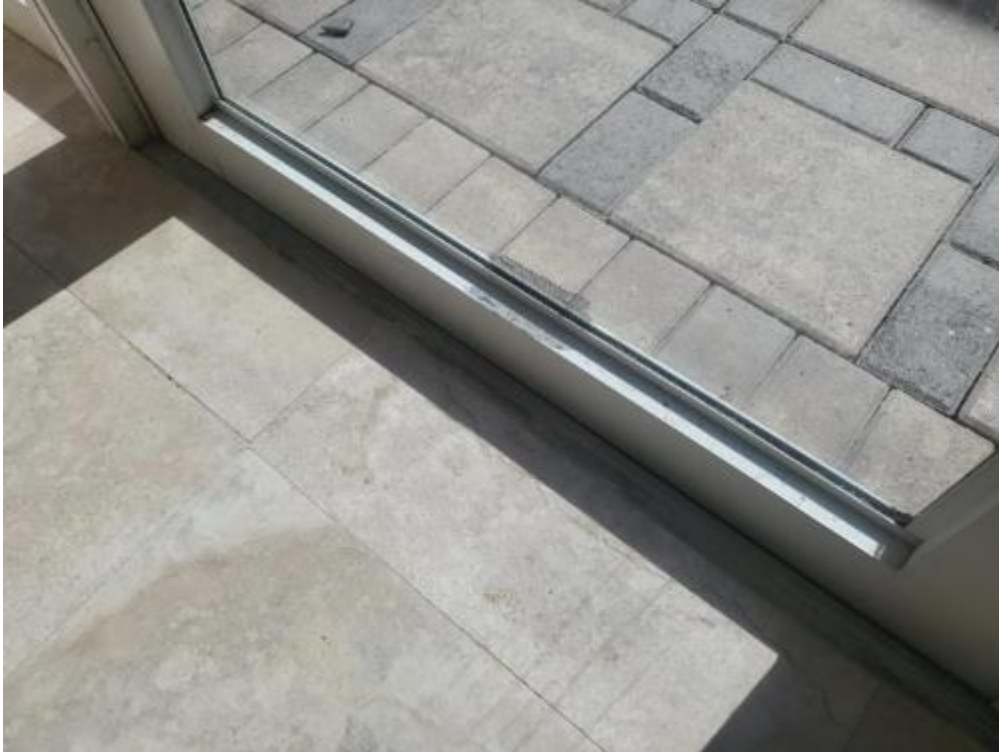
Photograph #68 – Light brown stains, peeled texture, and/or cracks were around the door and floor below the first story living room door (representative condition shown here).

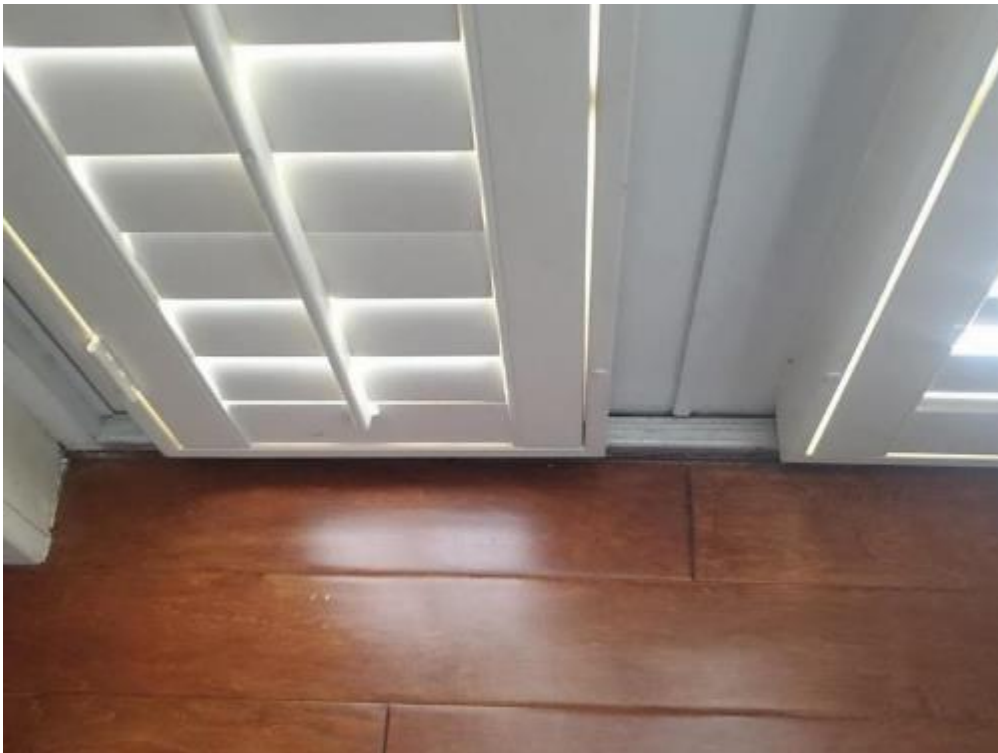
Photograph #71 – Light brown stains, peeled texture, and/or cracks were around the door and floor below the second story rear-left bedroom door (representative condition shown here).

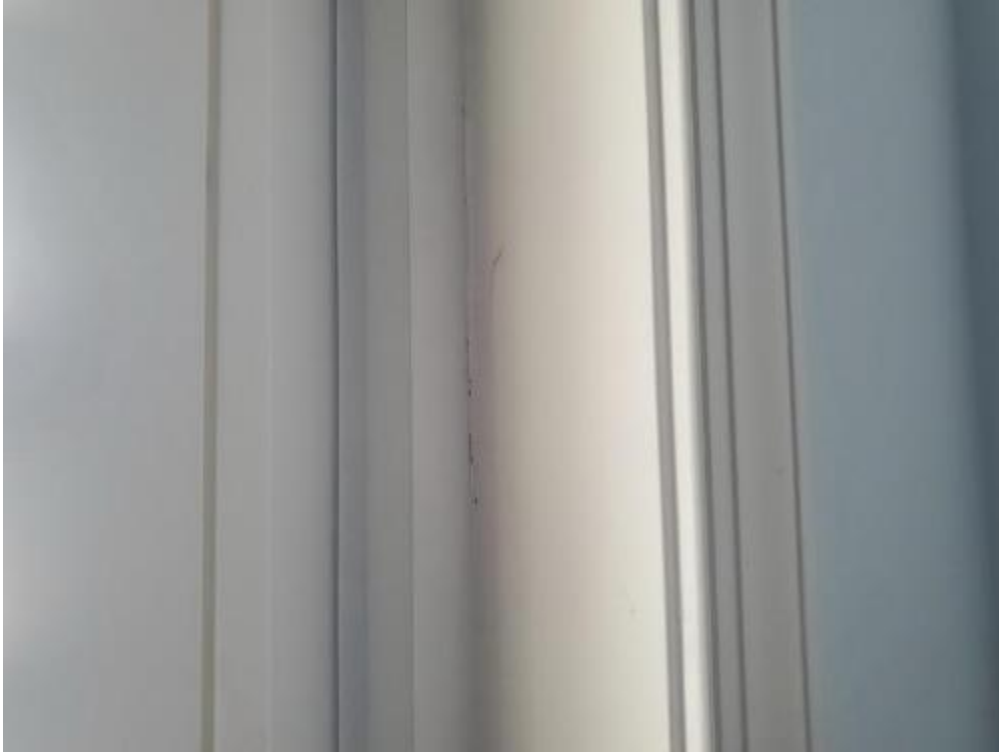
Photograph #72 – Light brown stains, peeled texture, and/or cracks were around the door and floor below the second story rear-left bedroom door (representative condition shown here).

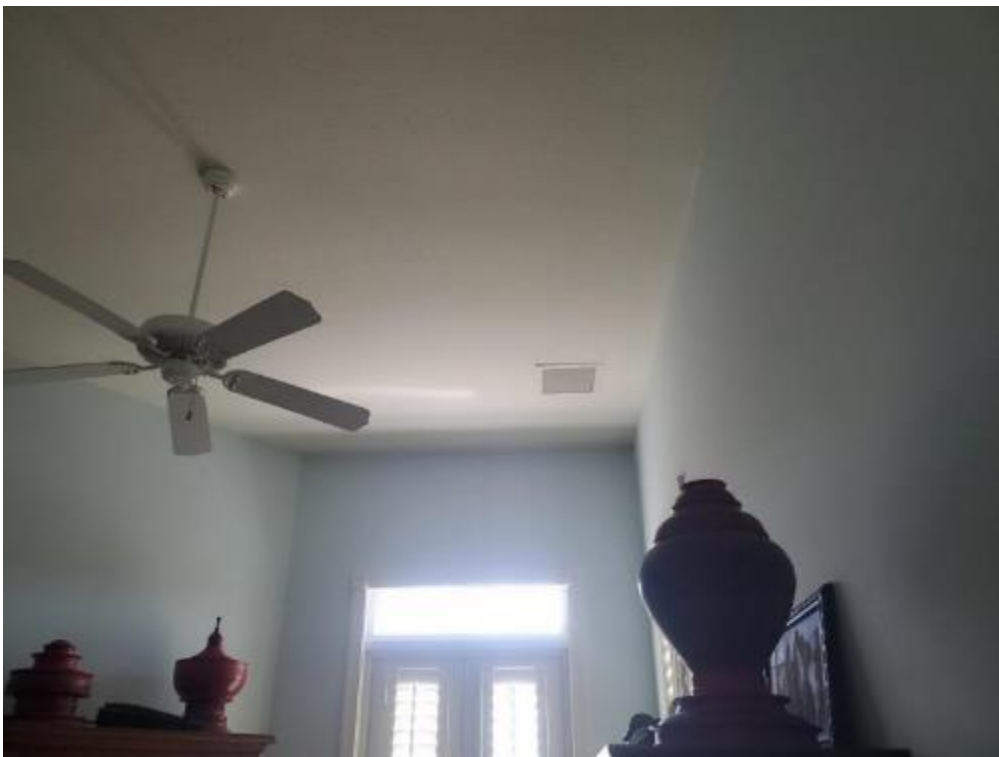
Photograph #73 – Peeled texture and/or cracks were around the second story rear-left bedroom door (representative condition shown here).

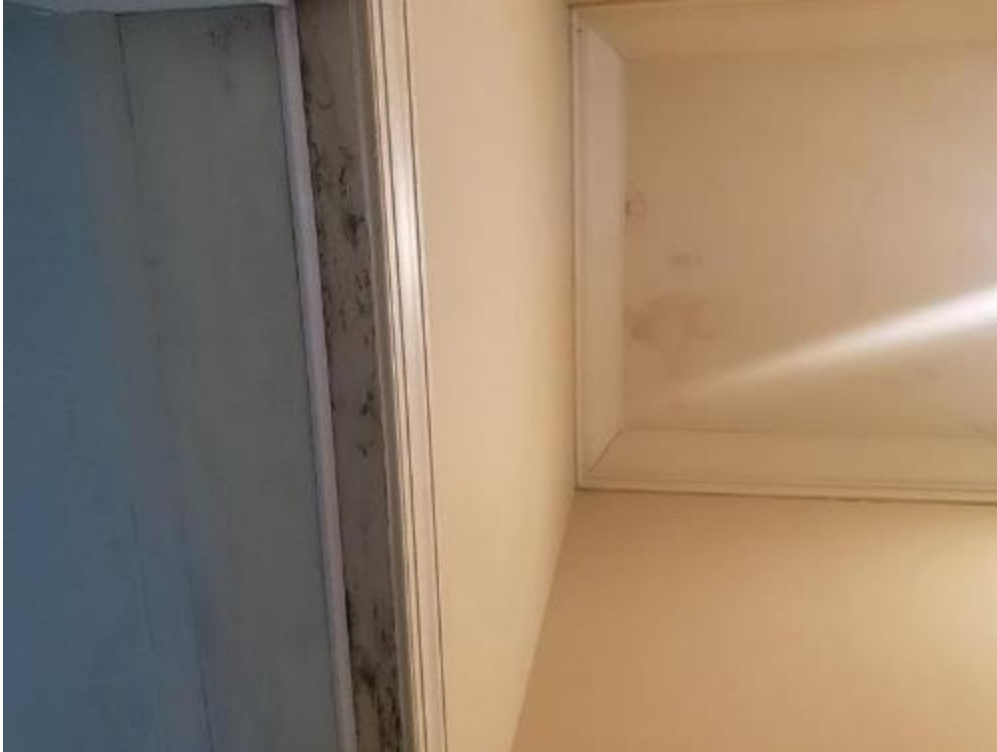
Photograph #76 – Dark brown stains were on the ceiling, wall, and around the door frame of the garage.

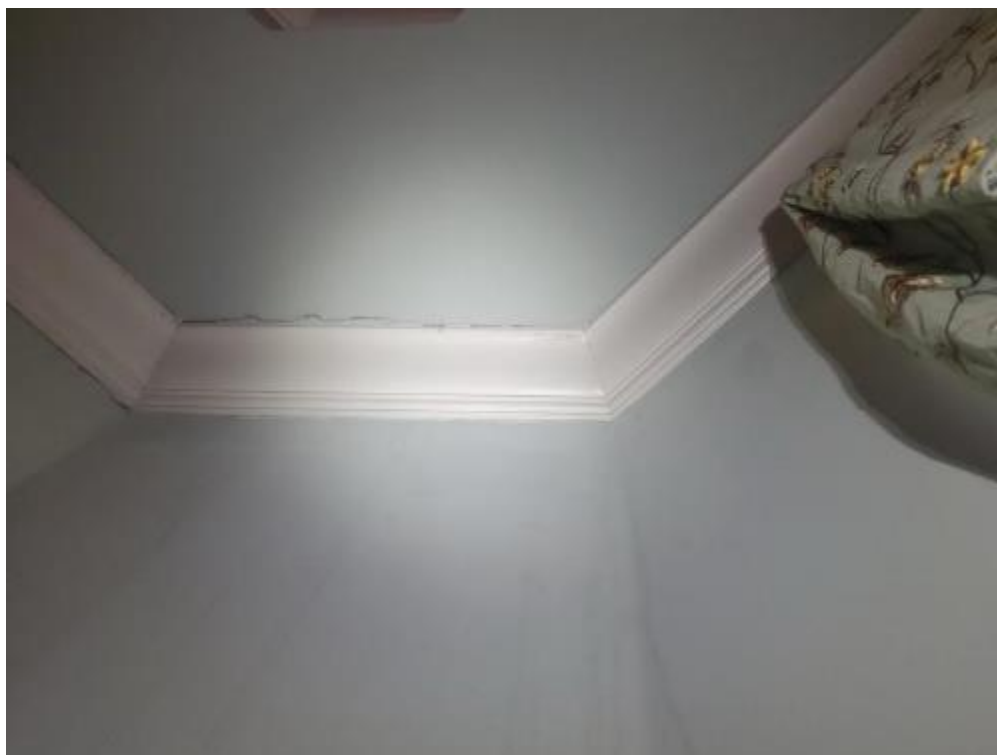
Photograph #79 – Light brown stains, vertical streaks, and/or cracks up to 1/8-inch wide were on the ceiling, ceiling-to-crown molding interface, and walls of the apartment living room.

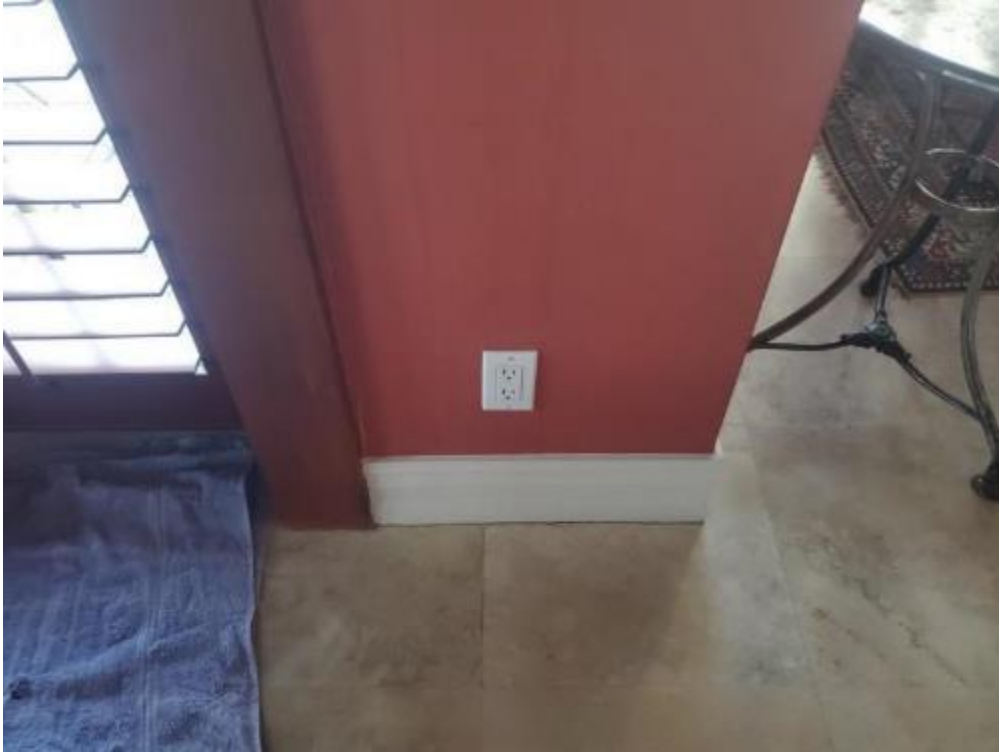
Photograph #82 – Light brown stains, vertical streaks, and/or cracks up to 1/8-inch wide were on the ceiling and wall of the first story game room.

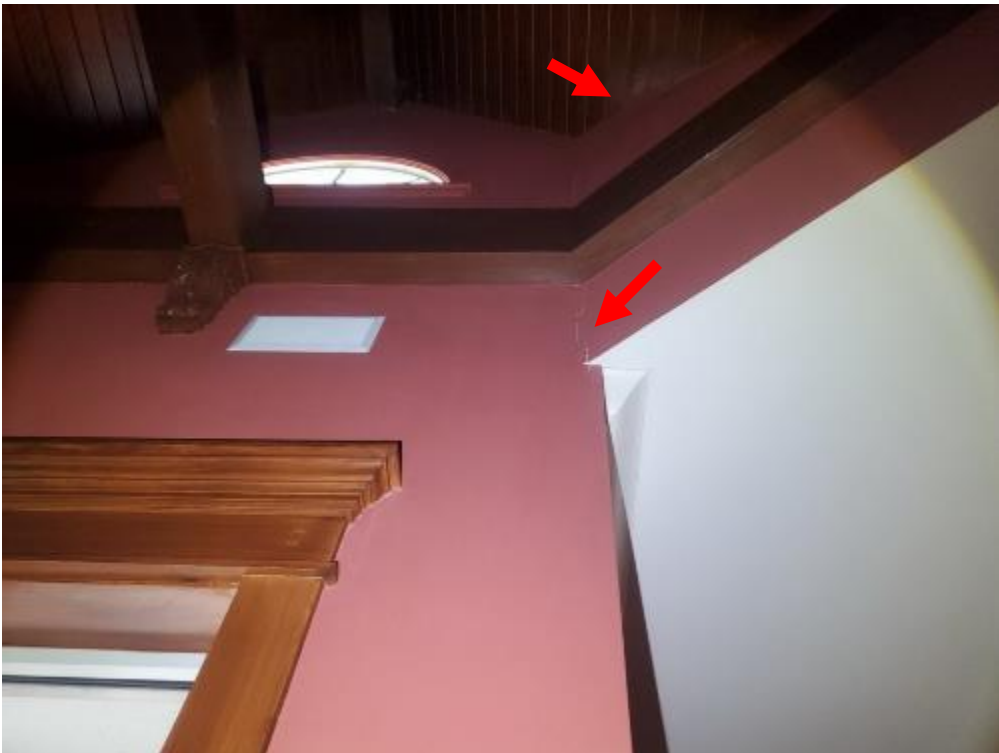
Photograph #83 – Light brown stains and vertical streaks were on the wall of the first story game room.

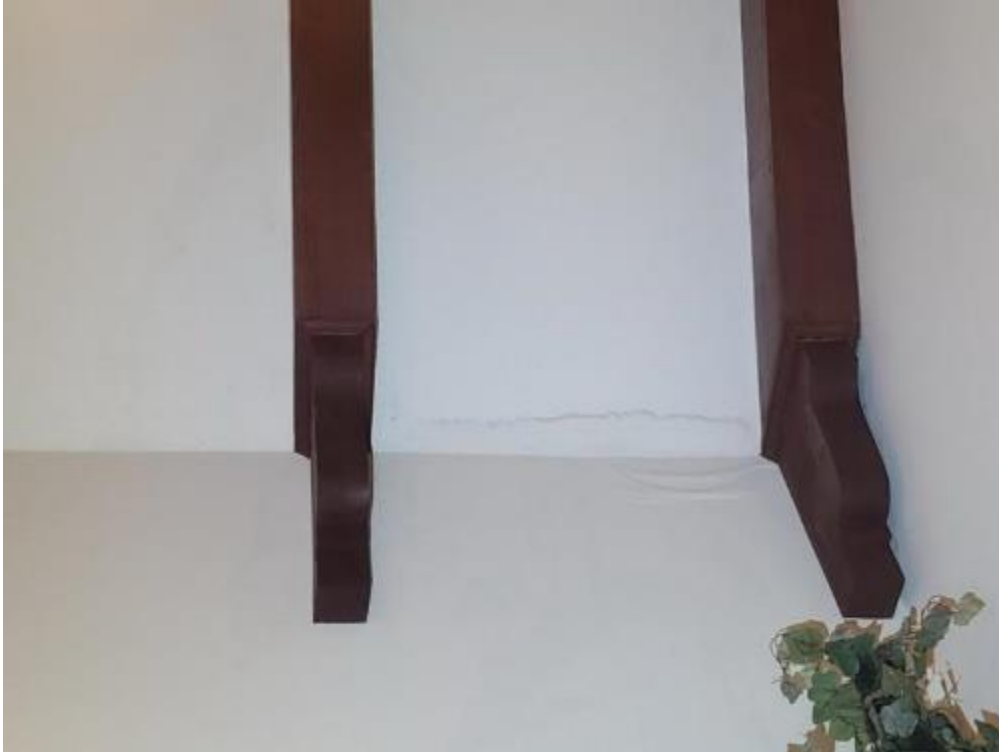
Photograph #86 – Light brown stains and peeled texture were on the first story kitchen ceiling.
