December 20, 2022

Insured:	Harry Silverglide
Address:	15771 Waite Island Drive Fort Myers, Florida 33908
D/O/L:	9/28/2022
Your File No.:	80134492
FCNA File No.:	105783

The purpose of the site investigation and this report was to provide an opinion on: (a) the cause, origin, duration, and extent of the reported damage to the exterior, interior, and roof, (b) whether this damage was a result of wind or flood associated with Hurricane Ian, and (c) the repairability of the roof.

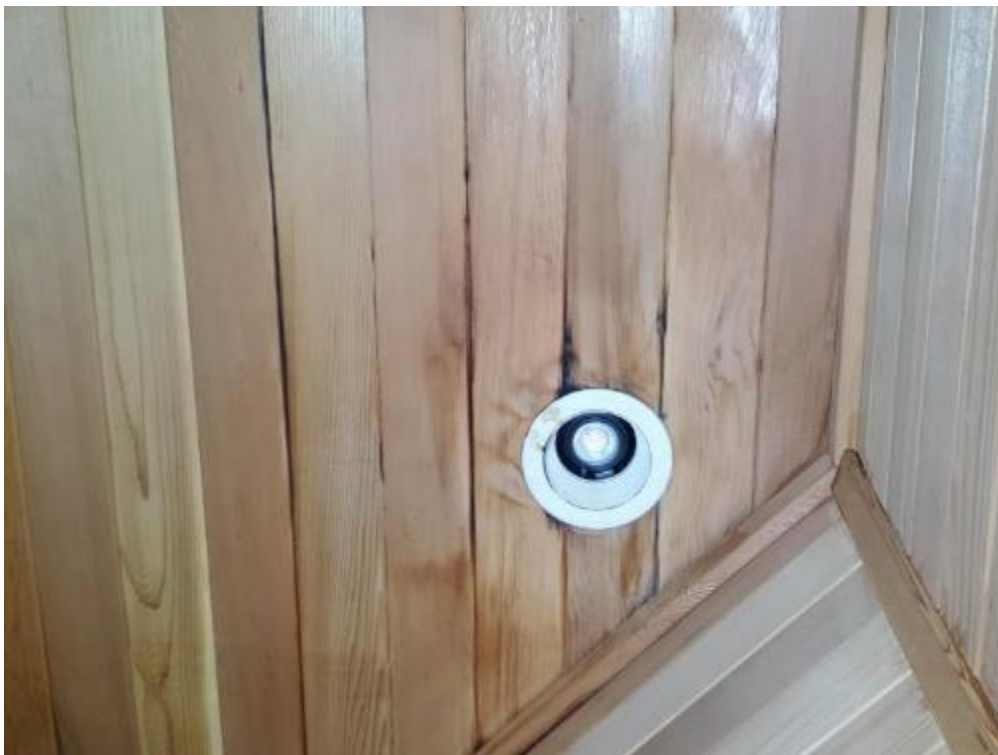
Photograph #89 – Dark brown stains were on the first story wine room ceiling.

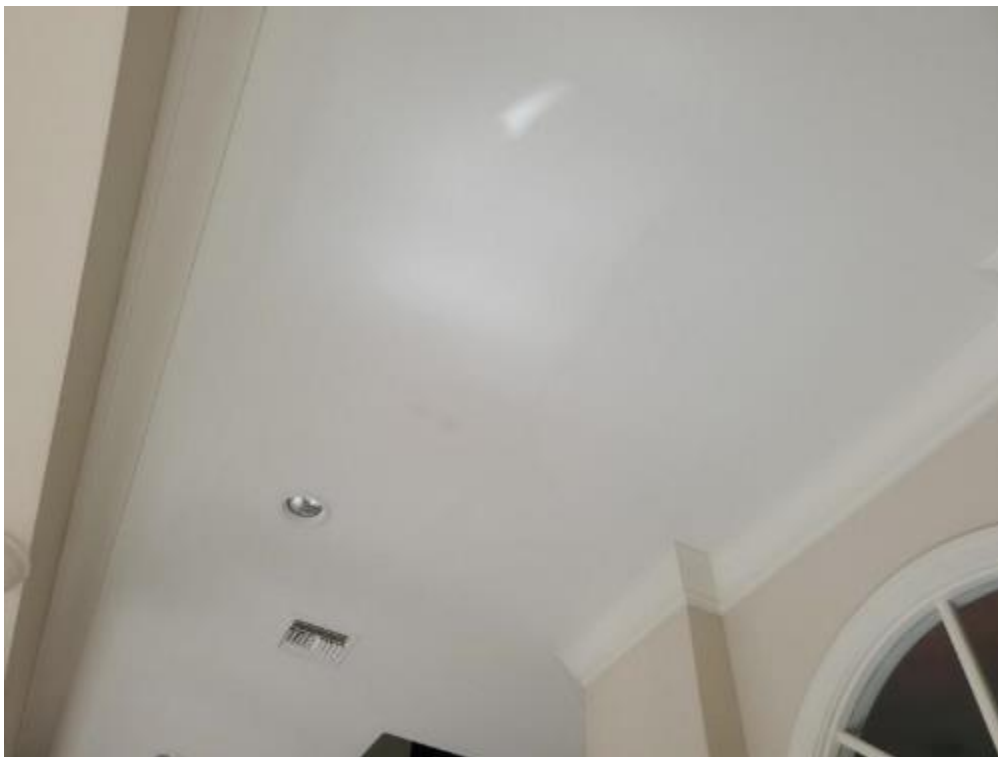
Photograph #91 – Light brown stains were on the first story entry hallway ceiling.

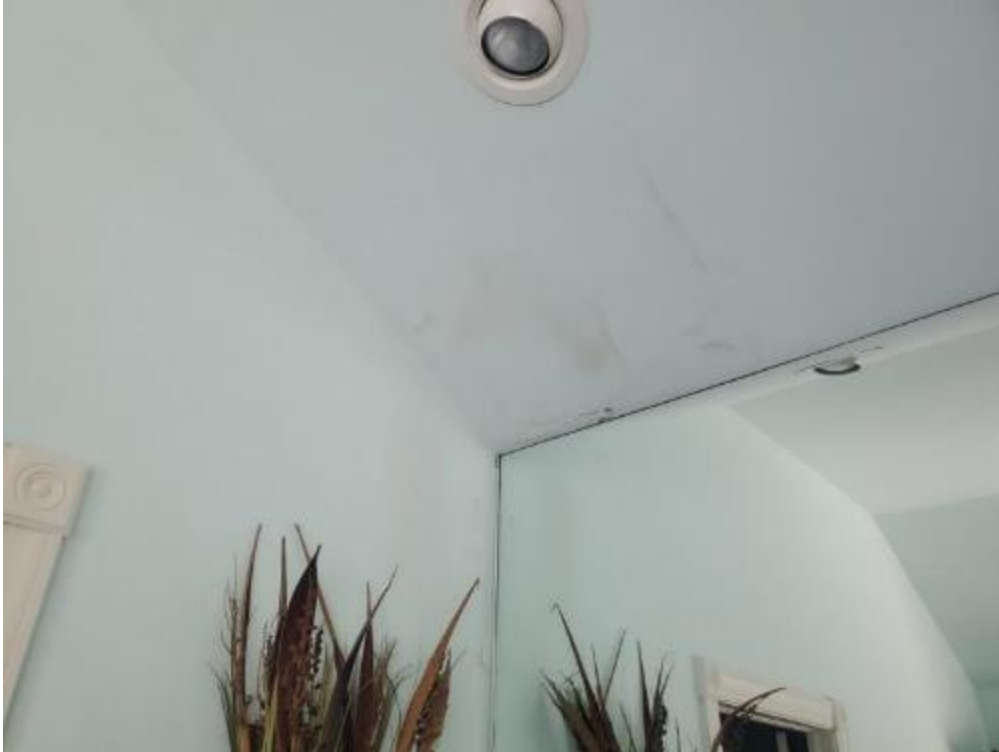
Photograph #94 – Dark brown stains were on the ceiling and wall of the second story gym.

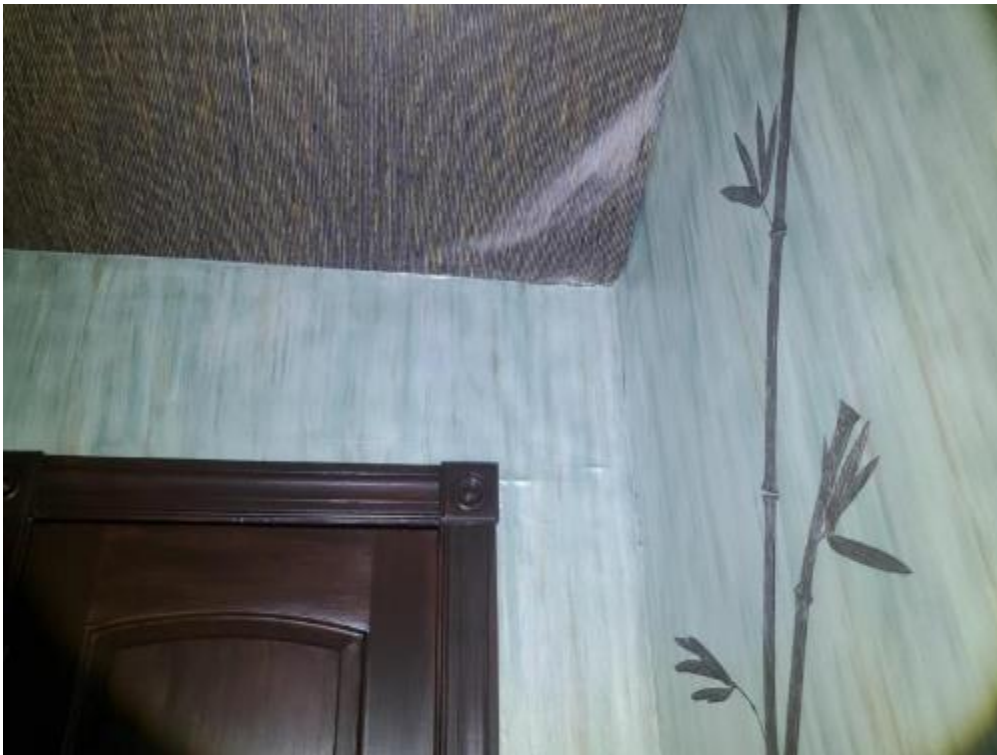
Photograph #97 – Light brown stains, peeled texture, and separations were on the ceiling and wall of the second story sauna.

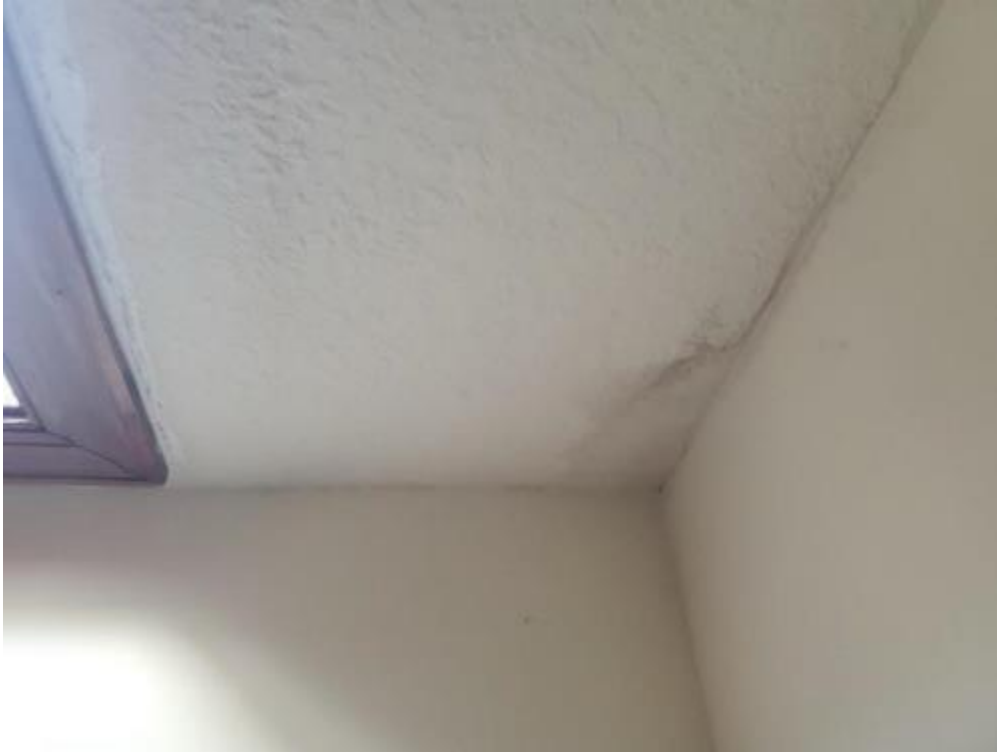
Photograph #100 – Dark brown stains and fungal decay were on the ceiling and wall of the second story left stairway to the roof decking area.

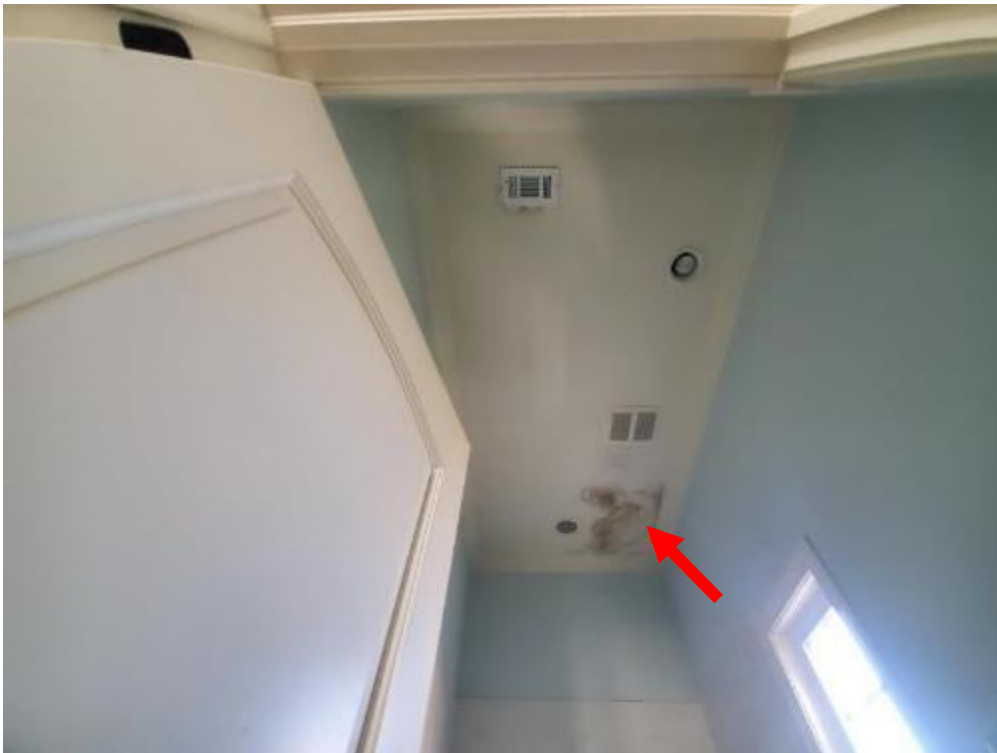
Photograph #101 – Dark brown stains and fungal decay were on the ceiling and wall of the second story left stairway to the roof decking area.

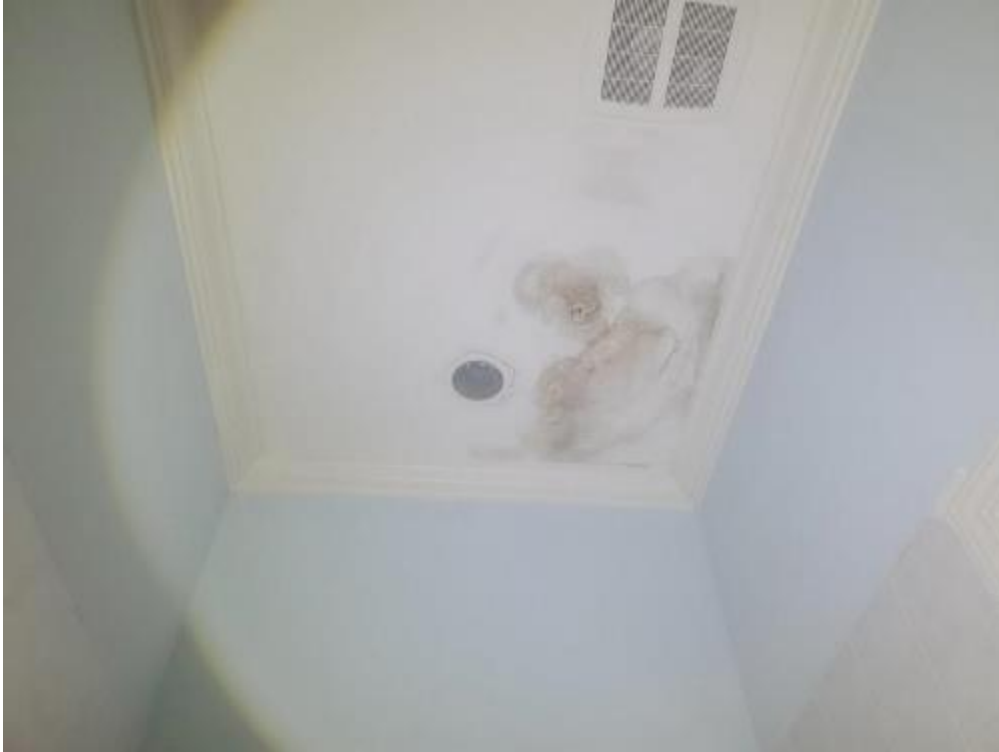
Photograph #102 – Dark brown stains and fungal decay were on the second story rear left bedroom ceiling.
