## Technical Report

### MAN Lion's Explorer – Windscreen replacements

**Report Date:** 14 April 2011

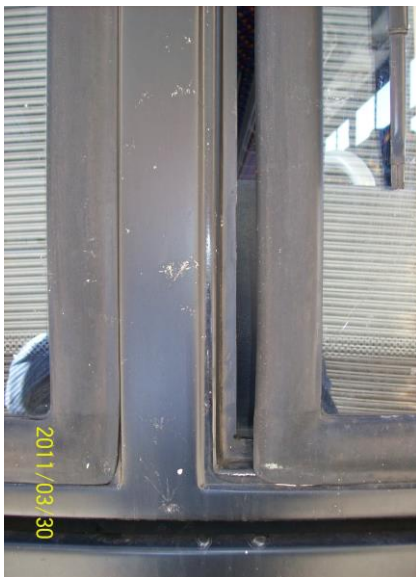
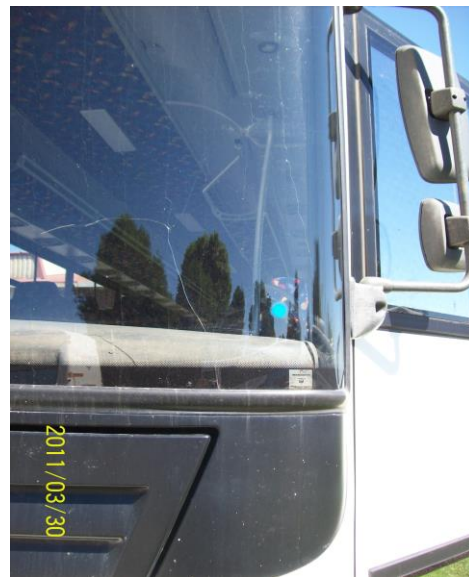
Several observations were made where the left hand windscreen started moving out of the body frame. In some instances the windscreens also cracked in the lower corner areas.

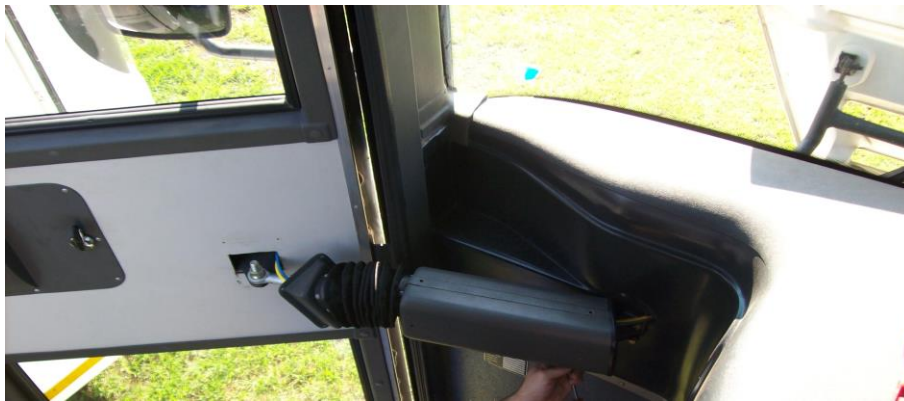
Location of actuation piston.

Excessive movement is evident around the anchor-point and the dashboard (in picture). Movement is also evident on the outside (under left windscreen)

- ✧ It is recommended that no external action be taken at this stage other than continued monitoring of the situation.
- ✧ In order to minimise the forces resulting in the system, it is recommended that the supply pressure be reduced to a minimum workable level (6 bar).
- ✧ It is further recommended that an effective system to capture the history be implemented to aid future investigations

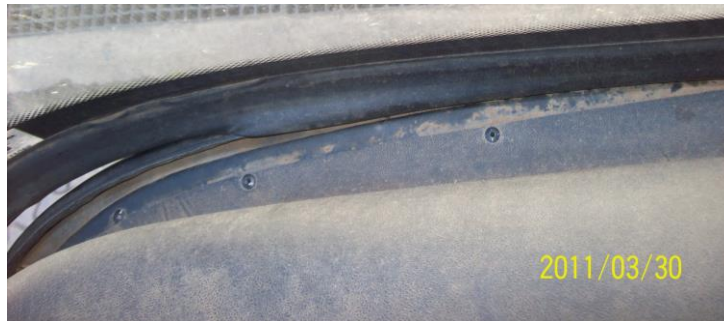
An example of a windscreen that moved to the left

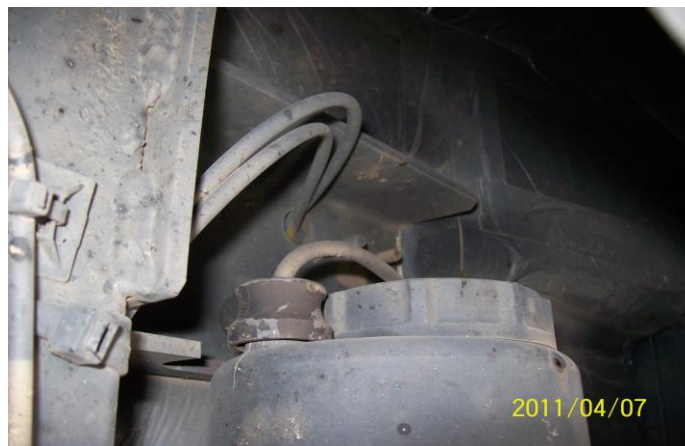
Frontal view of the anchor bracket of the actuation piston

This bracket transfers all forces related to the door into the sub structure. The forces are demonstrated in the analysis section of this report.

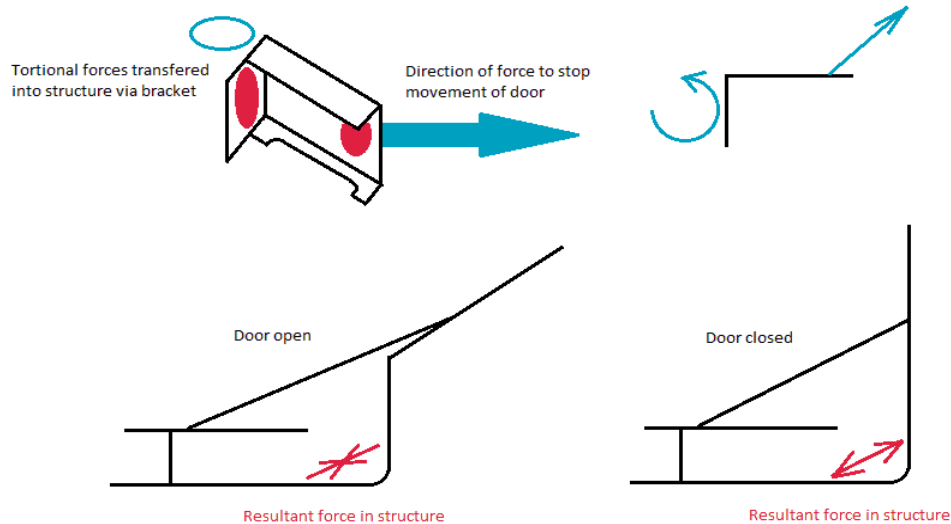
- The effective stress and release of the door results in tension and release in the structure under the windscreen.
- Higher than average re-fitments for the left hand windscreen supports the analysis
- Analysis of the replacement data shows the following results (all results from 1 April 2010):
