Auger Roll Over

February 2018 – ver 1.0

Author - DA Brand

Tanker 15033 over turned onto Truck D915

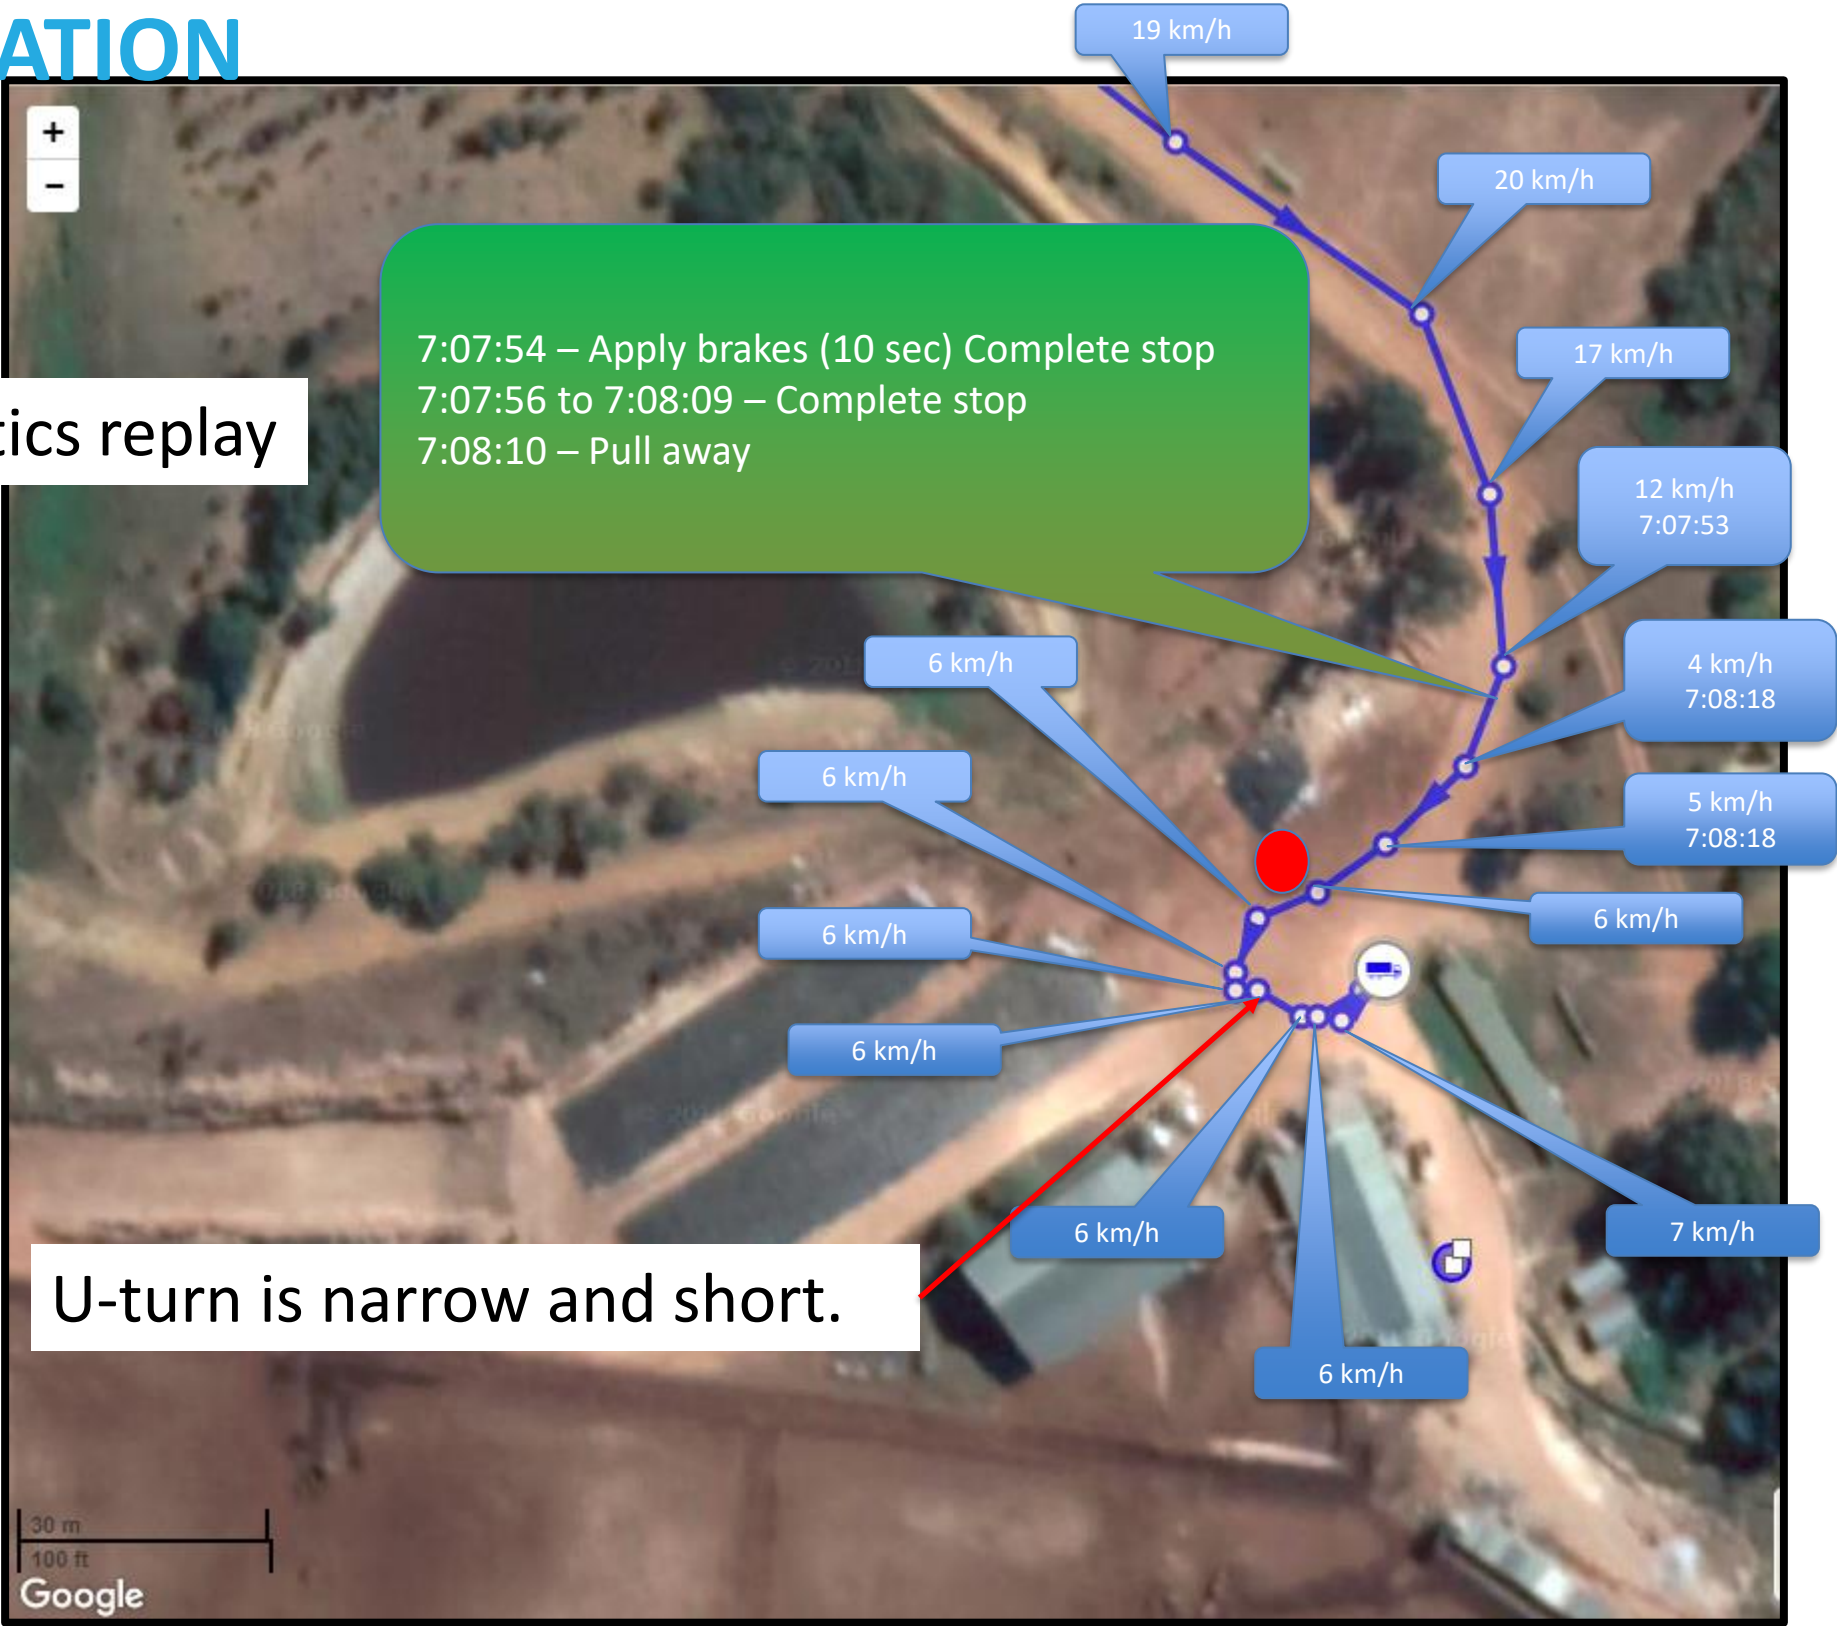
Telematics replay

Date (UTC+02:00) Harare, Pretoria	F1 = J1708/CAN - Speed (km/h)	I1 = Foot Brake Used
7:07:53 AM	13	0
7:07:54 AM	8	1
7:07:55 AM	4	1
7:07:56 AM	0	1
7:07:57 AM	0	1
7:07:58 AM	0	1
7:07:59 AM	0	1
7:08:00 AM	0	1
7:08:01 AM	0	1
7:08:02 AM	0	1
7:08:03 AM	0	1
7:08:04 AM	0	0
7:08:05 AM	0	0
7:08:06 AM	0	0
7:08:07 AM	0	0
7:08:08 AM	0	0
7:08:09 AM	0	0
7:08:10 AM	1	0
7:08:11 AM	2	0
7:08:12 AM	3	0
7:08:13 AM	5	0
7:08:14 AM	8	0
7:08:15 AM	8	0
7:08:16 AM	6	0
7:08:17 AM	4	0
7:08:18 AM	4	0

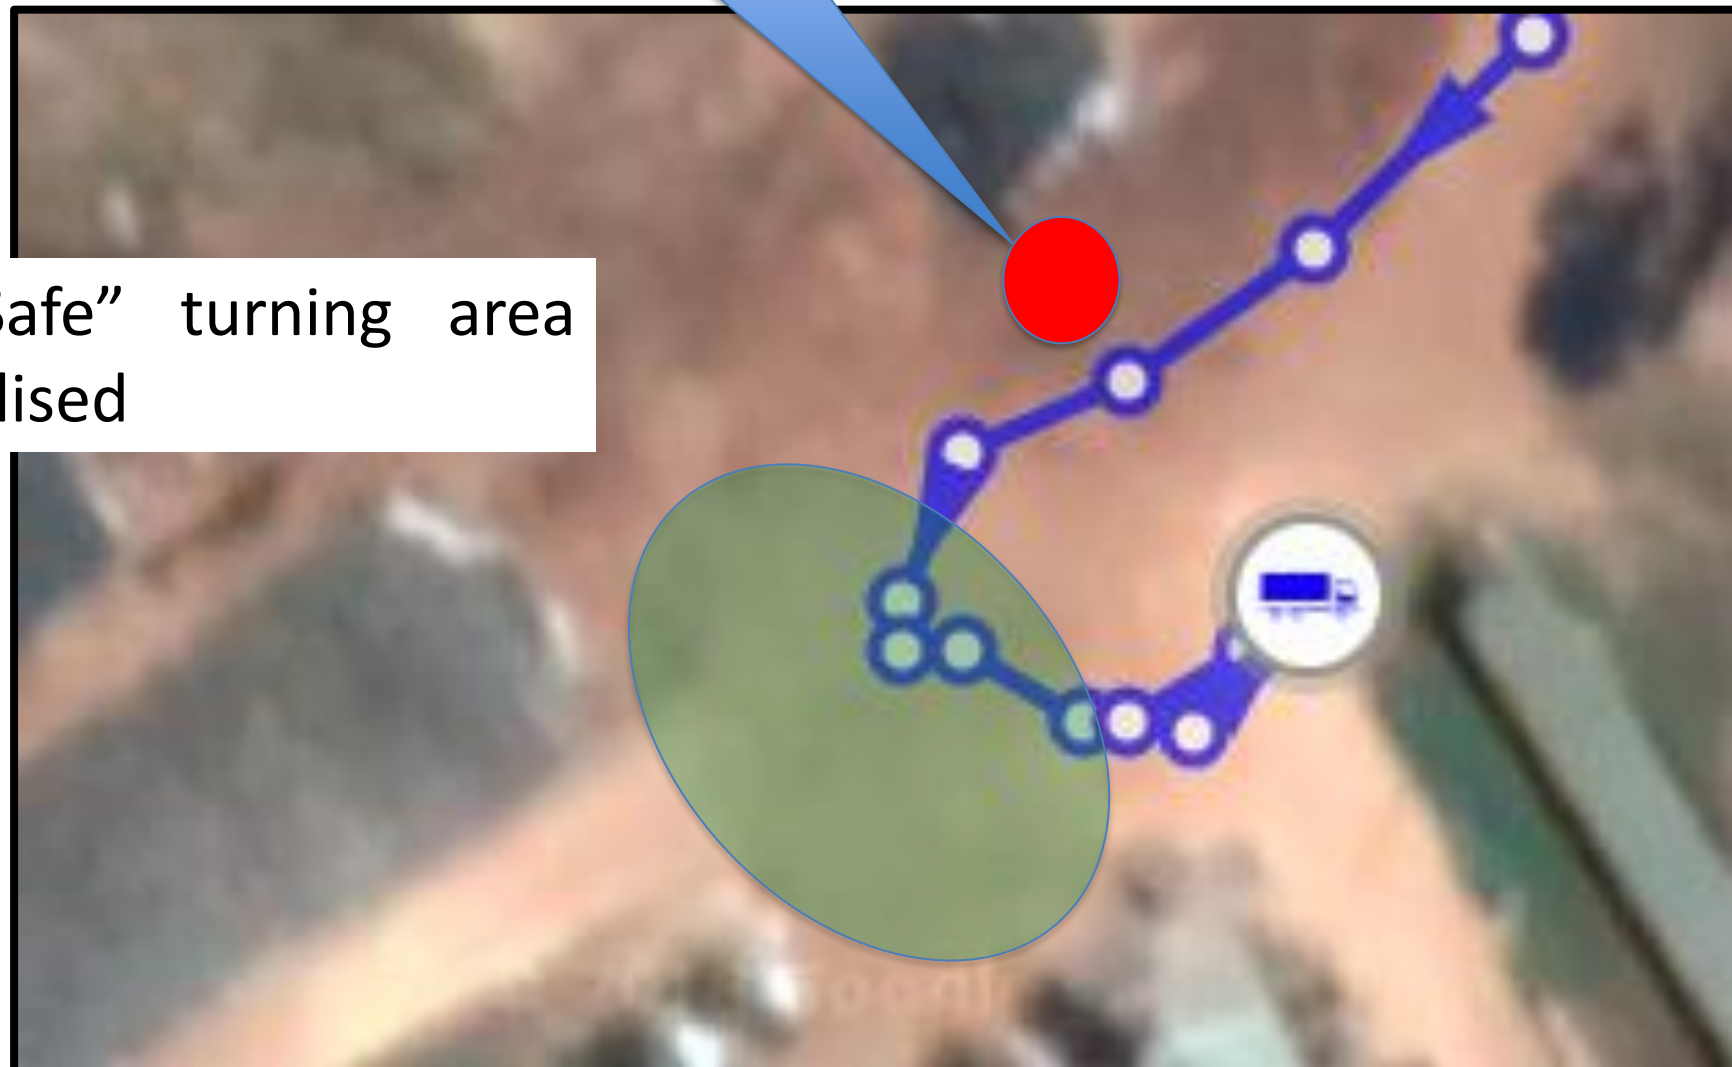
Obstruction

Normal “Safe” turning area
was not utilised

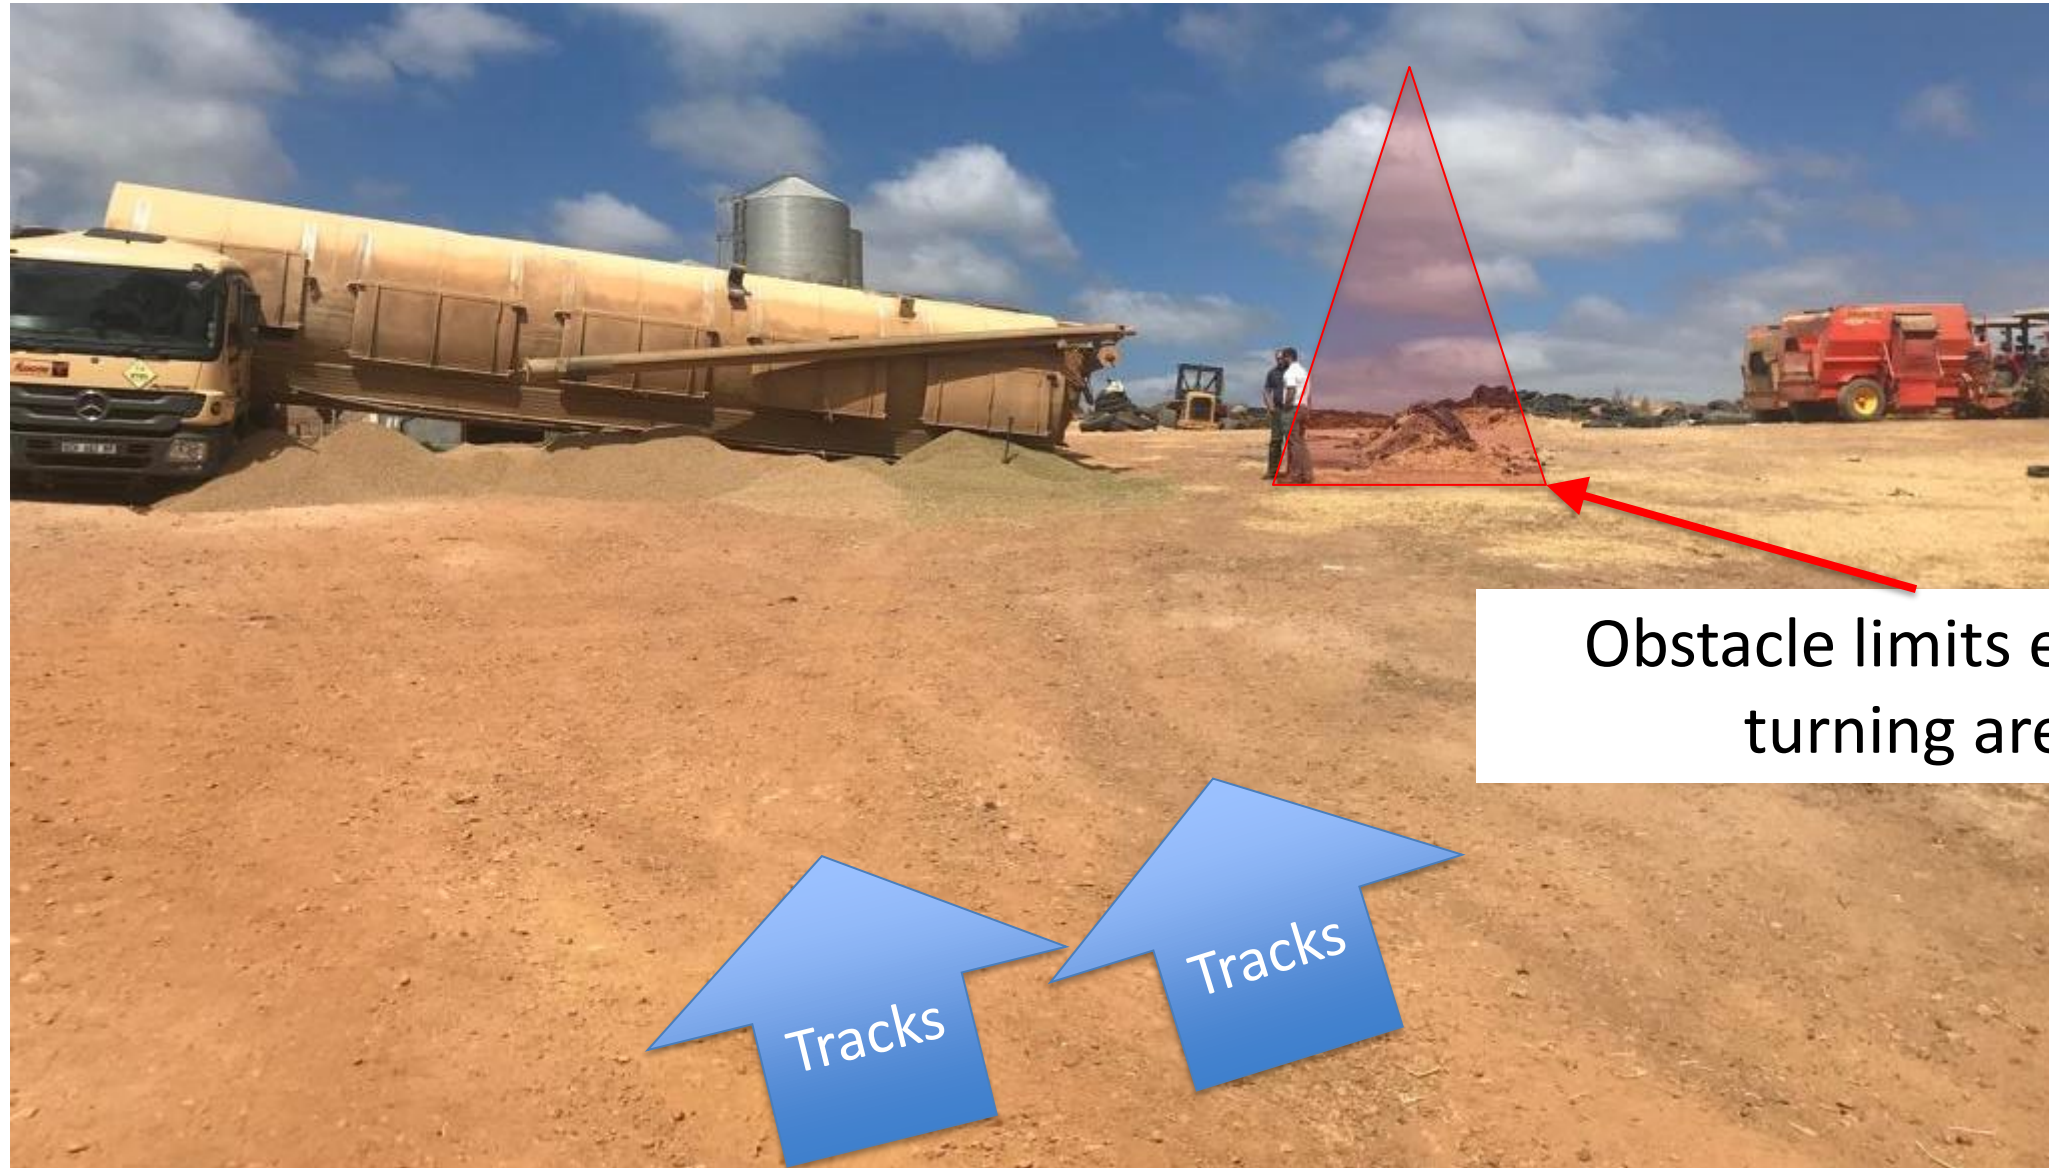
Obstacle limits entry to
turning area

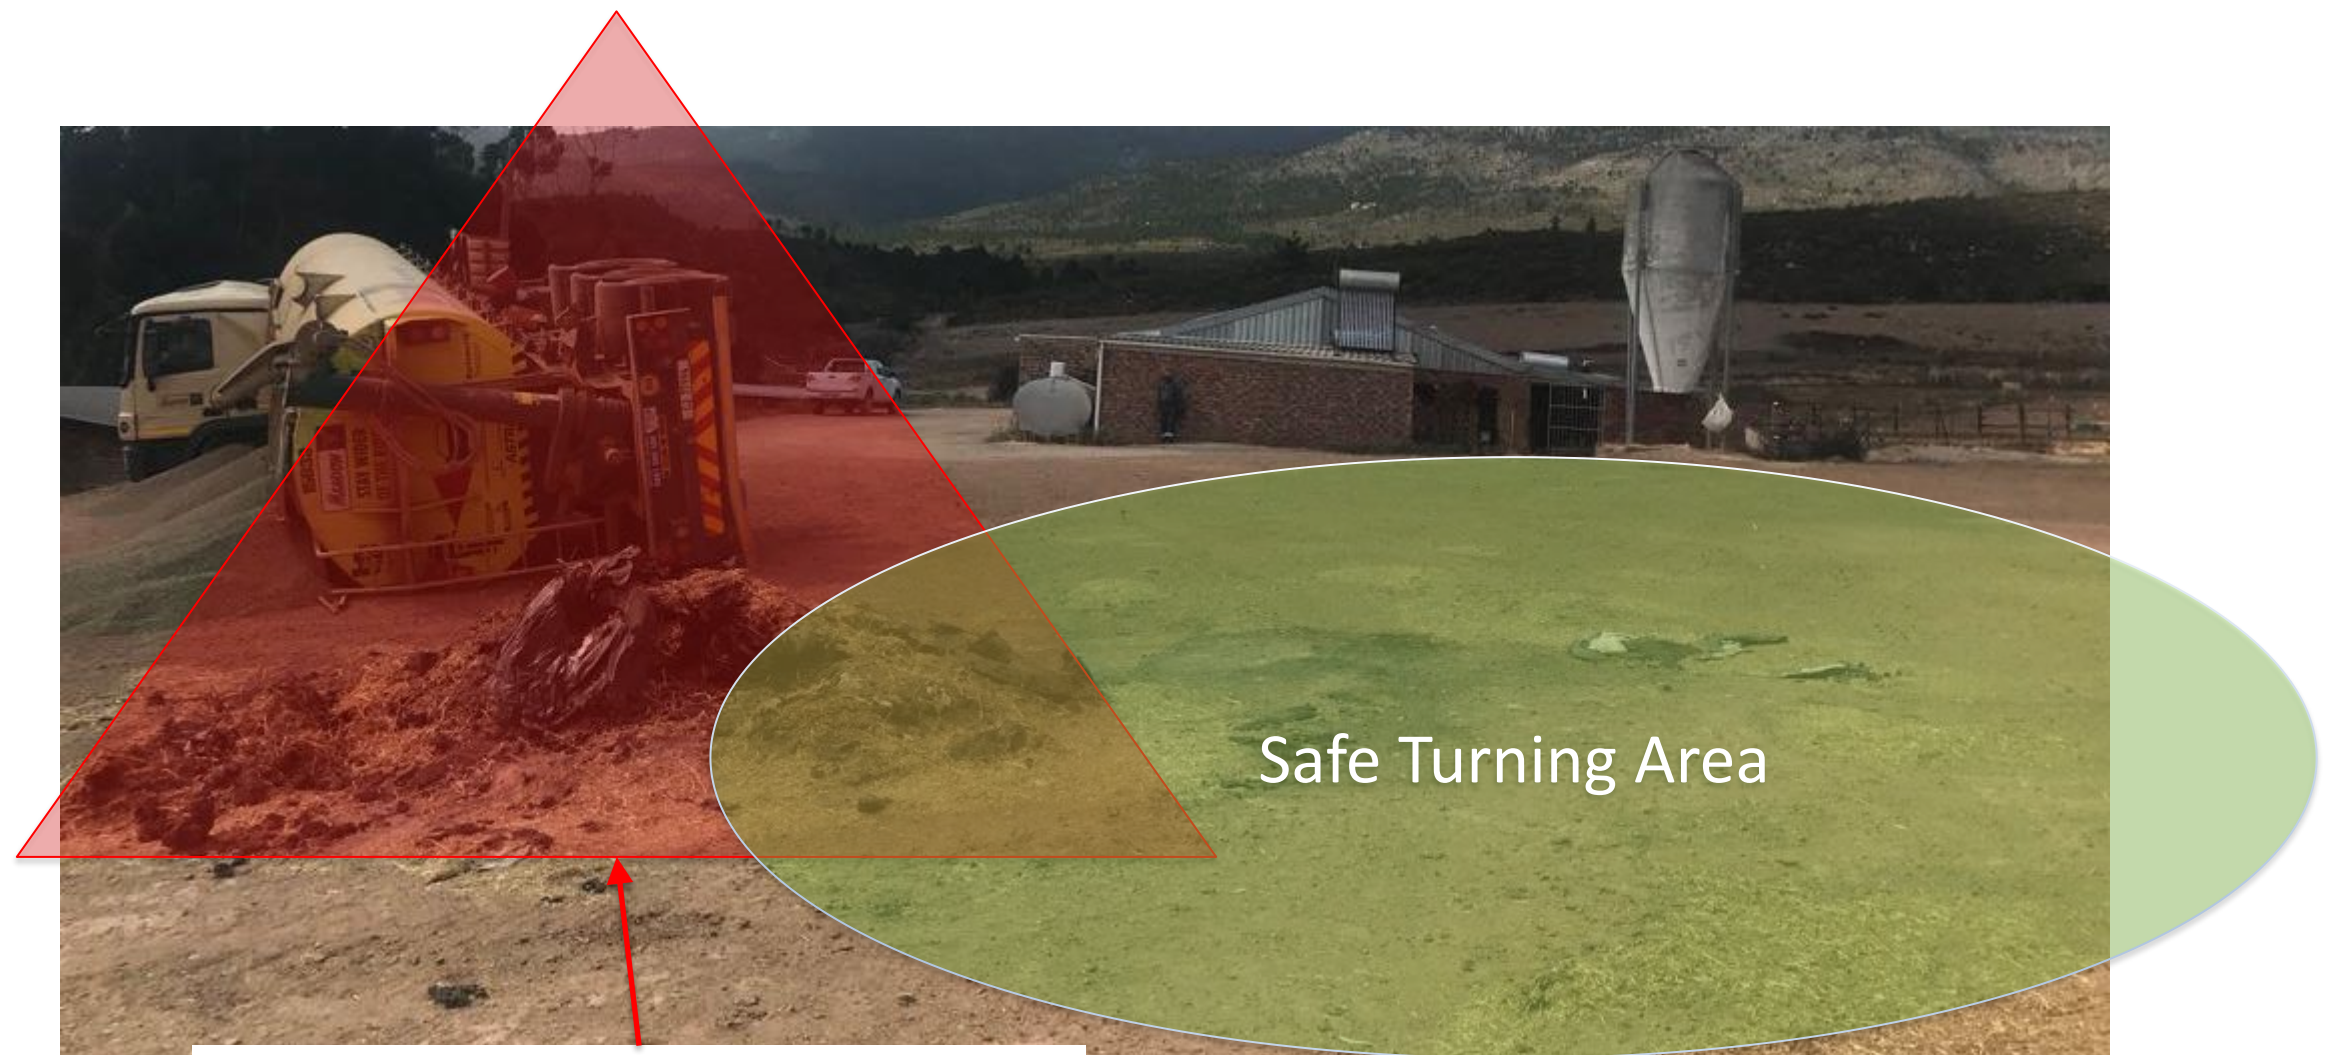
Obstacle limits entry to safe turning area

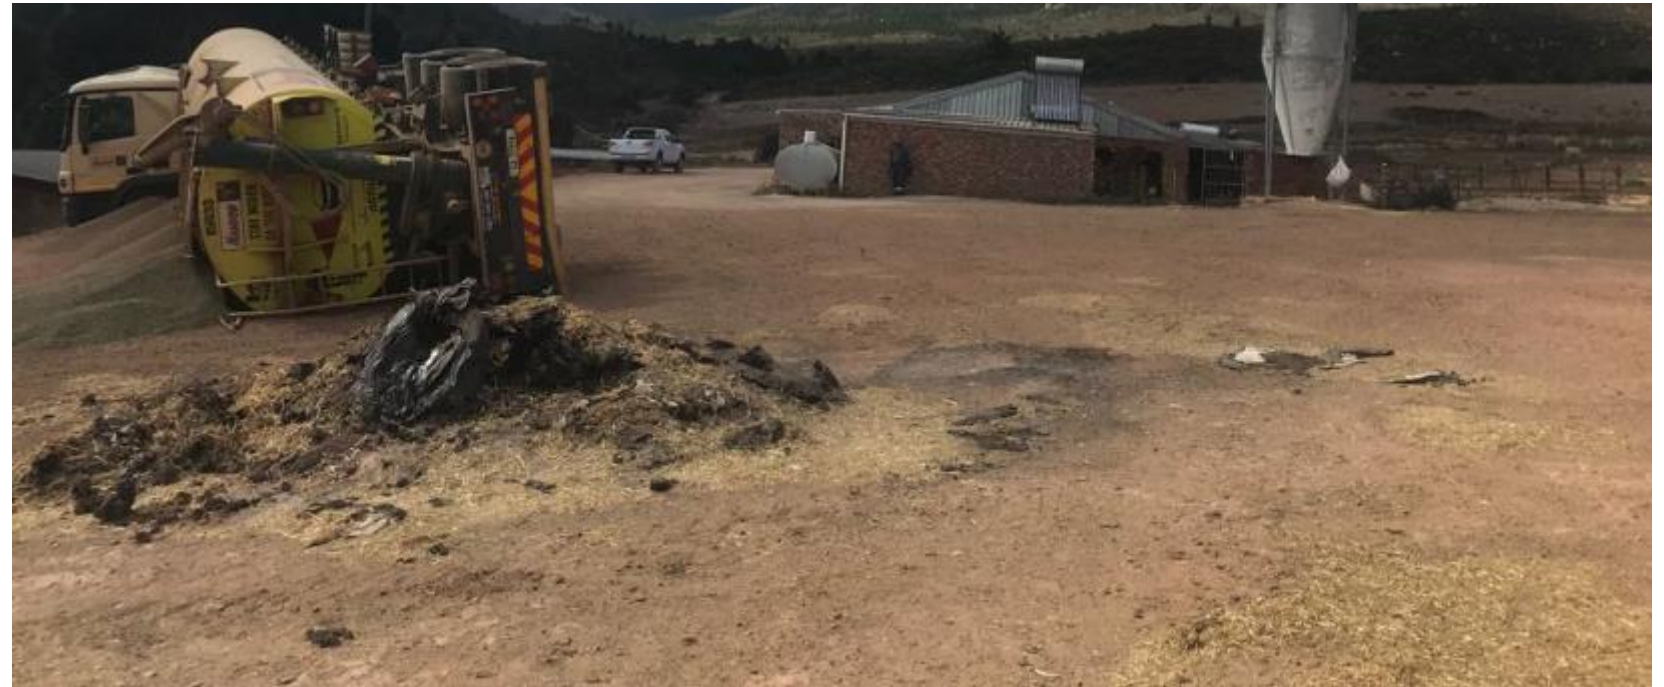
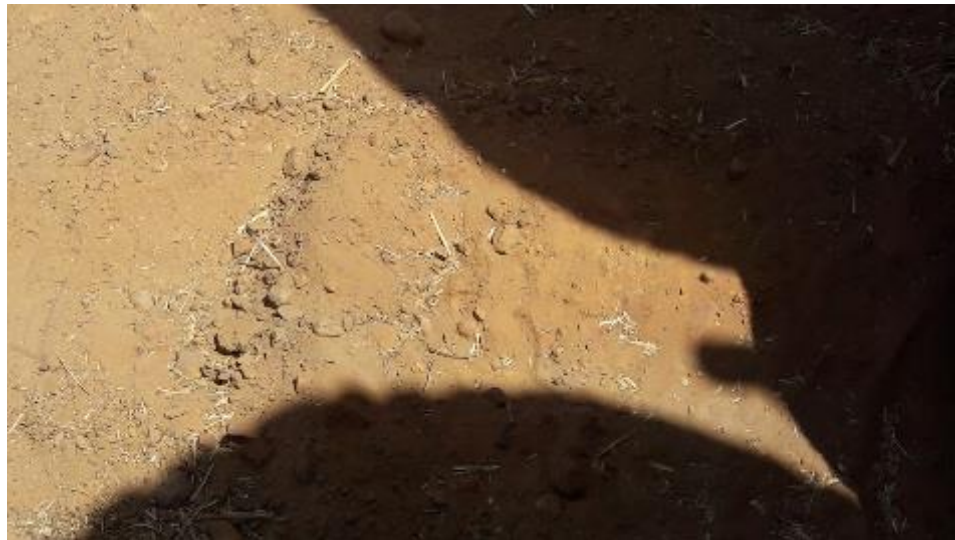
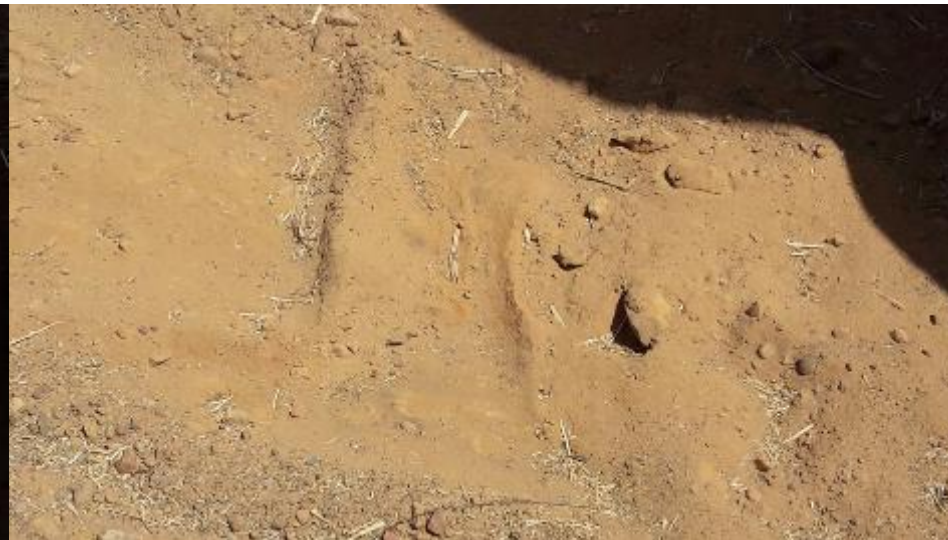
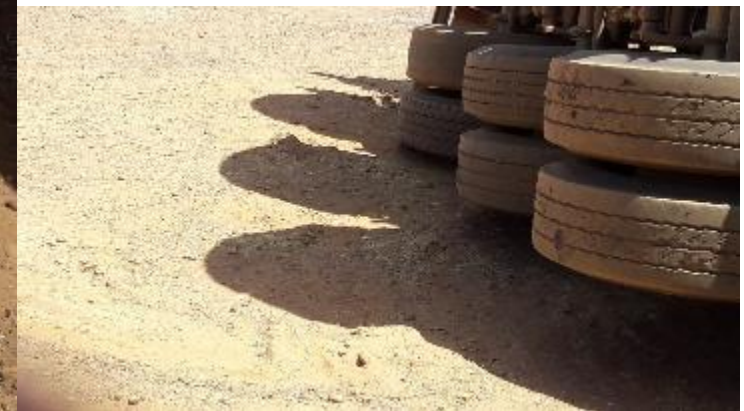
MECHANISM – ROAD SURFACE

- Dry hard ground
- Scuff marks indicates “digging in” of tyres

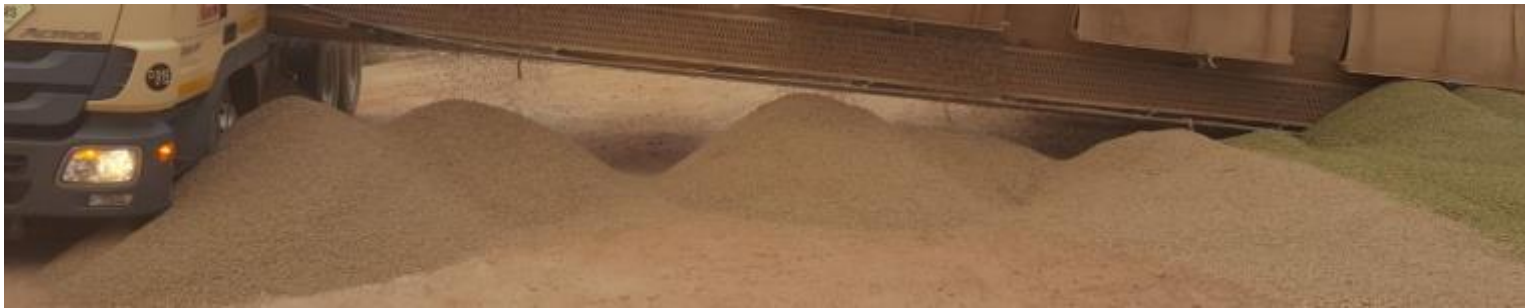
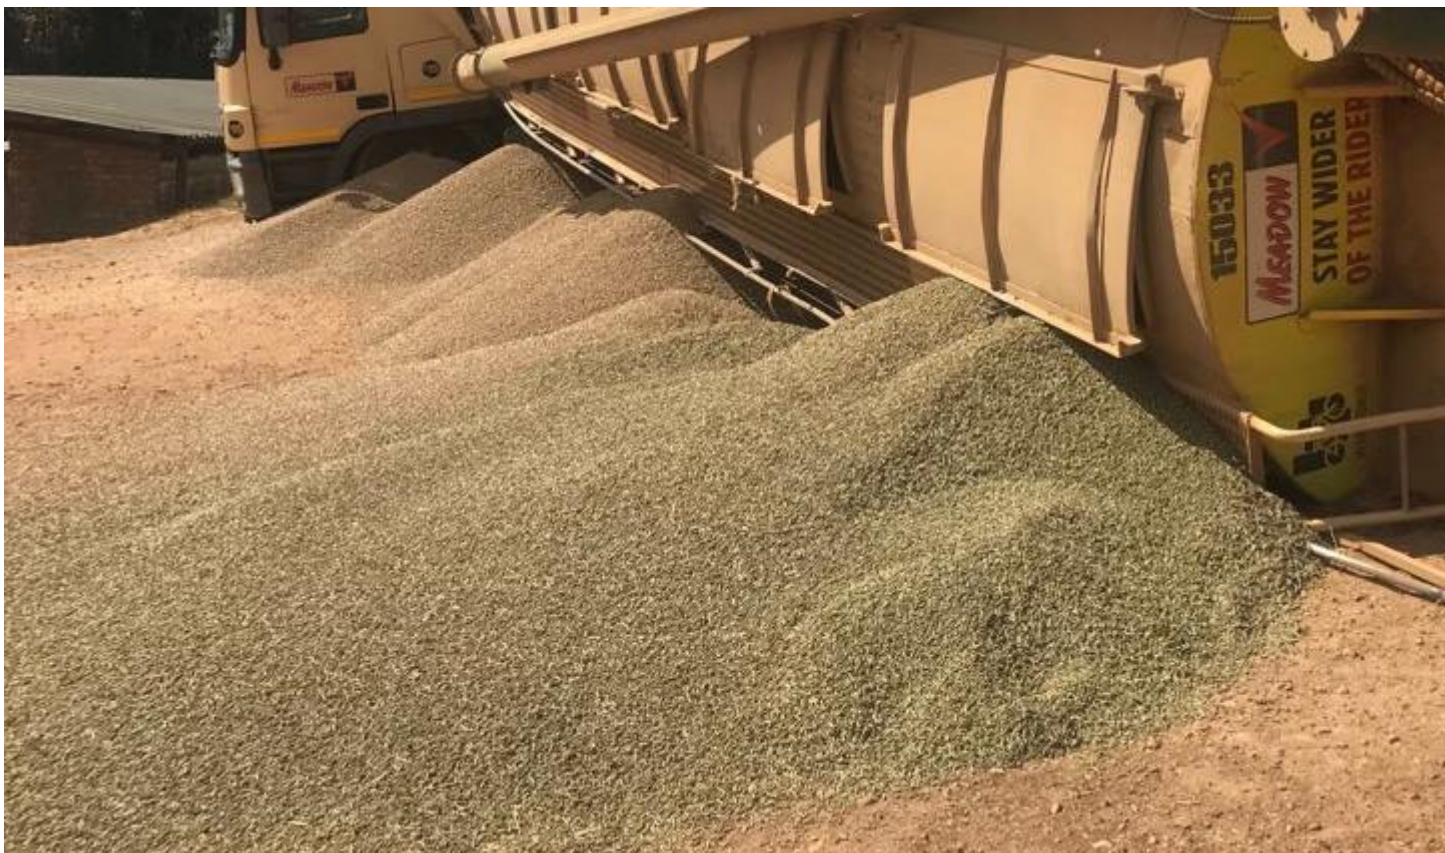
MECHANISM – PRODUCT

Ease of flow of product

Load shift was likely during the roll retardation just prior to the coupling failure

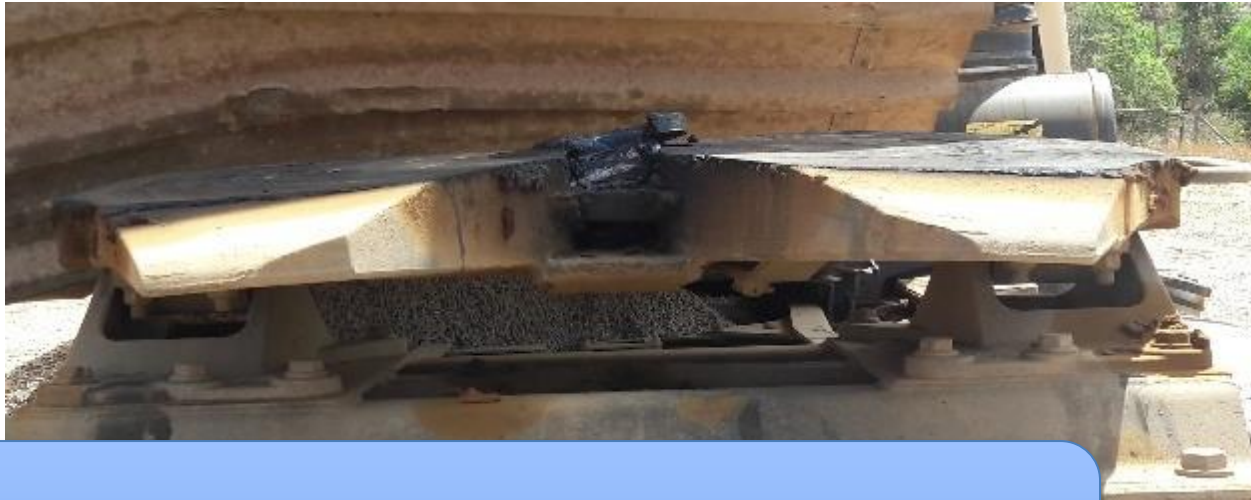
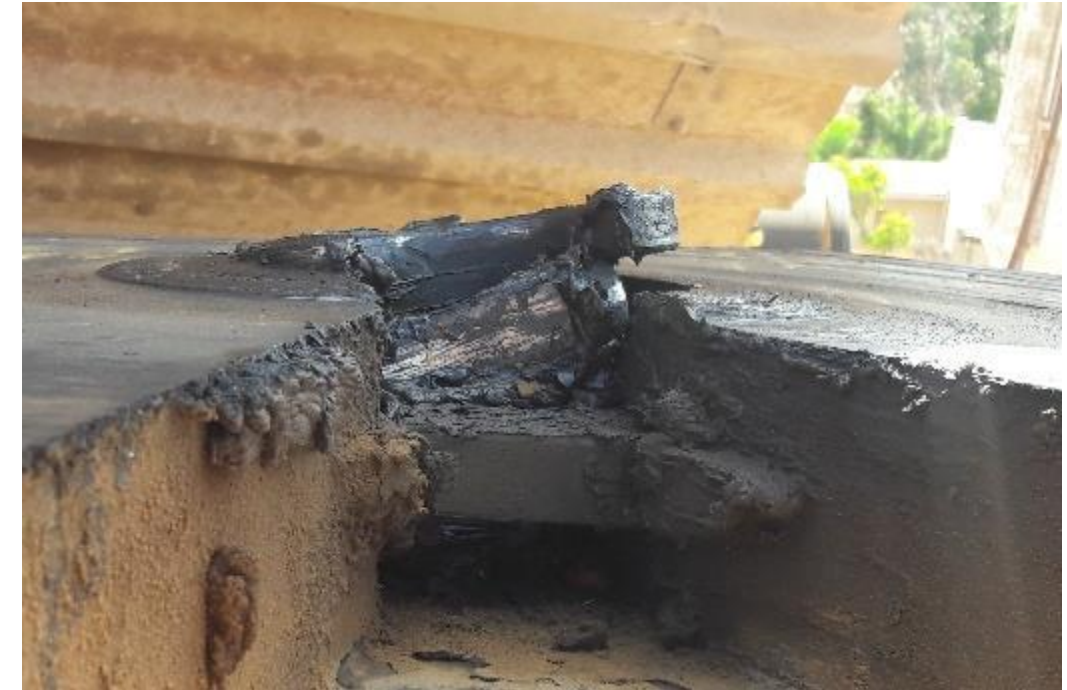
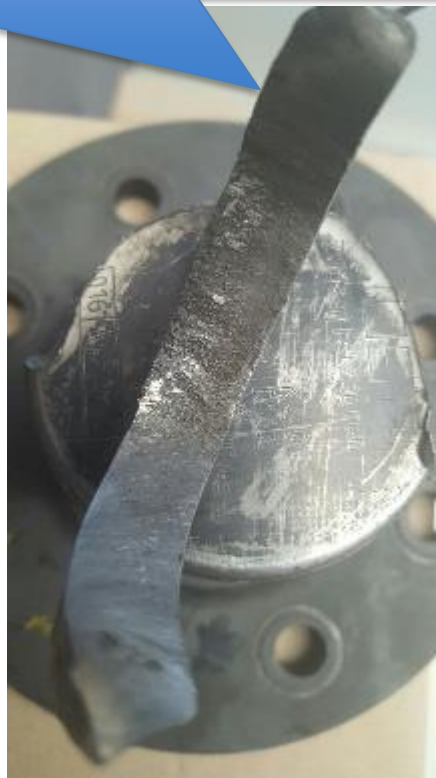
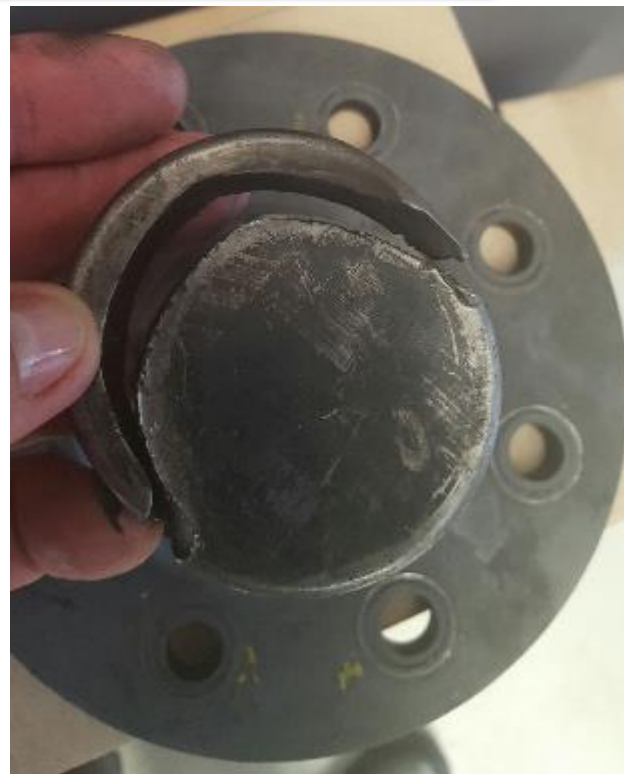
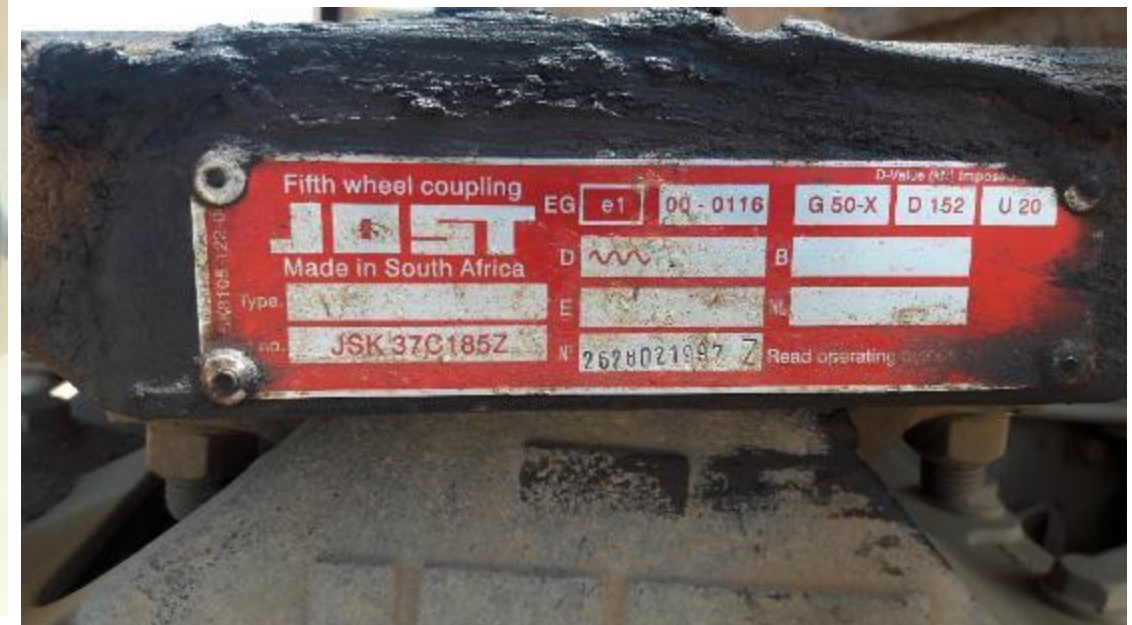
The material shows no “beach marks” of previous cracks.
The failure was instantaneous and catastrophic

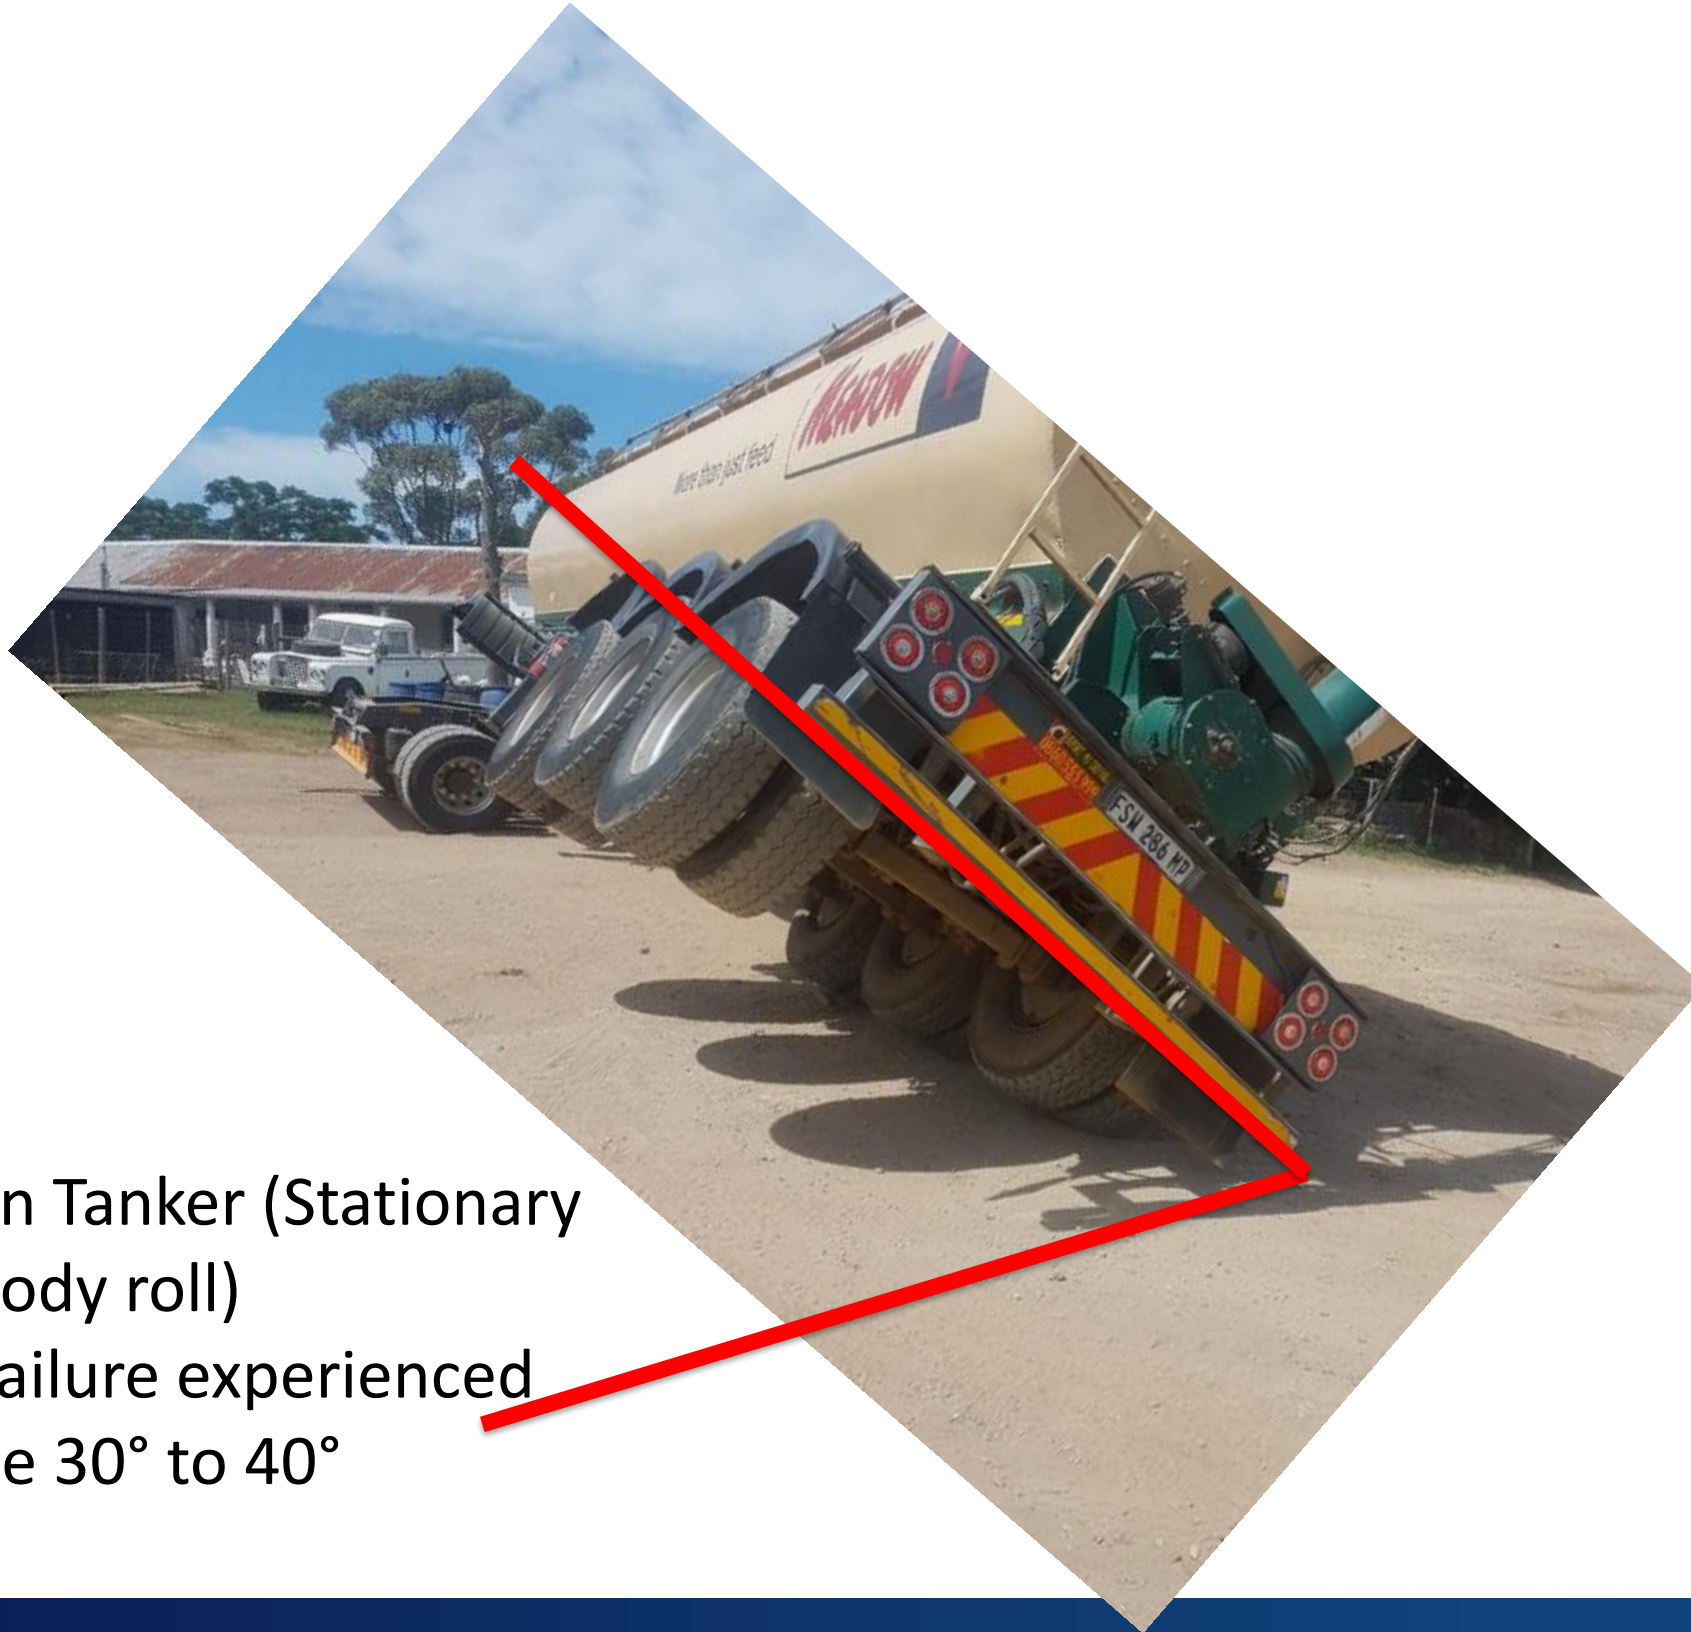
Tilted Unladen Tanker (Stationary
– no rate of body roll)
No coupling failure experienced
Estimate angle 30° to 40°

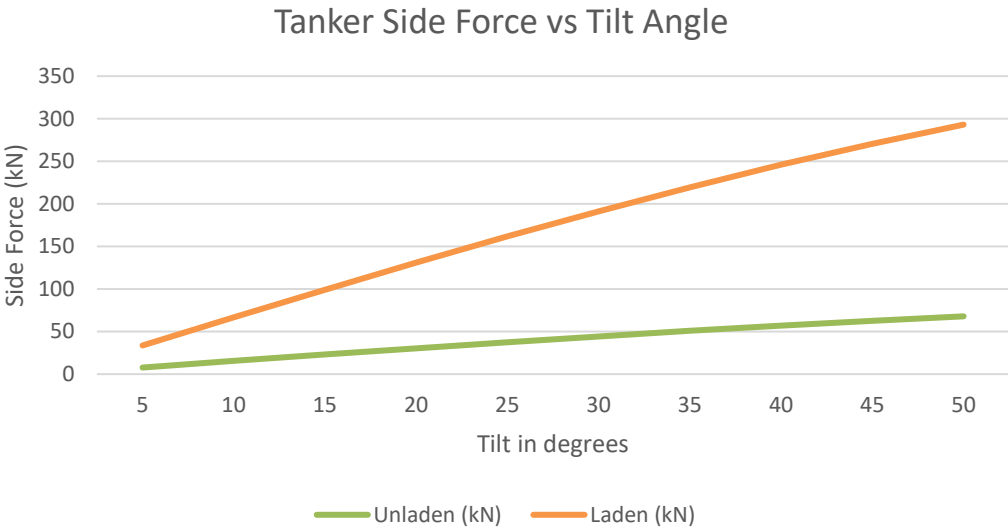
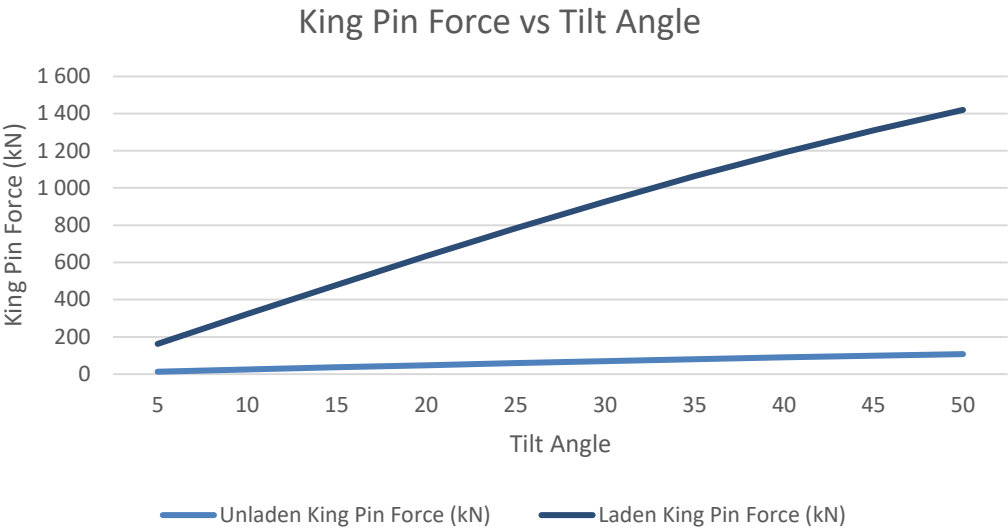
A static, fully laden tanker at tilt of 30° to 40° generates +/- 1,000 kN at the king pin.
The effect of the dynamic roll motion was not taken into consideration, but would add significantly to the resultant force.

The Fifth Wheel and King Pin failed due to an upward force
No destructive testing is done nor legally required in this direction of action
