## Technical Report

Executive Summary
<ul style="list-style-type: none"><li>• Fire was ignited by electrical cable.</li><li>• Fuel lines next to cables aggravated the damage.</li></ul>

<b>Registration Number:</b>		
<b>VIN:</b>		
<b>Chassis Make:</b>	Mercedes Benz	
<b>Chassis Model:</b>	OF2429	
<b>Body Make:</b>	Marcopolo	
<b>Fleet Number:</b>		
<b>Distance Reading:</b>	Unknown

Vehicle [REDACTED] was involved in an incident where the vehicle caught fire. The purpose of the investigation is to highlight any possible ignition points that could have started the fire.

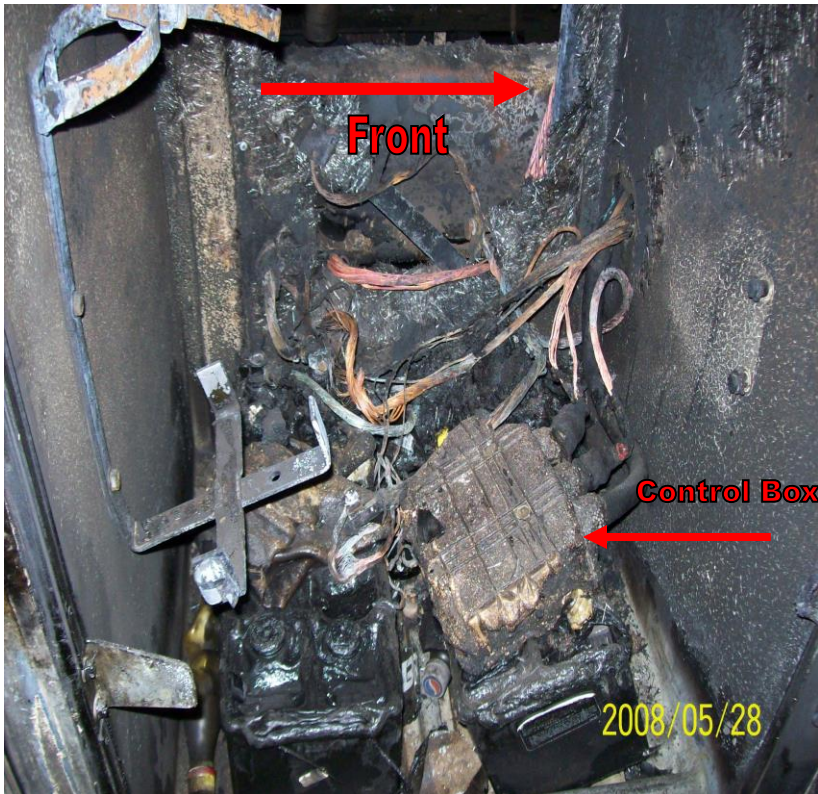
Photo 2

Heat damage (melted plastic) was visible on the batteries.

The retarder control box was melted to the front battery.

The battery terminals was melted (lead terminals)

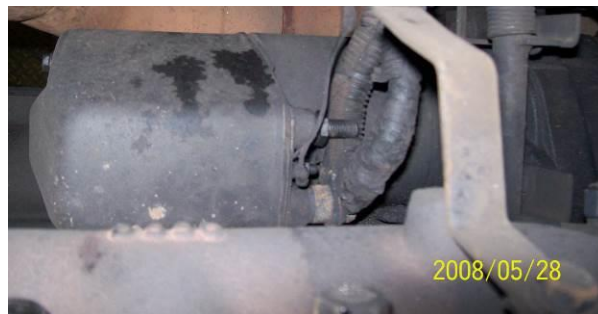
Photo 3

The electrical connections to the starter-motor was intact and without fire damage.

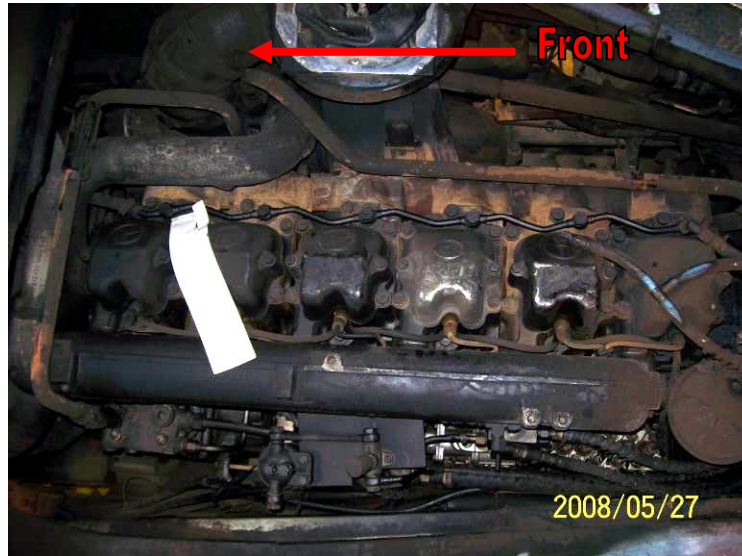
**Photo 4**

No fire damage was observed at the front of the engine compartment. The alternator was thus not suspected of any damage.

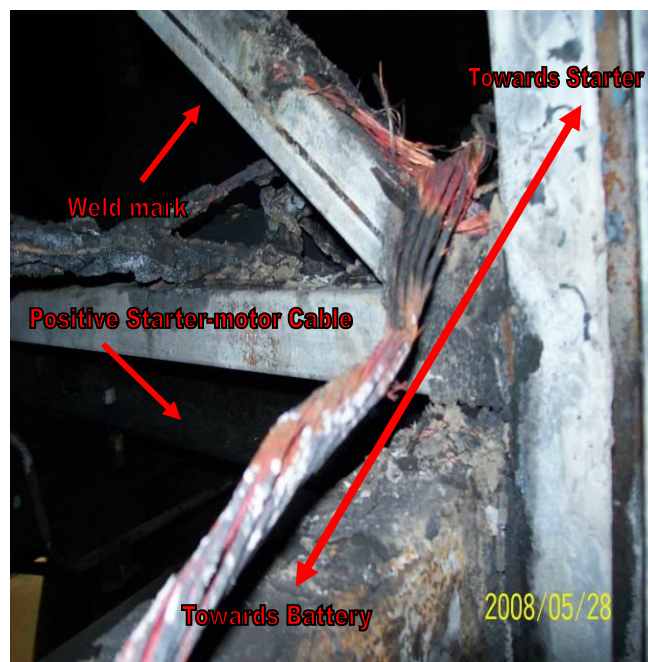
**Photo 5**

Positive starter-motor (terminal 30) cable.

The cable was welded to a cross member beam.

Insulation was missing between battery terminal (30) and cross member

- 2.1 Positive starter-motor cable chaffed through on chassis beam. This caused arcing and a very high heat condition. This cable cannot be fuse protected. This arcing would continue until the battery stopped supplying power or the cable burnt through.
- 2.2 The Retarder Earth cable heated up due to resistance build-up. This caused degradation of insulation. Next to the Earth cable was fuel lines and positive cables.

- 1) It is recommended that the OEM maintenance procedures be followed at the scheduled intervals.
- 2) It is recommended that all electrical cables be separated from fuel lines as far as possible.
- 3) It is recommended that all electrical cables ( $> 8.5 \text{ mm}^2$ ), in and around the chassis, be replaced at 1 000 000 km interval irrespective of condition.
- 4) It is recommended that all electrical and fuel lines be placed in heat sleeving in the vicinity of a Telma Retarder. This can be extended to 0.5 m on both sides on the retarder.

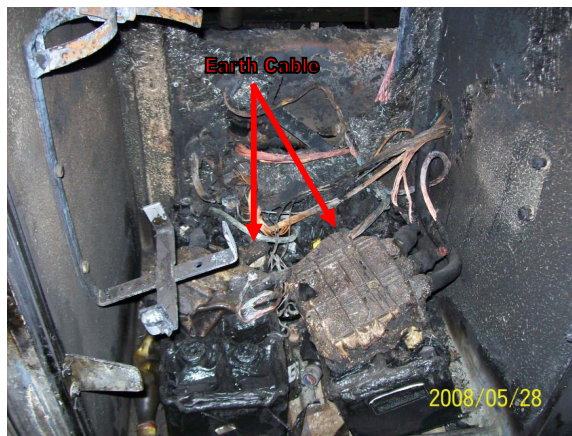
**Photo 6**

Positive cables (4 stages) to Retarder

The cables were intact.

Fire damage was observed on insulation.

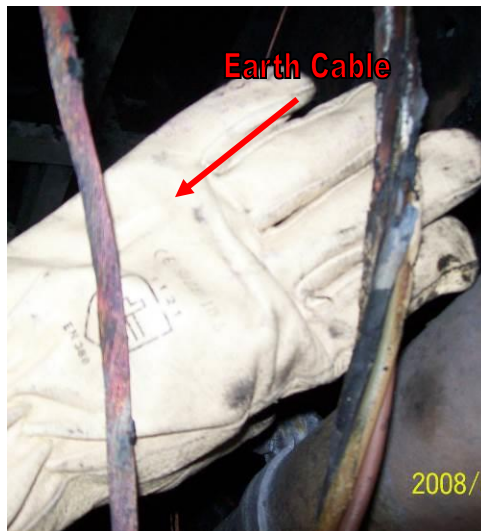
**Photo 7**

Earth cable retarder

The cable was intact.

Shaving damage was observed corresponding to the retarder rotor.

All insulation was gone except a section corresponding to the retarder rotor area.

3.1 Lack of insulation. The lack of insulation on the cable (not only in the centre) could indicate that the insulation was at elevated temperature for an extended period.

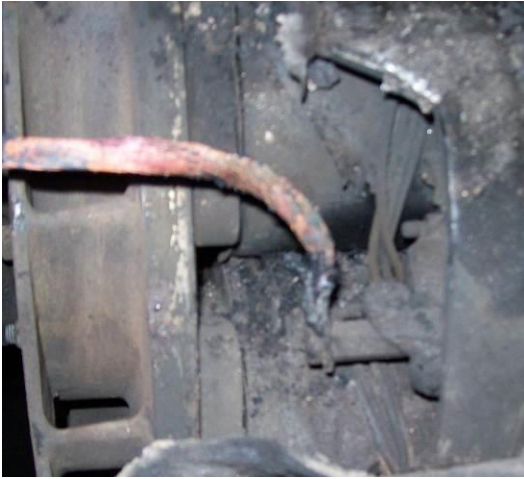
**Photo 8**

The earth terminal was found loose on the retarder.

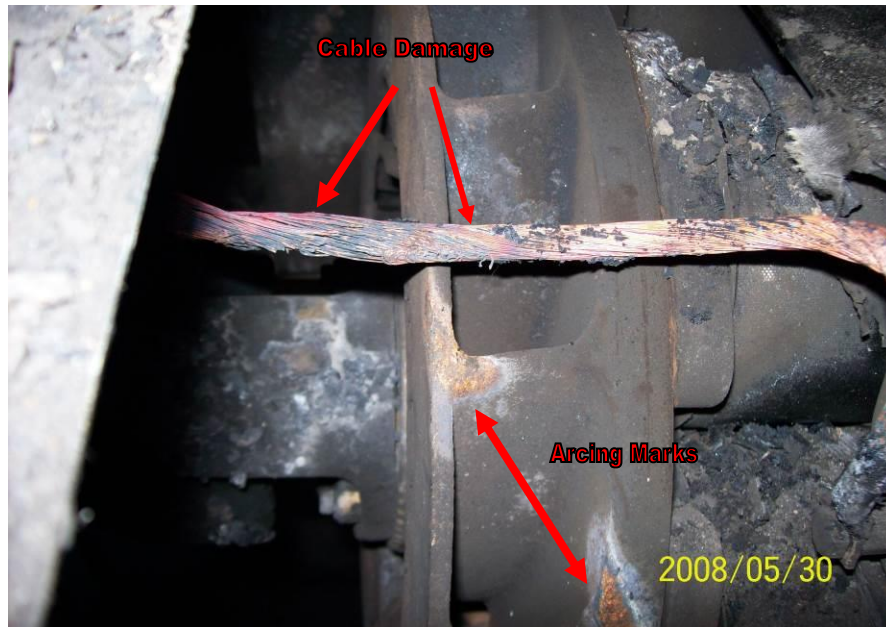
**Photo 10**

Arcing marks was found on the rotor of the retarder. Corresponding damage was found on the earth cable

3.2 Arc marks on retarder. This indicates that the resistance through the retarder, gearbox, chassis and battery was less than through the Retarder Earth Cable.

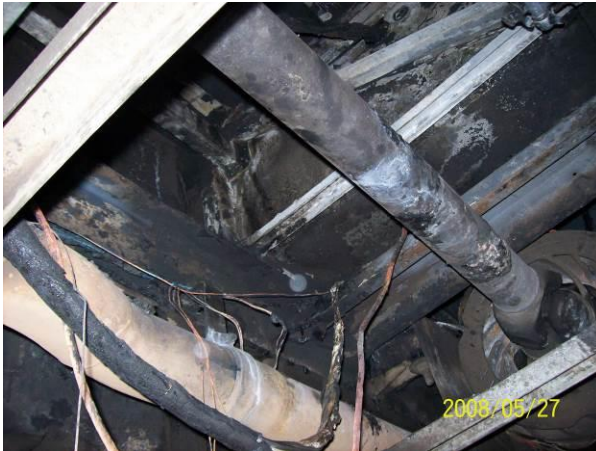
**Photo 11**

The area of the most intense heat was found in the area between the gearbox and retarder.
