Envelope Construction Progress Inspection

| Street Address | 21814 Tamworth Hollow Tr |
| Builder | Taylor Morrison Homes |
| Inspection Type | Substrate |

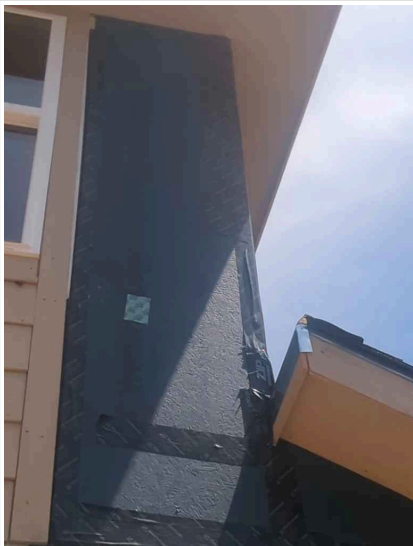
| Photo Description | Wall |

| General Observation | Flashing tape appears tooled or rolled and bonded. |

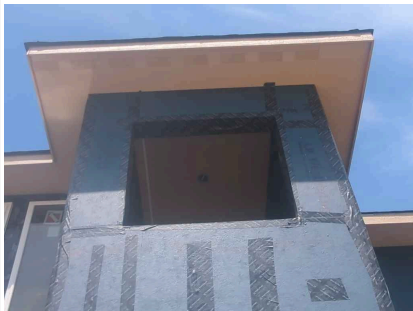
| Photo Description | Wall |

| General Observation | Flashing tape appears tooled or rolled and bonded. |

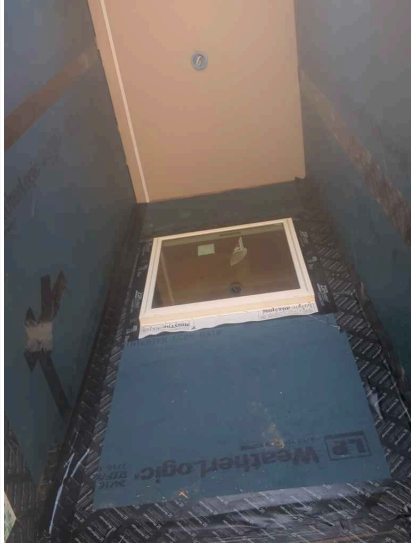
| Photo Description | Wall |

| General Observation | Flashing tape appears tooled or rolled and bonded. |

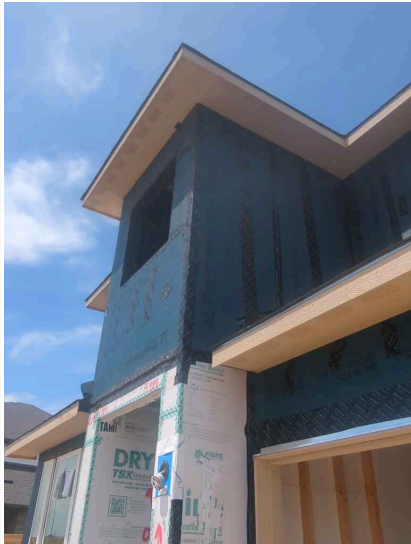
| Photo Description | Wall |

| General Observation | Flashing tape appears tooled or rolled and bonded. |

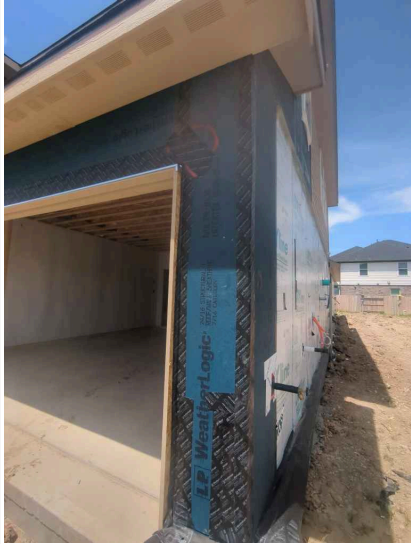
| Photo Description | Wall |

| General Observation | Flashing tape appears tooled or rolled and bonded. |

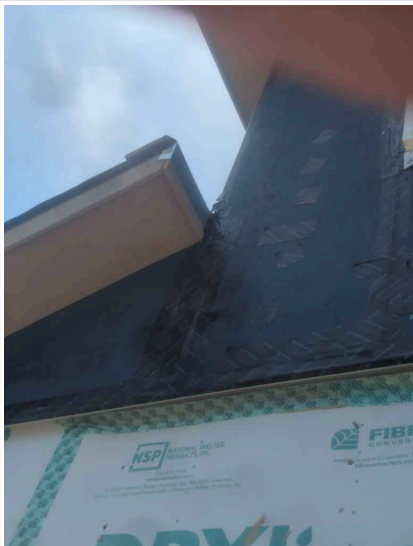
| Photo Description | Wall |

| General Observation | Flashing tape appears tooled or rolled and bonded. |

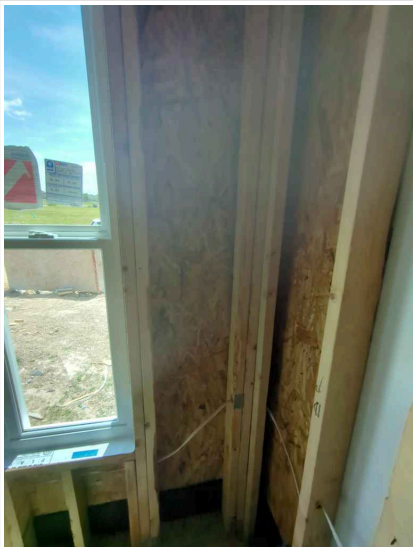
| Photo Description | Wall |

| Condition | Action Item |
| Action Item | 1/8 inch gap at sheathing not visible at the time of inspection due to blocking or interior finishes. |
