This document details hardware fixes done on the MPOS-STD2 EV-KIT revision A.

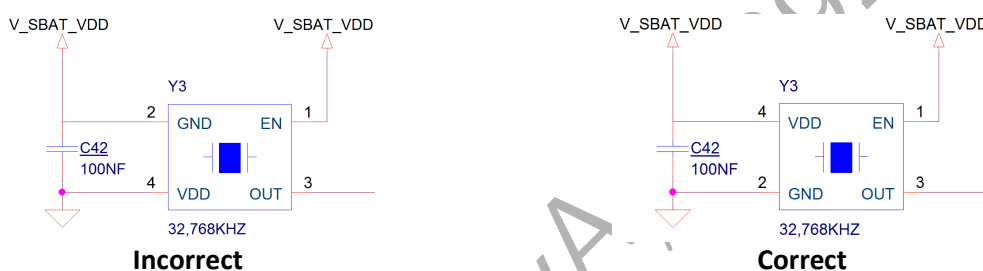
1) BLUETOOTH 32.768KHZ OSCILLATOR (Y3)

Y3 oscillator is not properly connected: Pin 2 and 4 are inverted.

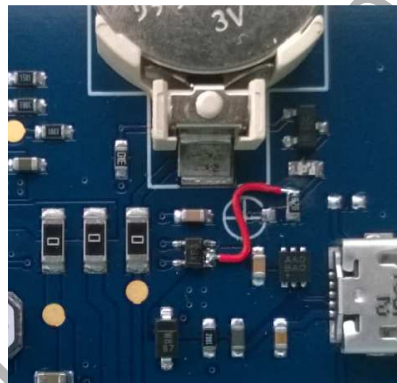
2) BATTERY CHARGE LED (D9)

The LED D9 lights when the secondary battery charge is completed. This indicator should normally be enabled only while charging, when V_VBUS is present. In the schematic the LED D9 is powered by V_SBAT_VDD instead of V_VBUS. Consequently, the indicator is enabled even if there is no external power source connected to then it could draw current from the secondary battery.

R81 has been connected to V_VBUS and its value is updated accordingly.

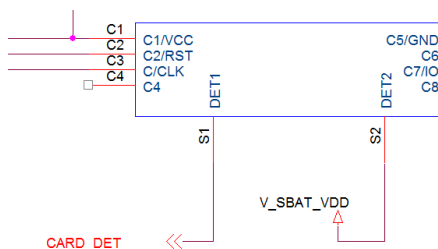
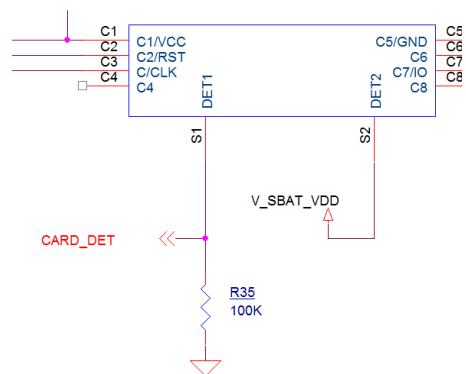
3) SMARTCARD CARD DETECTION POLARITY

Even if the MAX32550's card detection polarity can be selected by software, it is recommended to use the high level with a version up to A3. This is to avoid missing the first card insertion event. Because the MAX32550's card detection I/O includes a weak pull-up, an external pull down is needed with normal open detection switch.
