for MITSUI—MAN B&W engines, Countermeasure for erosion of nozzle ring on TCA turbocharger		No. 199	
		APPROVED	N. Osako
		CHECKED	
		PREPARED	T. Matsubara
ENGINE TYPE	TCA turbocharger	DATE	2019.1.15

Erosion on TCA nozzle rings in two-stroke engines

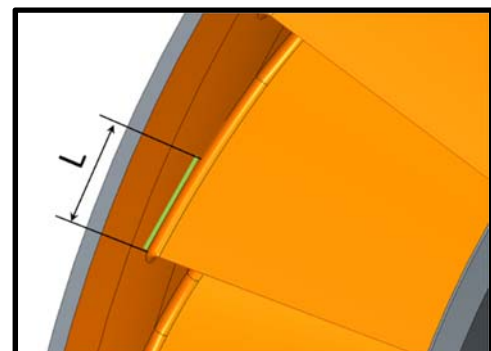
Figure 2. Criteria of Erosion at the base of the blade

In case of the erosion is detected as shown in Figure 2, the nozzle ring can be re-used, if the longest length "L" of all relevant blades is within the following table.

Type	Length "L"
TCA55	27mm
TCA66	36mm
TCA77	42mm
TCA88	48mm

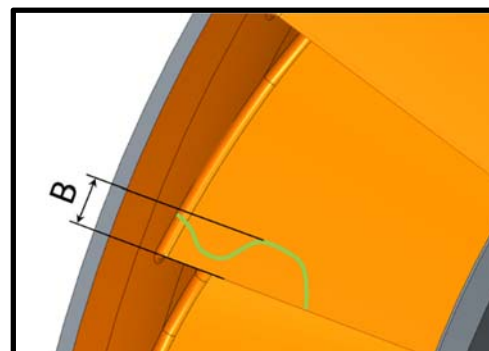
Figure 3. Criteria of Erosion on the trailing edges of the blade

In case of the erosion is detected on the trailing edges of the blade as shown in Figure 3, the nozzle ring can be re-used by rotating nozzle ring, if the widest width “B” of all relevant blades is within the following table.

Type	Width “B”
TCA55	14mm
TCA66	18mm
TCA77	21mm
TCA88	24mm

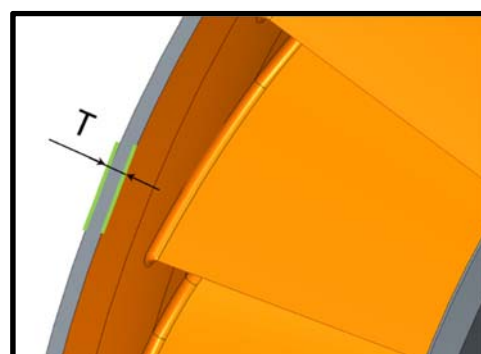
Figure 4. Criteria of Erosion on the outer ring

In case of the erosion is detected on the outer ring as shown in Figure 4, the nozzle ring can be re-used by rotating nozzle ring, if the thinnest dimension “T” of all relevant blades is within the following table.

Type	Dimension “T”
TCA55	3mm
TCA66	3.5mm
TCA77	4mm
TCA88	4.5mm

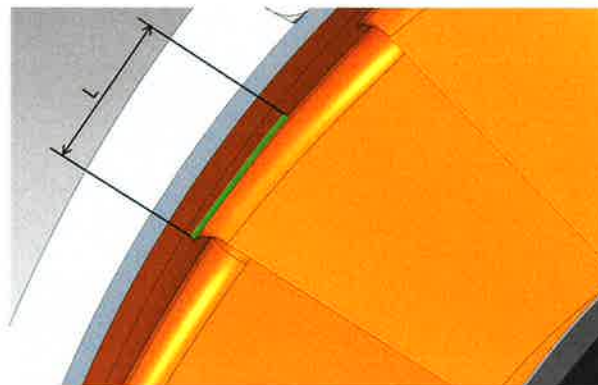
Erosion at the base of the blade

The following erosion values are permitted between the base of the blade and the outer ring:

Type	Length "L"
TCA55	27mm
TCA66	36mm
TCA77	42mm
TCA88	48mm

The specified length "L" relates to the most severely affected blade. If at least one blade exceeds the specified value, twisting of the nozzle ring is not permitted.

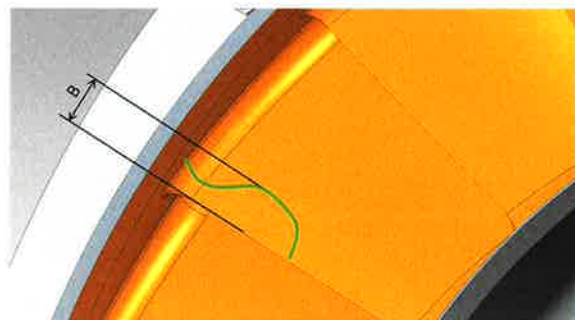
Erosion on the trailing edges of the blades

The following maximum values are permitted for the dimension "B" on the trailing edge of the blade:

Type	Width "B"
TCA55	14mm
TCA66	18mm
TCA77	21mm
TCA88	24mm

The specified width "B" relates to the most severely affected blade. If at least one blade exceeds the specified value, twisting of the nozzle ring is not permitted.

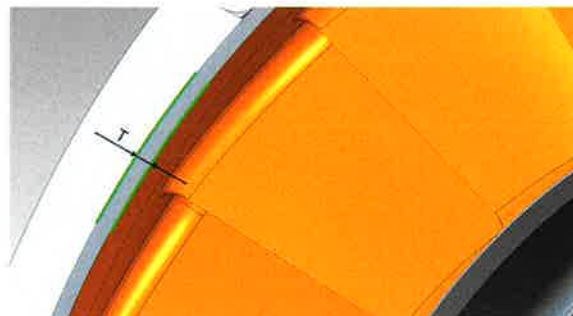
Erosion on the outer ring

The following minimum values are permitted for the dimension "T" on the outer ring of the nozzle ring:

Type	Dimension "T"
TCA55	3mm
TCA66	3,5mm
TCA77	4mm
TCA88	4,5mm

The specified dimension "T" relates to the most severely affected location on the outer ring. If the value for dimension "T" falls below the specified value in at least one location on the circumference, twisting of the nozzle ring is not permitted.
