# YANMAR SERVICE NEWS

Subject	Intercooler Case Corrosion	No. : 18-2-G-12-010-N Issued: 2018.02	
Engine Model	6EY17W	Use	Marine Main Engine
		Engine Nos.	_____

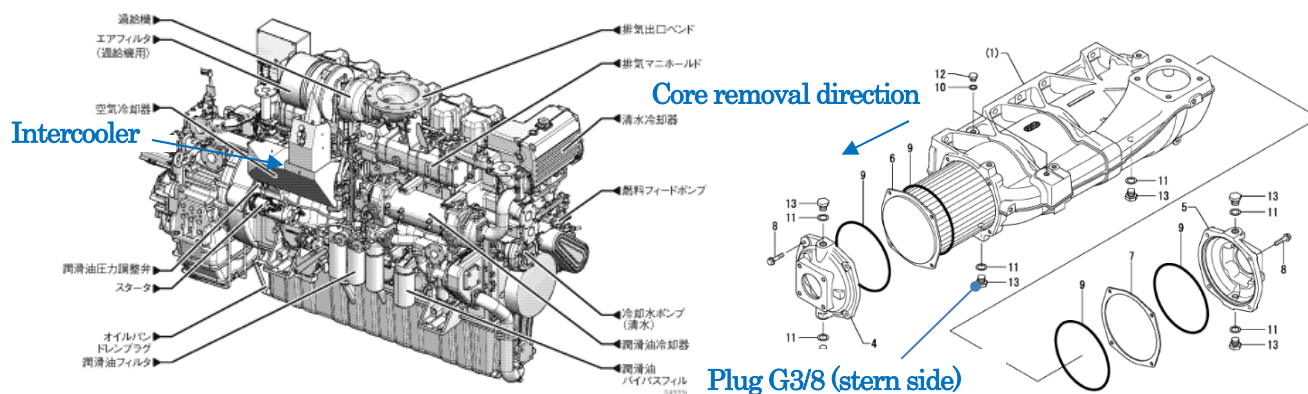
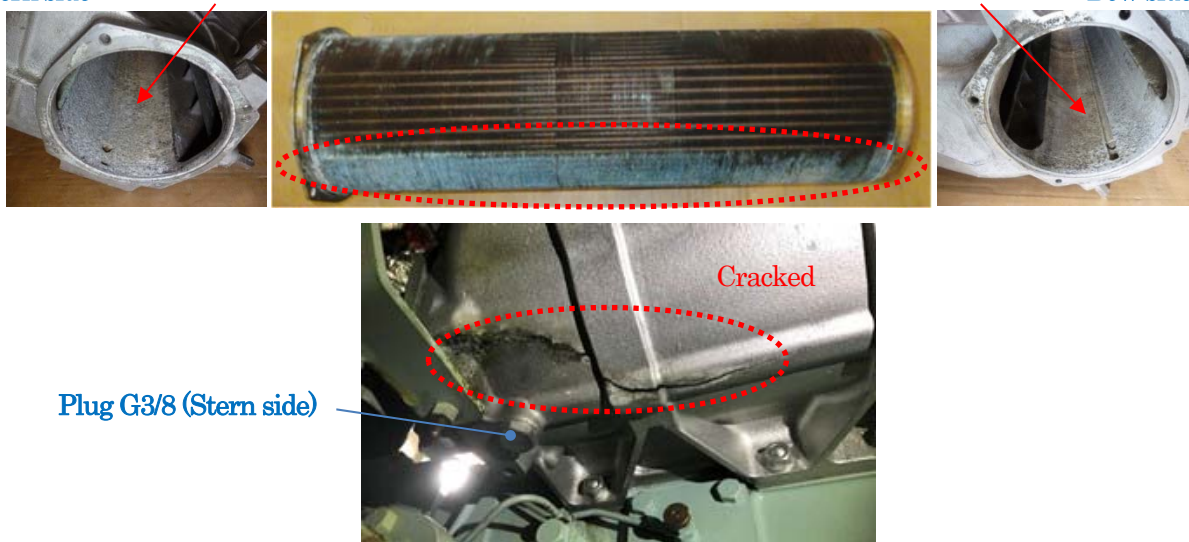
Photo 1. Damage of Intercooler

In some of the 6EY17W engines, while servicing the intercooler, the removal of the core was sometimes very hard. Upon inspection of the faulty product, as shown in the photo below, the intercooler case inner face was found corroded and aluminum oxide precipitated deposited on the area between core and case. This hindered the removal of the core. Corrosion is attributable to the chlorine component contained in condensed water of the seawater atmosphere in the charging air. This trouble in the worst case, can lead to the cracking of the case due to the accumulation of aluminum oxide.

Stern side      Corroded      Aluminum oxide accumulated      Corroded      Bow side

- Concerning the engines already shipped, whenever the core was removed for maintenance and cleaning, we recommend to paint the corrosion-proof paint, having equivalent effectiveness to that of the surface treatment above, to the whole area of the case's charging air line.
