The Hazards of Snap-back

Initial learnings from a serious incident of mooring line failure

September 2015

Oil Companies International Marine Forum

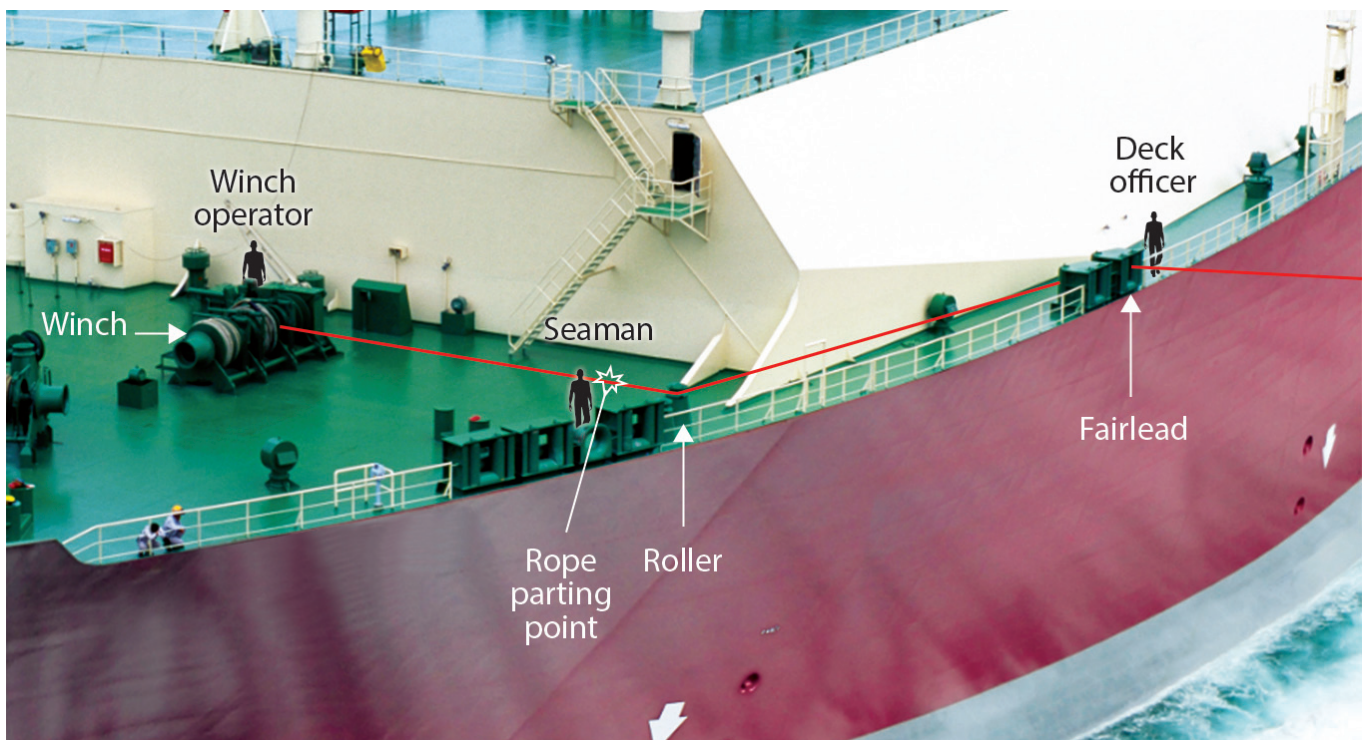
At the time of the incident, the vessel was being warped into position by tensioning the forward back springs. The deck officer was in charge of the forward mooring party standing aft of the fairlead through which the spring lines passed. He was directing operations by signalling to a seaman who was located well forward, and who was in a position to relay the signals to the winch operator.

The mooring line parted inboard from a pedestal fairlead. The section of the line between the break and the port shoulder roller fairlead struck the deck officer on the head as it whipped back before going overboard through the fairlead. The deck officer was found lying unconscious forward of the roller fairlead. He had sustained multiple skull fractures.

The mooring line that failed was a 44-millimetre diameter sheathed ultra-high modulus polyethylene (UHMPE) line. The line was fitted with a 22-metre long polyester/polyethylene tail. The section of UHMPE line in use between the winch and the connection with the tail was approximately 68 metres long.

Figure 1: Location of injured deck officer relative to rope parting point

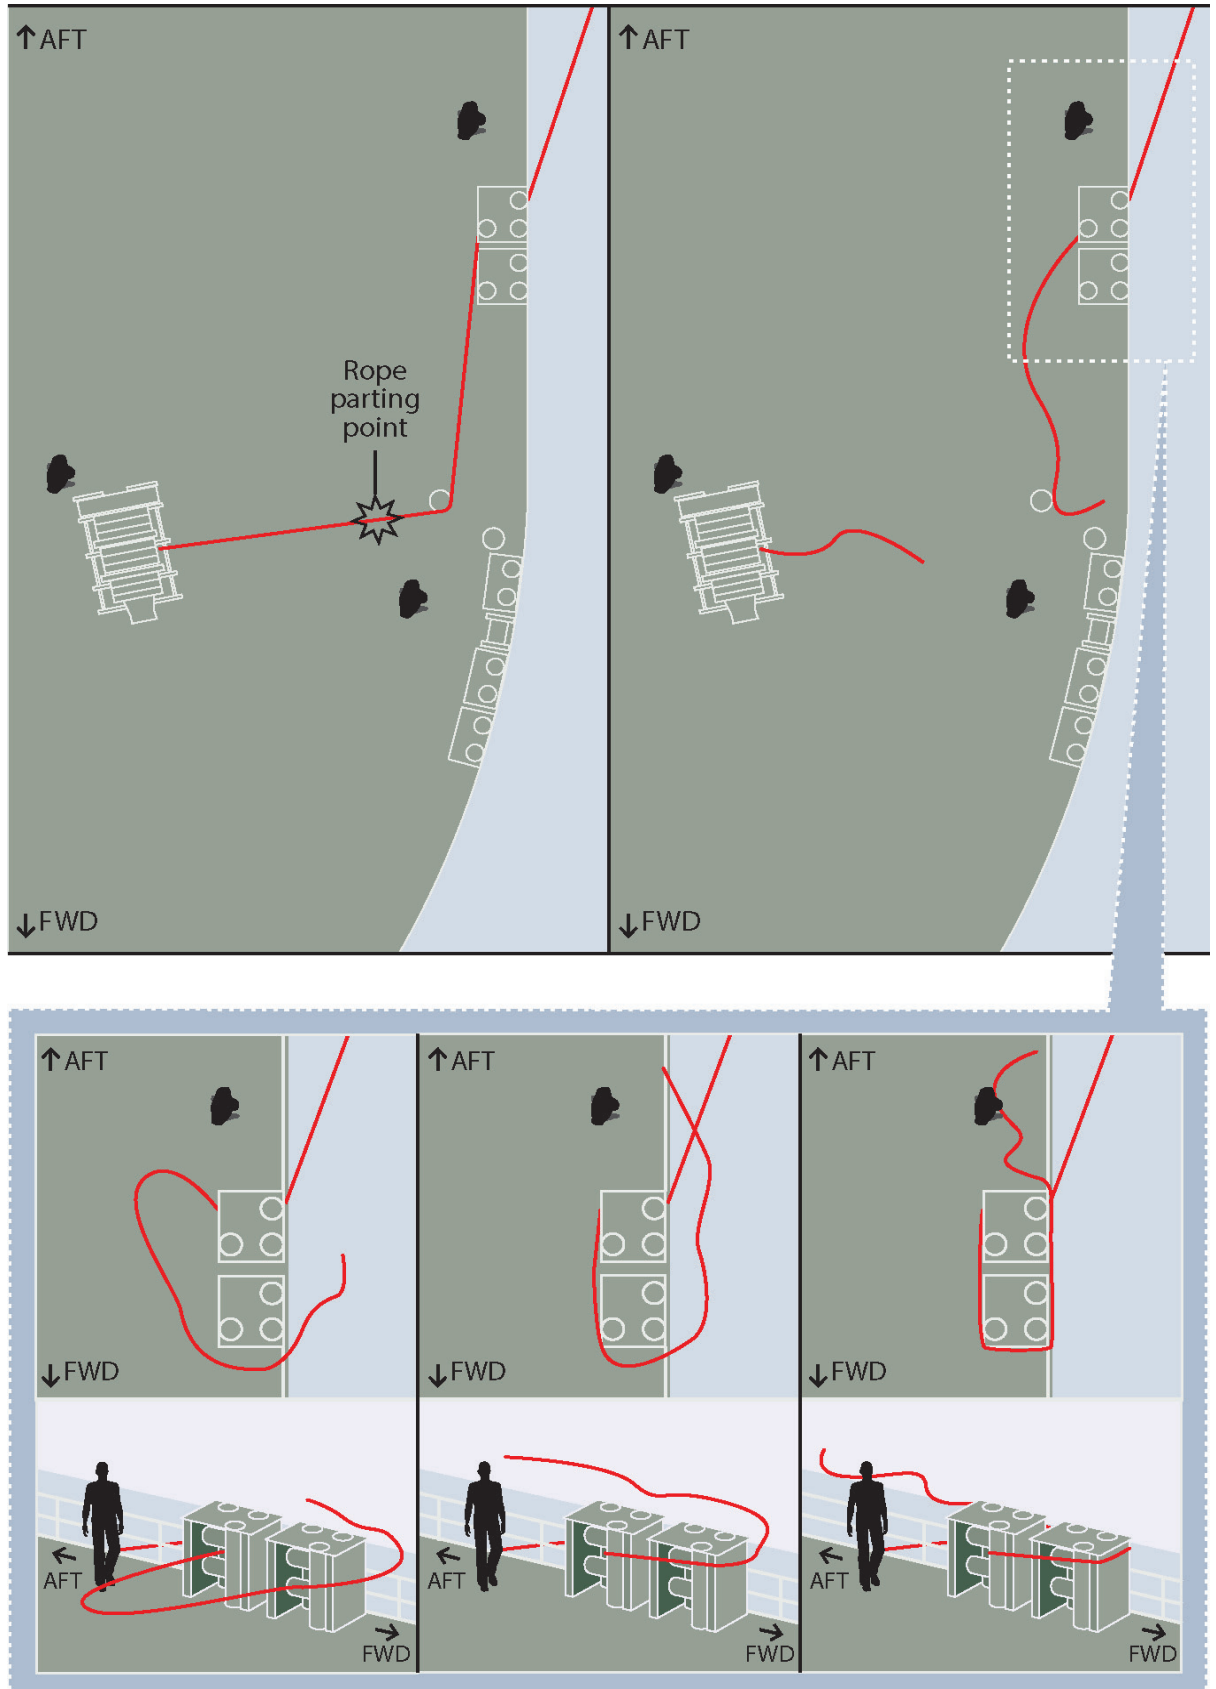
Following the incident, computer modelling was used to assess the dynamic trajectory of the entire length of the UHMPE rope from its point of failure. The modelling indicated that it was highly probable that the rope would go aft of the roller fairlead and wrap around it before finally going outboard. The results support the theory that the deck officer was struck while standing aft of the roller fairlead, and that he was knocked forward to the position where he was found.

Figure 2: Example trajectory of failed line between 0.19 and 0.29 seconds after parting
