Fretting marks on piston crown and skirt assembly surfaces

SL2020-691/JNN
February 2020

Owners and operators of
MAN four-stroke diesel engines.

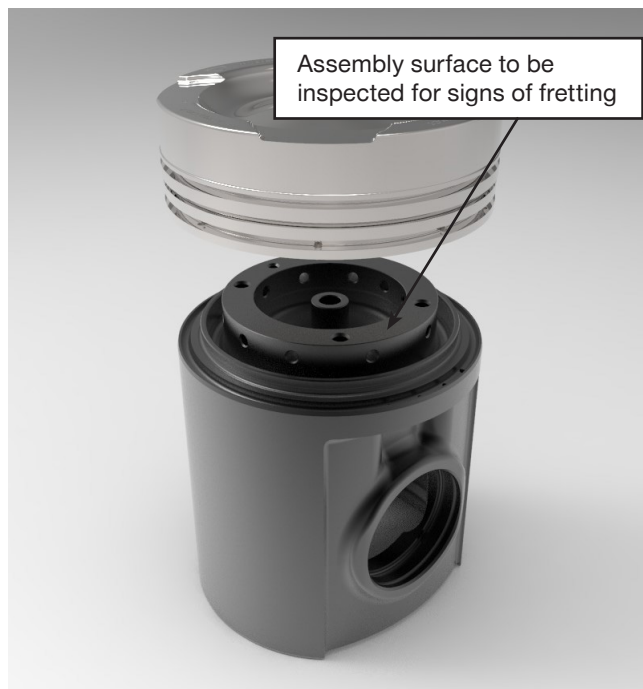
Two-part piston dismantled for inspection

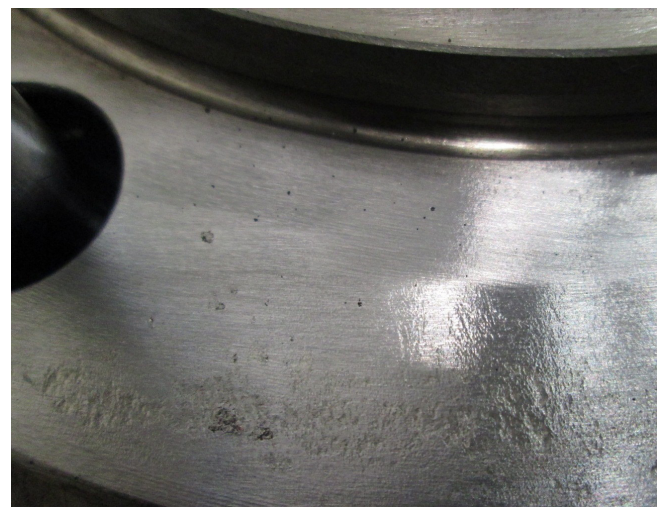
Due to the high forces and temperatures that the piston parts are exposed to during operation, fretting may develop over time.

Fretting is caused by micro movements between two parts under high load.

The above picture shows an example of fretting marks on the (cleaned) assembly surface of the piston crown.

In order to ensure the best possible contact between the surfaces of the piston skirt and crown, any local material accumulation (high spots) of the fretting must be removed prior to reassembly.

If the fretted area exceeds 30% of the total mating surface the piston has to be scrapped.

If below 30% the fretted area can be reworked, see below.

The material accumulations are to be removed as follows:

Step 1: Remove local peaks by means of emery paper with increasingly finer grades (240 – 400).

Step 2: Finish by means of an oil stone. Move the oil stone in circumferential direction of the mating surface for removal of additional material on the surface.

All smoothed areas must be crack-tested by means of a penetrant test or a magnetic particle test method to detect potential cracks.

The piston crown and skirt must be without cracks. In case cracks are detected the complete piston must be replaced.
