for MITSUI—MAN B&W engines,  <b>Product Safety Warning for TCA type turbocharger</b>		<b>No.203</b>	
		<b>APPROVED</b>	<b>M.Kobayashi</b>
		<b>CHECKED</b>	
		<b>PREPARED</b>	<b>T.Matsubara</b>
<b>ENGINE TYPE</b>	<b>TCA type turbocharger (TCA55, TCA66, TCA77)</b>	<b>DATE</b>	<b>2021.02.17</b>
<p>Recently, our Licensor, MAN Energy Solutions (Augsburg), issued an Important Safety Warning (Product Safety Warning) for TCA type turbocharger.</p> <p>This warning is announced for the recommendation of your immediate preventive measures as the purpose of the keeping safety, because TCA turbocharger built by MAN suffered from a compressor wheel hub burst and the compressor wheel fragments were ejected from the turbocharger structure in the field incident.</p> <p>The hazardous area has been described on the instruction manual. Besides, along this warning information, we recommend to avoid an unnecessary stay near TCA turbocharger while the engine is in operation more than 50% load and set larger hazardous area than the conventional hazardous area on the instruction manual.</p> <p>The larger hazardous area around the engine and the TCA turbocharger is shown on Figure1,2 and in the attached “Ad

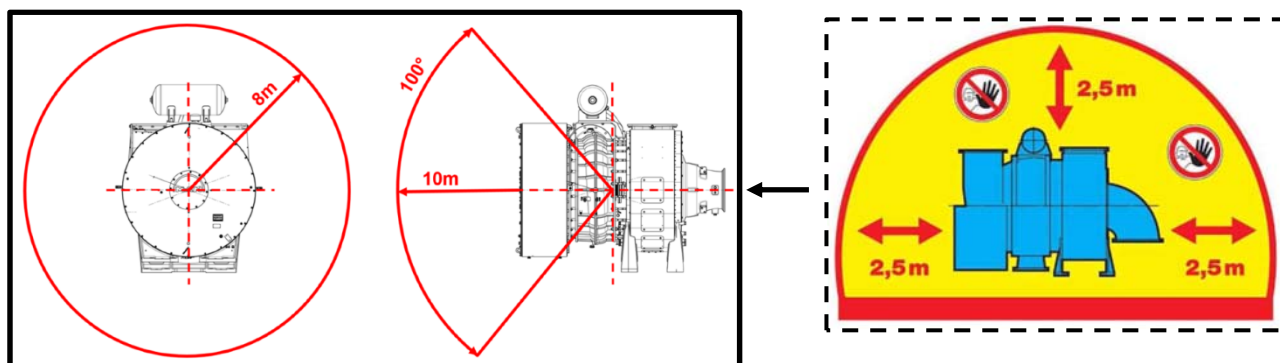
Figure2. Hazardous area (around turbocharger)

[Left: recommendation of this letter, Right: recommendation of conventional instruction manual]

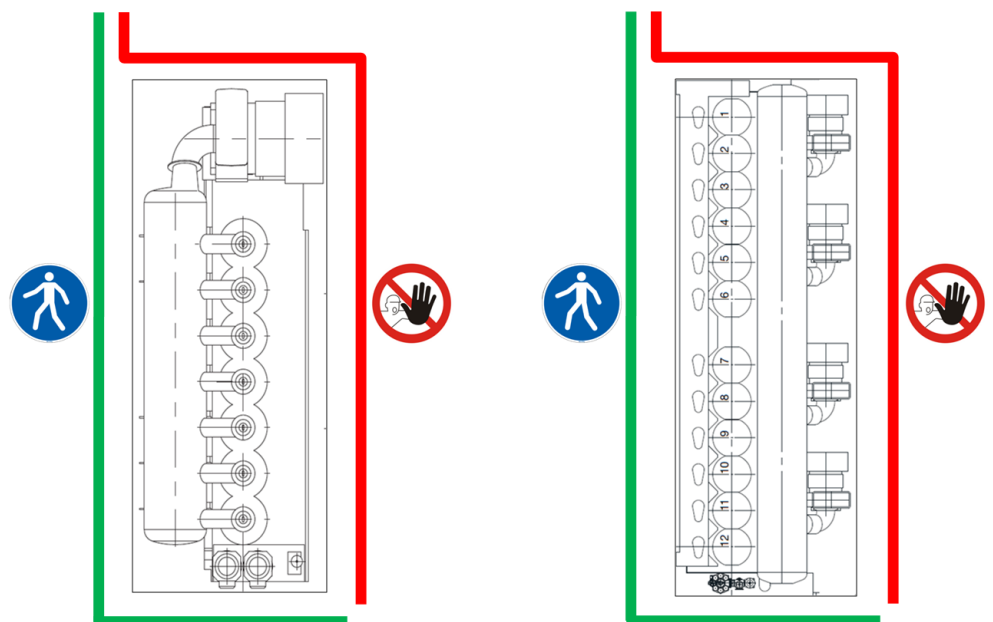
Fig. 1: Example of an optimized path around the engine

In any case please optimise your path through the engine room in order to minimize your stay in the hazardous area (Figure 1).

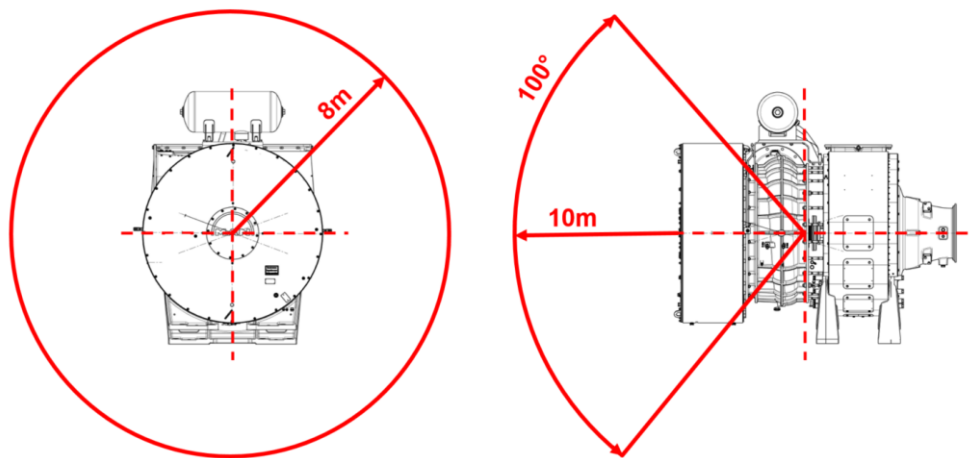
Fig. 2: Red zone = extended safety zone (extended compared to the safety zone which is defined in the Instruction Manual)

During extended maintenance work a longer stay in the engine room may be necessary. In this case please do not perform this work in the extended safety zone (Figure 2).

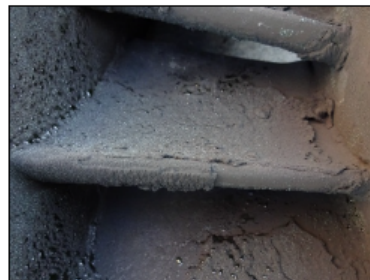
It has often been observed that turbocharger in the field are not being adequately cleaned. Cleaning according to specification and instruction manual is necessary, in order to ensure a reliable and safe operation of the turbocharger. Wet and dry cleaning is mandatory when the engine is operated with HFO.

Figure 1: Heavily contaminated nozzle ring vane

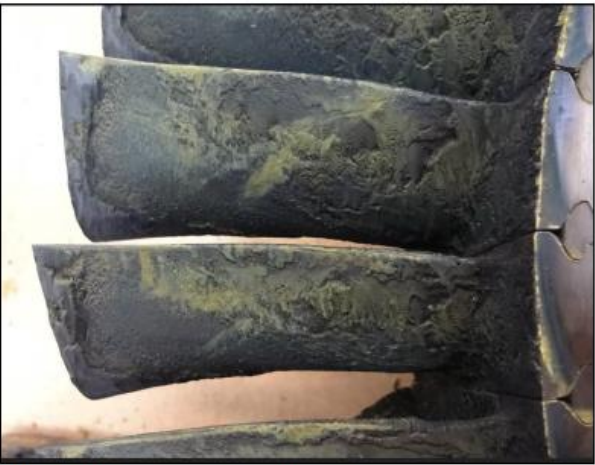
A high contamination level, caused by exhaust gas deposits, lead to an offset of the normal gas-flow parameters. This can lead to a temperature rise right in front of the turbine and/or surging, as well as to a significant increase of unfavorable excitation orders, which may lead to severe damage to the turbocharger.

Figure 2: Inhomogeneous fouling of turbine blades

Turbocharger cleaning must be carried out in accordance with the turbocharger operating manual (figure 3), furthermore it is mandatory to check adjustments of the cleaning system such as air and water pressures, pipe connections and installation.
