Inspection of Compressor wheel surface hardness		No.077	
		APPROVED	Y. Nishioka
		CHECKED	
		PREPARED	H. Miyake
ENGINE TYPE	NA, TCA Turbochargers	DATE	2012/2/29
<p>Parts replacement criterion was already informed in our Techno News No.6 for NA turbochargers; however, occasionally poor performance or total breakdown of turbocharger is reported. In some of these cases, the replacement criterion for key components such as compressor wheel or turbine blade was not followed. In this technical news, the compressor wheel damage is highlighted.</p> <p>The compressor wheel is made of a heat resistance aluminum alloy, but its hardness drops corresponding to exposing temperature and time as its characteristic. Further the dropping rate increases corresponding to temperature level and time, accordingly to intake air temperature, regular engine load, and running hours. If the compressor wheel is operated in significantly low hardness condition for long time, it shall breakdown. In worst case, it shall lead to the total breakdown of the turbocharger.</p> <p>Recommended hardness measuring position and the sample photo of the damaged compressor wheel are shown in next page. It is recommended to ch

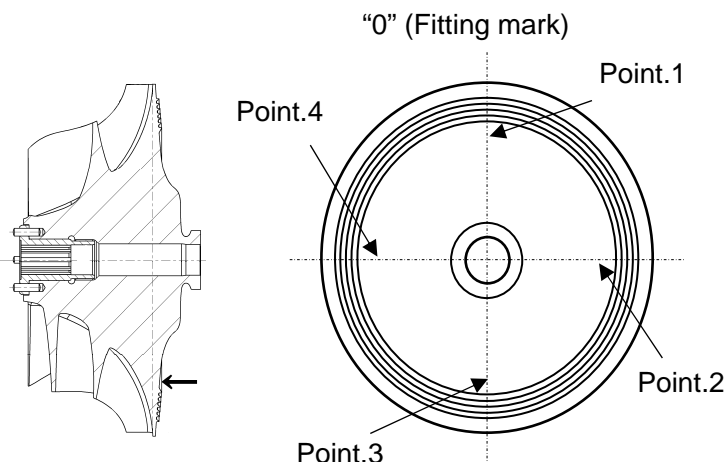
Measured surface hardness should be evaluated in average measured at 4 points at backside disk and inside of Labyrinth part that highlighted by arrow in sketch below. A portable measuring instrument can be used for this inspection.

\* Correct hardness cannot be measured, if measured at other position above mentioned.

**Minimum limit : 105 HB**

**Measuring interval: Every overhaul**

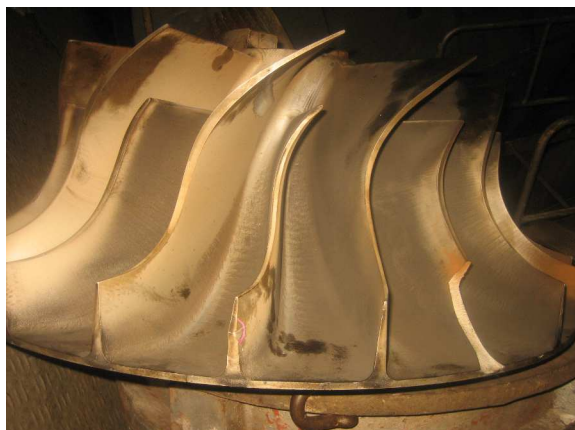
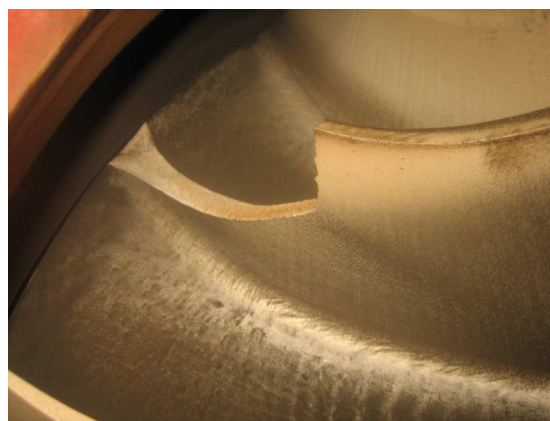
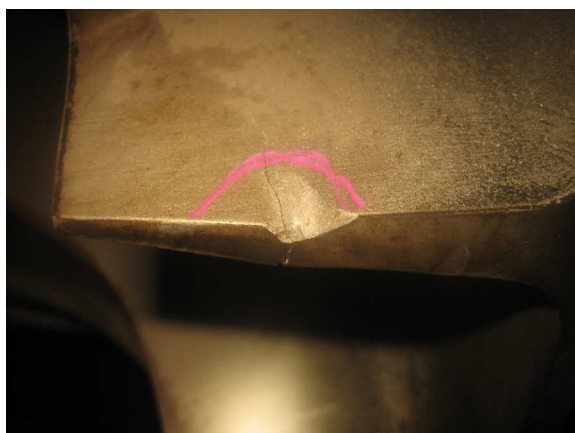
## 2. Trouble experiences due to lack of surface hardness on compressor wheel (1)

Turbocharger type : NA70/TM9

Running hour : approx. 101,000 hrs (16 years after delivery)

Measured hardness on compressor wheel : **83 HB**

Blade at the part on air outlet side had been damaged. Dent marks with crack had occurred due to impact of the fractured blade.

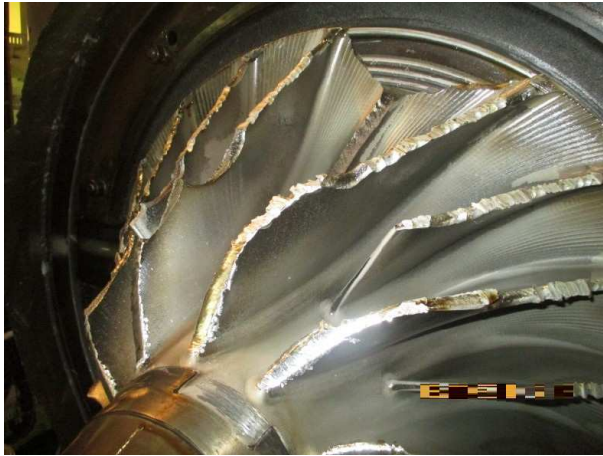
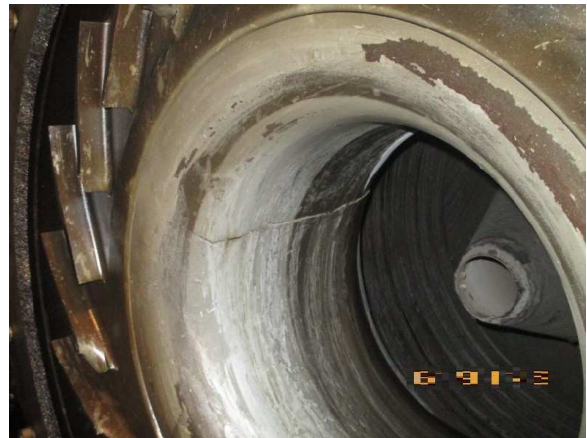
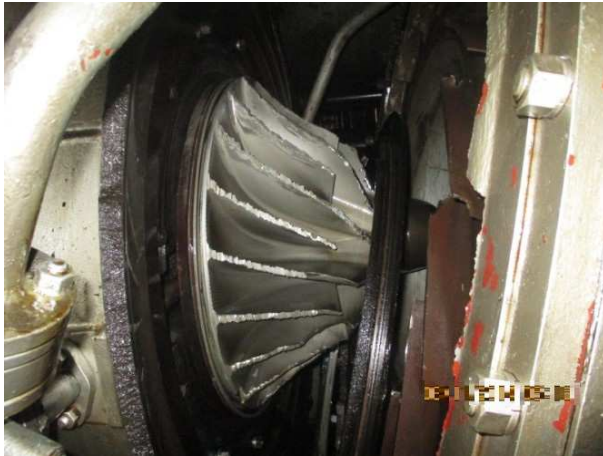
### 3. Trouble experiences due to lack of surface hardness on compressor wheel (2)

Turbocharger type : NA57/TO9

Running hour : approx. 103,000 hrs (16 years after delivery)

Measured hardness on compressor wheel : **92 HB**

- Cracks occurred on some blades on compressor wheel → Blades had partly damaged
- unbalance of rotor shaft → compressor wheel contacted to shroud casing
- Shroud was damaged
- Big vibration of silencer and compressor casing → Shroud casing fractured
- Connected part of compressor casing and bearing casing was fractured due to the shock

The condition of “reduction of hardness” could be influenced due to engine operation condition / environment and maintenance situation etc. Therefore, in order to use the turbocharger safely, it is recommended to plan and to carry out the inspection and maintenance regularly and to measure the hardness on compressor wheel by all means regardless of the actual using hours.
