Eight Discipline Report (8D Report)

To:	8D report No.:
From: :	RMA claim No.:
CC :	Chicony Power P/N: W065RP02P-SA01
	Customer P/N:
Submit date: 2019/10/04	Product description:
Receive date: 2019/10/04

Subject : EFT 測試 PWM MOS 損壞 (EFT 引發 SR 誤動作造成 PWM & SR MOS 同時導通)
干擾, 雜訊, 突波, 異常動作 [EFT, short through]

65W Power EFT Issue

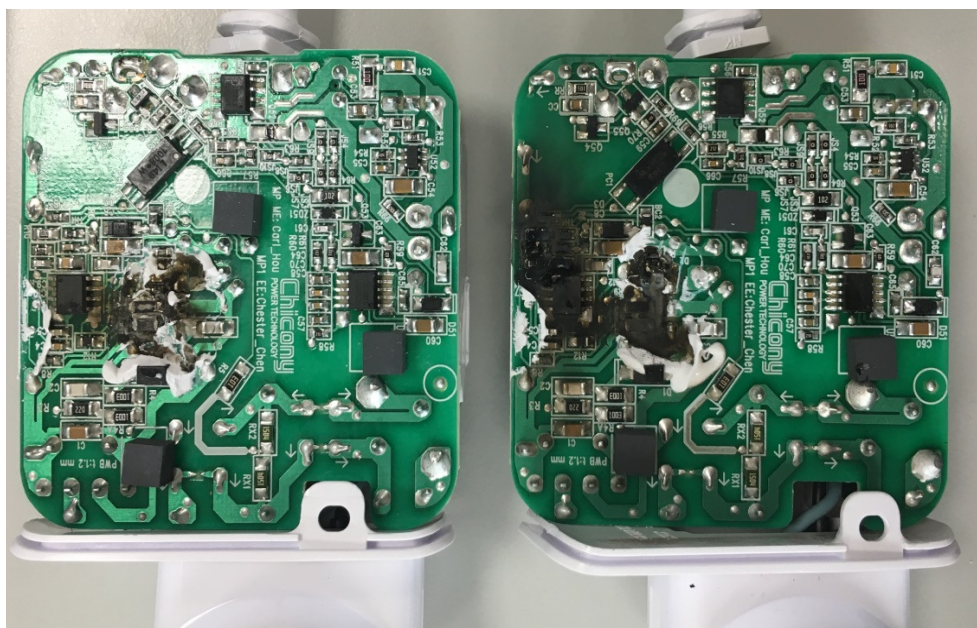
1. 在客戶端測試 4KV EFT 時, 發生 adapter damage 現象。
2. 開蓋後如下, Q1 & PWM IC 及其周邊有焦黑現象。

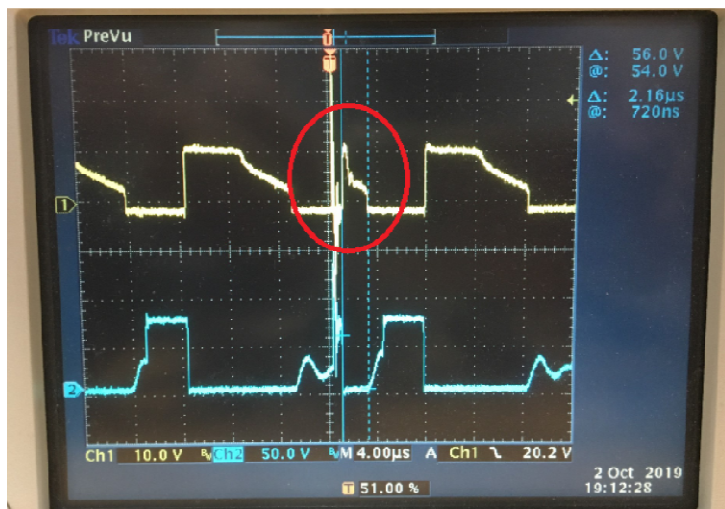
1. 將二次側 SR circuit 改為 schottky, 測試結果為 PASS
2. 推估是由於一二次側 MOS 同時導通而造成 damage。
3. 實際所勾的波型中發現, 在 EFT 過程中確實 Vgs 會有誤動作的現象, 由於 SR IC 受到 noise 干擾, 使得原本應該 turn off 的 MOS turn on, 而造成一二次側 MOS 同時導通現象。

1. 原本使用 SR IC 為 MPS6907, 將其改為 MPS6908。
2. MP6908 比起 MP6907 新修改了 Min on time 1.6uS→1.1uS, 因此 Vgs 發生誤動作時可減少 Q1 與 SR 同時導通的時間。

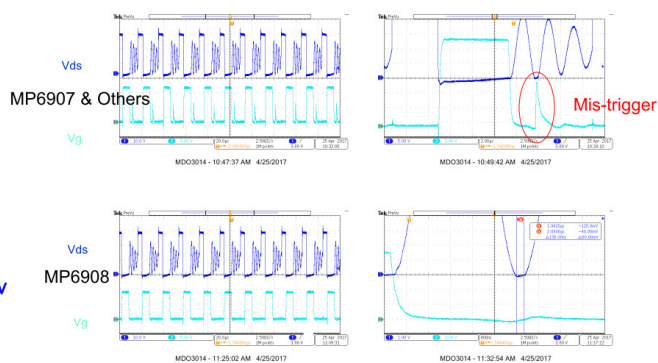
MP6907 to MP6908

- Vreg: -70mV → -40mV
- Turn-off propagation delay: 20ns → 15ns
- IQ: 2mA → 110uA. (Don't need LL mode)
- Min. on time: 1.6us → 1.1us
- VDS Turn-on threshold: -200mV → -80mV
- Both turn-on/off delay: Shrinks to 15ns

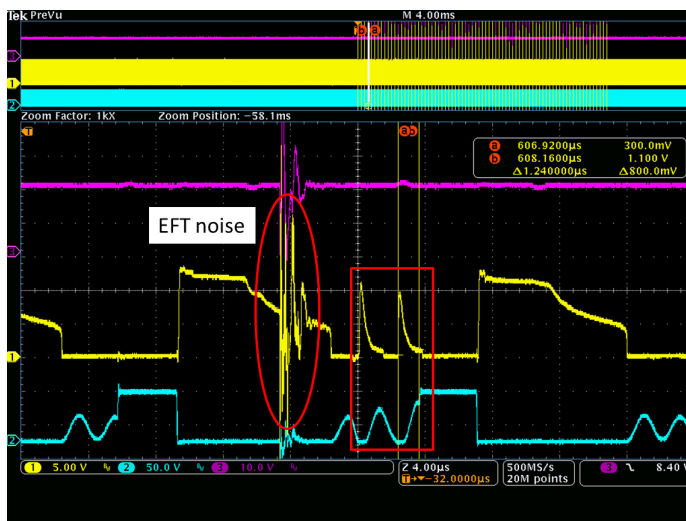
- 在發生 EFT noise 的干擾之後，原 MP6907 Vds DCM ring 會造成 Vgs 誤觸發而 turn ON。

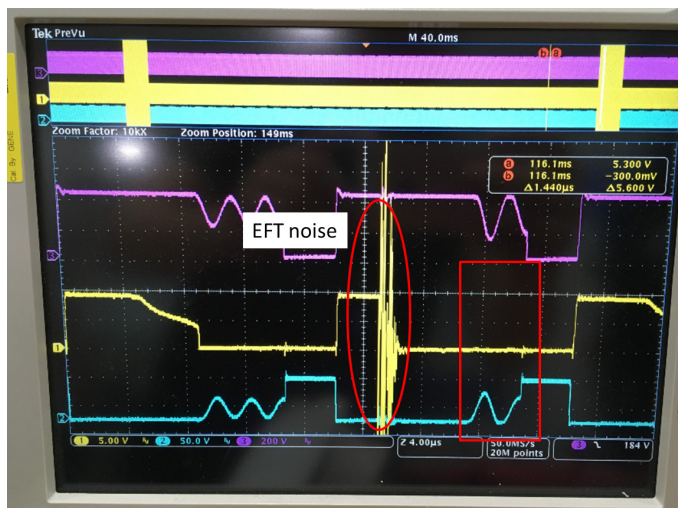
- 同樣在發生 EFT noise 的干擾之後，改成 MP6908 的 Vds DCM ring 並不會造成 Vgs 有誤動作現象。

2. MP6907 改為 MP6908
