## Eight Discipline Report (8D Report)

To: 8D report No.: **CPJ0303**

Submit date: **2019/3/7** Product description: **65W adapter**

Subject : **abnormal output \* 1pc**

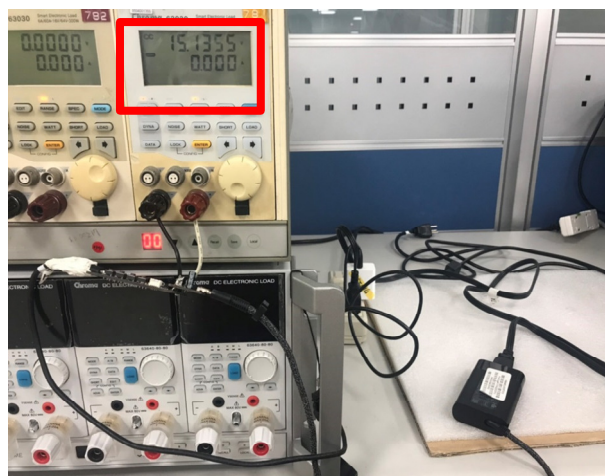
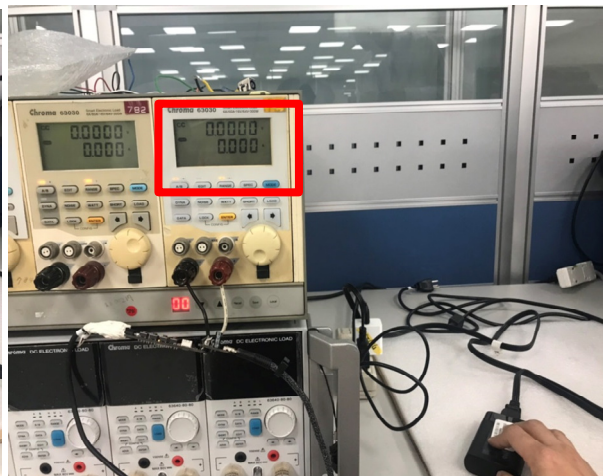
- Take the PSU to do the turn on test, it can power on normally. But when touch to the SR it hasn't the output, after release hand the defective symptom disappeared.**

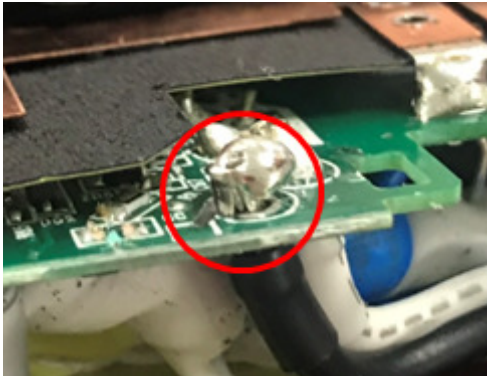
- Open the case to observe the soldering side and the component side, see the negative pole of the DC cable was false solder that cause it open in the circuit.

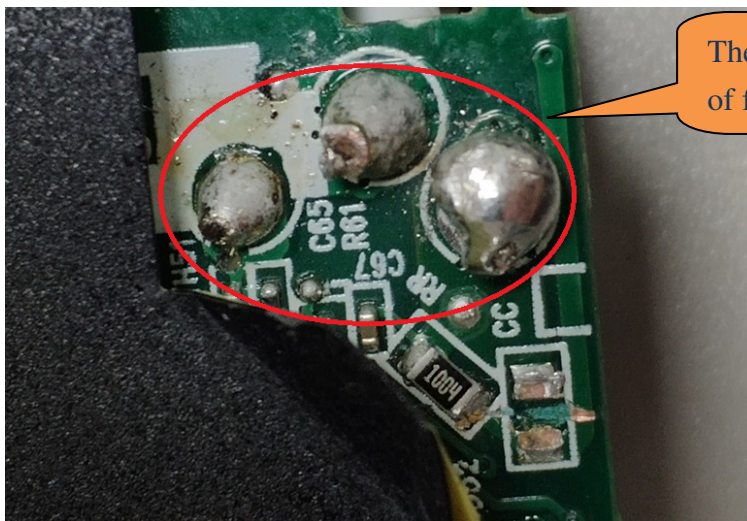
- Check the process, and below two stations have the risk which causes such failure: automatic soldering station and repair station.

Observe the defective soldering; the PCB has the traces of flux. This failure is similar as the operator cannot repair well then causes the false solder.

- From the sampling record of the automatic soldering station, the rate of soldering defect is about 0.33%, so the rate of the operator hasn't repaired well is much lower.
