Eight Discipline Report (8D Report)

To: 8D report No.: **CPCQ20221214**
 From: **Chicony Power Technology** RMA claim No.: **N/A**
 CC : **N/A** Chicony P/N: **W045RP05P-VE01-01**

Subject : **Adapter trace 未鋪白漆導致 ESD fail [ESD, PCB, 白漆]**

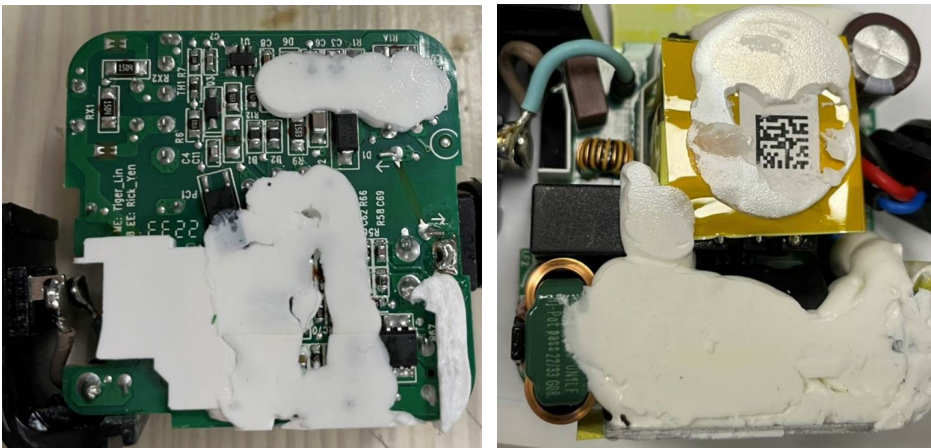
2.1.Adapter 收到時已經是開蓋的狀態,檢查確認零件面及錫面.如下圖:

When the adapter is received, the cover is already open. The parts surface and tin surface are shown as follows.

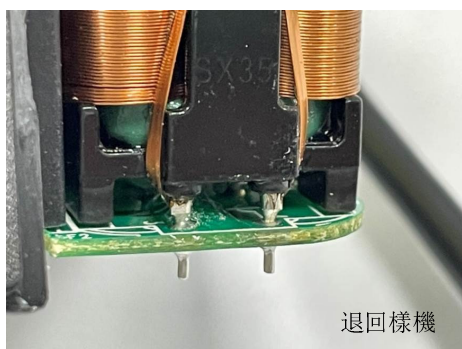
退回樣機

2.2.觀察退回樣機發現 LF2 底下 PCB 無白漆(為對策前產品).此樣機生產日期 2022/10/28,是對策前產品.ESD Fail 對策 PCB 加白漆於 2022/11 月中導入.

The PCB board under LF2 of the returned unit has no white paint (it is the product before the countermeasure was implemented). The production date of this unit is 2022/10/28. PCB board with white paint has been introduced in the middle of 2022/November.

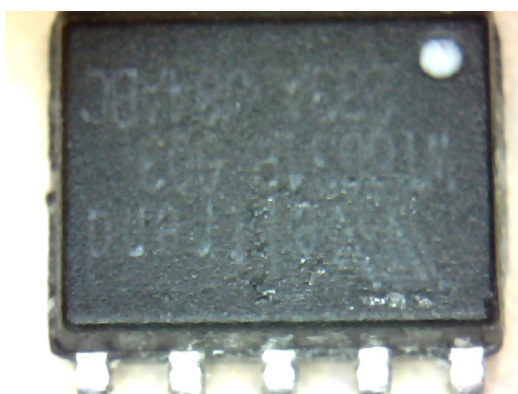
2.3.量測錫面各個零件,發現 U52 & PC1 NG.

Each part of the tin surface was measured step by step, and it was found that U52 & PC1 NG.

U52 的 VCC pin(pin 10)與 GND(pin 1) short

綜上所述:U52 & PC1 NG 造成產品無輸出.

In conclusion: U52 & PC1 NG resulting in the adapter no power.

2.4.Adapter 更換 U52 & PC1 後滿載燒機無不良現象,B/I 8Hr Pass.

After replacing the failed parts, full load B/I 8Hr, the output of adapter is normal.

1.將不良 U52 送予廠商分析.

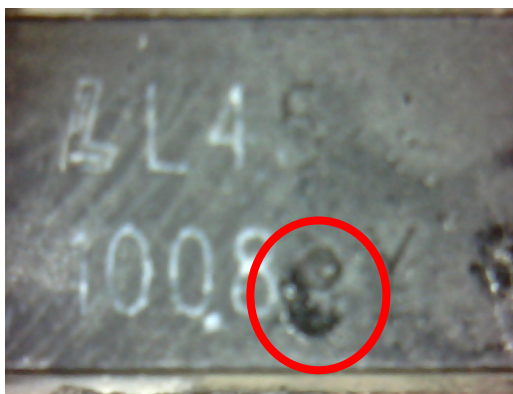
PC1 擊穿
