Eight Discipline Report (8D Report)

To:	8D report No.:
From: :	RMA claim No.:
CC :	Chicony Power P/N: N025A001Q-CT01
	Customer P/N:
Submit date: 2020/12/03	Product description:
Receive date: 2020/12/03	
Subject : 磁鐵影響電源運作 (永久磁鐵占用鐵芯磁路造成變壓器飽和觸發電源保護) 磁鐵, 磁路, 鐵芯, 磁飽和 [磁件]	
D1.) 問題解決成員: Use Team Approach	
主持者 (Team Leader) : 內部成員 (Internal Team Members): 外部成員 (External Team Member):	
D2.) 問題說明: Problem Description: (Note: Use who, what, when, where, why, how, how many to specify the Customer's problem.) 20W Power flicker Issue After assembling the magnet, the power module will cause LED turn off or flicking.	
D3.) 內部或客戶的暫時解決辦法及實施日期: Implement and Verify Containment Action: (Note: Internal / external containment action effectiveness and date.) 1. FAE of CPT got this PSU from customer for further analysis. 2. CPT send 1pc PSU to customer for exchange.

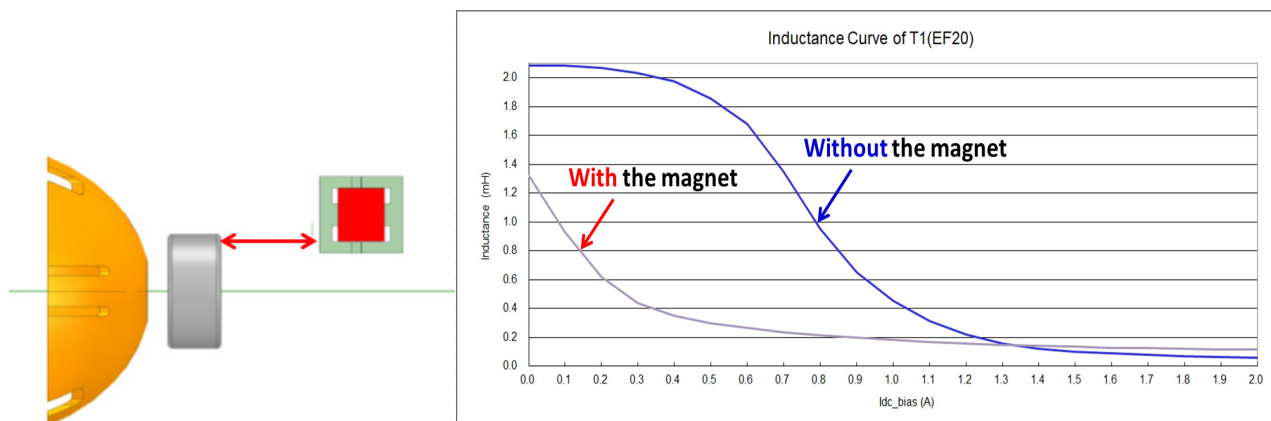
The distance from magnet to Transformer(T1) is 21.0185mm

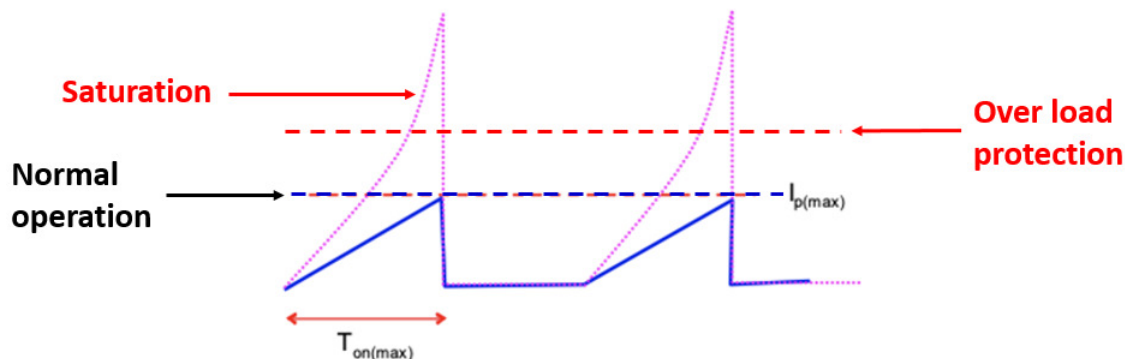
● **Transformer saturation and magnetic coupling risk.**

- Transformer inductance value suddenly drop and peak current will become non-linear increase.
- Control IC trigger over load protection induce power turn off or auto retry.
