Eight Discipline Report (8D Report)

To: 8D report No.: **CPCQ0421**
 From : **Chicony Power Technology** RMA claim No.: **N/A**
 CC : **N/A** Chicony P/N: **A045R00CH-HW01-0A**
 Customer P/N:
 Submit date: **2015/05/11** Product description: **45W adapter**
 Receive date: **2015/04/21** Defect D/C or Lot No.: **WEJZB0AGC7J0D2(Version 0A)**
 Subject : **45W adapter sample ISN failed**

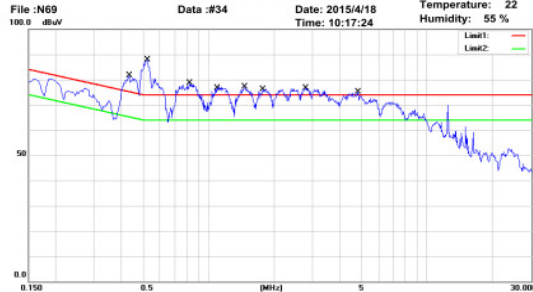
Conducted Emission Measurement
Data :#34 Date: 2015/4/18
Time: 10:17:24 Operator: Fred
Temperature: 22
Humidity: 55 %

Fail sample: (Version 0A S/N: WEJZB0AGC7J0D2)

Site : QCMC EMC CE Shielding Room
Condition : ISN(Voltage)-CLASS B (QP)
EUT : N69 SKU2
Model: Adapter:Chicony 45W
Test Mode : ISN-10M
Note : Rework ,PC Only ISN(Adapter:Chicony 45W)

Mk. No.	Frequency (MHz)	Reading (dBuV)	Detector	Correction factor(dB)	Result (dBuV)	Limit (dBuV)	Margin (dB)	Comment
X 1	0.4380	59.09	QP	19.34	78.43	75.10	3.33	
X 2	0.4380	52.15	AVG	19.34	71.49	65.10	6.39	
X 3	0.5197	65.76	QP	19.31	85.07	74.00	11.07	
* 4	0.5197	60.12	AVG	19.31	79.43	64.00	15.43	
X 5	0.8363	56.07	QP	19.23	75.30	74.00	1.30	
X 6	0.8363	51.06	AVG	19.23	70.29	64.00	6.29	
7	1.0947	54.56	QP	19.20	73.76	74.00	-0.24	
X 8	1.0947	49.79	AVG	19.20	68.99	64.00	4.99	
9	1.4629	54.21	QP	19.25	73.46	74.00	-0.54	
X 10	1.4629	49.54	AVG	19.25	68.79	64.00	4.79	
11	1.7801	53.47	QP	19.19	72.66	74.00	-1.34	
X 12	1.7801	48.70	AVG	19.19	67.89	64.00	3.89	
13	2.8098	54.32	QP	19.13	73.45	74.00	-0.55	
X 14	2.8098	49.41	AVG	19.13	68.54	64.00	4.54	
15	4.7941	51.17	QP	19.16	70.33	74.00	-3.67	
X 16	4.7941	45.78	AVG	19.16	64.94	64.00	0.94

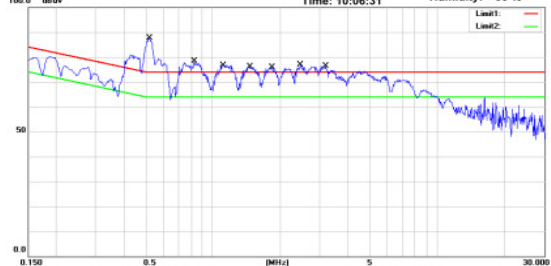
Conducted Emission Measurement
Data :#33 Date: 2015/4/18
Time: 10:06:31 Operator: Fred
Temperature: 22
Humidity: 55 %

Site : QCMC EMC CE Shielding Room
Condition : ISN(Voltage)-CLASS B (QP)
EUT : N69 SKU2
Model: Adapter:Chicony 45W
Test Mode : ISN-100M
Note : Rework ,PC Only ISN(Adapter:Chicony 45W)

Mk. No.	Frequency (MHz)	Reading (dBuV)	Detector	Correction factor(dB)	Result (dBuV)	Limit (dBuV)	Margin (dB)	Comment
X 1	0.5206	66.28	QP	19.31	85.59	74.00	11.59	
* 2	0.5206	59.58	AVG	19.31	78.89	64.00	14.89	
X 3	0.8393	55.90	QP	19.23	75.13	74.00	1.13	
X 4	0.8393	50.47	AVG	19.23	69.70	64.00	5.70	
5	1.0991	54.10	QP	19.20	73.30	74.00	-0.70	
X 6	1.0991	49.13	AVG	19.20	68.33	64.00	4.33	
7	1.4781	53.91	QP	19.25	73.16	74.00	-0.84	
X 8	1.4781	49.27	AVG	19.25	68.52	64.00	4.52	
9	1.8274	53.34	QP	19.18	72.52	74.00	-1.48	
X 10	1.8274	48.73	AVG	19.18	67.91	64.00	3.91	
11	2.4468	53.84	QP	19.12	72.96	74.00	-1.04	
X 12	2.4468	49.06	AVG	19.12	68.18	64.00	4.18	
13	3.1431	53.35	QP	19.13	72.48	74.00	-1.52	
X 14	3.1431	48.22	AVG	19.13	67.35	64.00	3.35

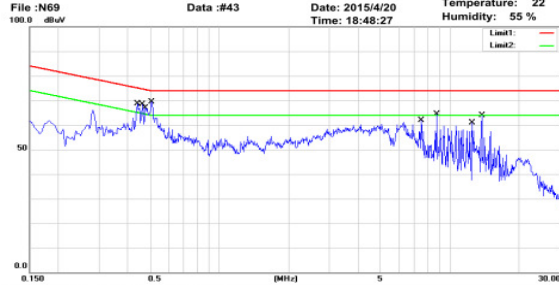
Conducted Emission Measurement
Data :#43 Date: 2015/4/20
Time: 18:48:27 Operator: Fred
Temperature: 22
Humidity: 55 %

Pass sample:

Site : QCMC EMC CE Shielding Room
Condition : ISN(Voltage)-CLASS B (QP)
EUT : N69 SKU2
Model: Adapter:Chicony 45W
Test Mode : ISN-10M
Note : Rework ,PC Only ISN(Adapter: Use SKU3 Chicony A045R00CH 45W)

Mk. No.	Frequency (MHz)	Reading (dBuV)	Detector	Correction factor(dB)	Result (dBuV)	Limit (dBuV)	Margin (dB)	Comment
1	0.4419	41.58	QP	19.34	60.92	75.03	-14.11	
2	0.4419	35.70	AVG	19.34	55.04	65.03	-9.99	
3	0.4658	37.40	QP	19.33	56.73	74.59	-17.86	
4	0.4658	31.02	AVG	19.33	50.35	64.59	-14.24	
* 5	0.4762	45.52	QP	19.33	64.85	74.41	-9.56	
6	0.4762	38.75	AVG	19.33	58.08	64.41	-6.33	
7	0.5080	43.68	QP	19.32	63.00	74.00	-11.00	
8	0.5080	36.26	AVG	19.32	55.58	64.00	-8.42	
9	7.5004	41.95	QP	19.18	61.13	74.00	-12.87	
10	7.5004	35.45	AVG	19.18	54.63	64.00	-9.37	
11	8.7422	26.21	QP	19.20	45.41	74.00	-28.59	
12	8.7422	18.64	AVG	19.20	37.84	64.00	-26.16	
13	12.4986	41.44	QP	19.27	60.71	74.00	-13.29	
14	12.4986	34.12	AVG	19.27	53.39	64.00	-10.61	
15	13.7490	36.38	QP	19.29	55.67	74.00	-18.33	
16	13.7490	29.33	AVG	19.29	48.62	64.00	-15.38

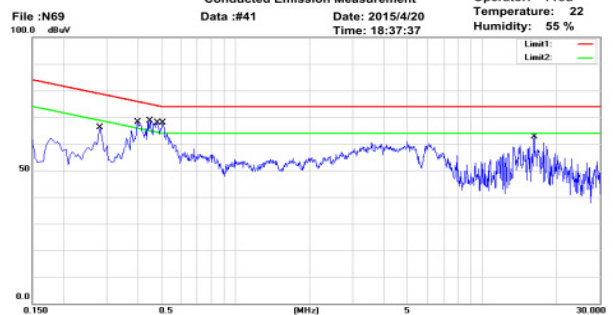
Conducted Emission Measurement
Data :#41 Date: 2015/4/20
Time: 18:37:37 Operator: Fred
Temperature: 22
Humidity: 55 %

Site : QCMC EMC CE Shielding Room
Condition : ISN(Voltage)-CLASS B (QP)
EUT : N69 SKU2
Model: Adapter:Chicony 45W
Test Mode : ISN-100M
Note : Rework ,PC Only ISN(Adapter: Use SKU3 Chicony A045R00CH 45W)

Mk. No.	Frequency (MHz)	Reading (dBuV)	Detector	Correction factor(dB)	Result (dBuV)	Limit (dBuV)	Margin (dB)	Comment
1	0.2810	43.90	QP	19.47	63.37	78.79	-15.42	
2	0.2810	42.11	AVG	19.47	61.58	68.79	-7.21	
3	0.4028	45.57	QP	19.36	64.93	75.80	-10.87	
4	0.4028	39.17	AVG	19.36	58.53	65.80	-7.27	
5	0.4500	44.14	QP	19.34	63.48	74.88	-11.40	
6	0.4500	33.90	AVG	19.34	53.24	64.88	-11.64	
7	0.4810	44.62	QP	19.33	63.95	74.32	-10.37	
8	0.4810	39.04	AVG	19.33	58.37	64.32	-5.95	
9	0.5080	41.06	QP	19.32	60.38	74.00	-13.62	
10	0.5080	31.35	AVG	19.32	50.67	64.00	-13.33	
11	16.2286	42.90	QP	19.36	62.26	74.00	-11.74	
* 12	16.2286	40.57	AVG	19.36	59.93	64.00	-4.07

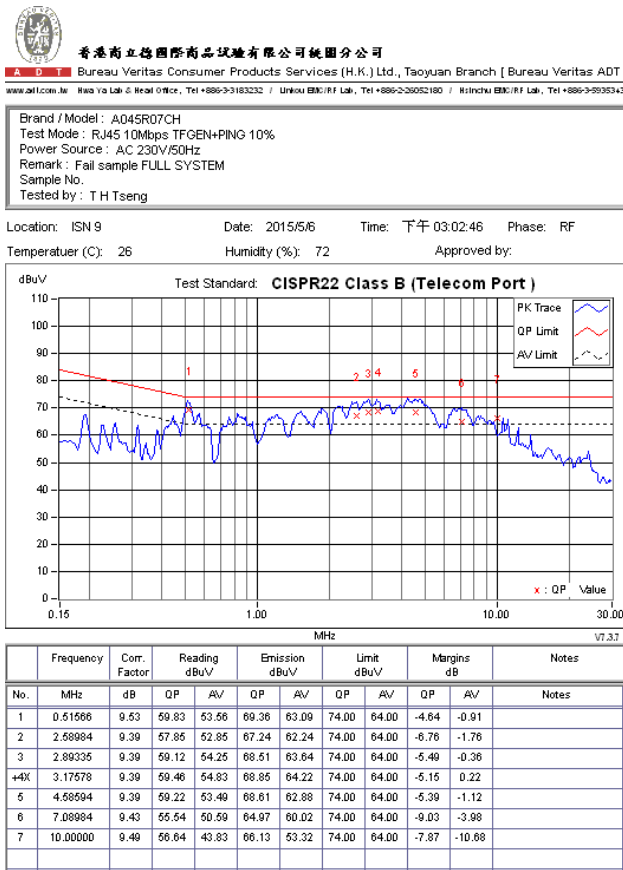
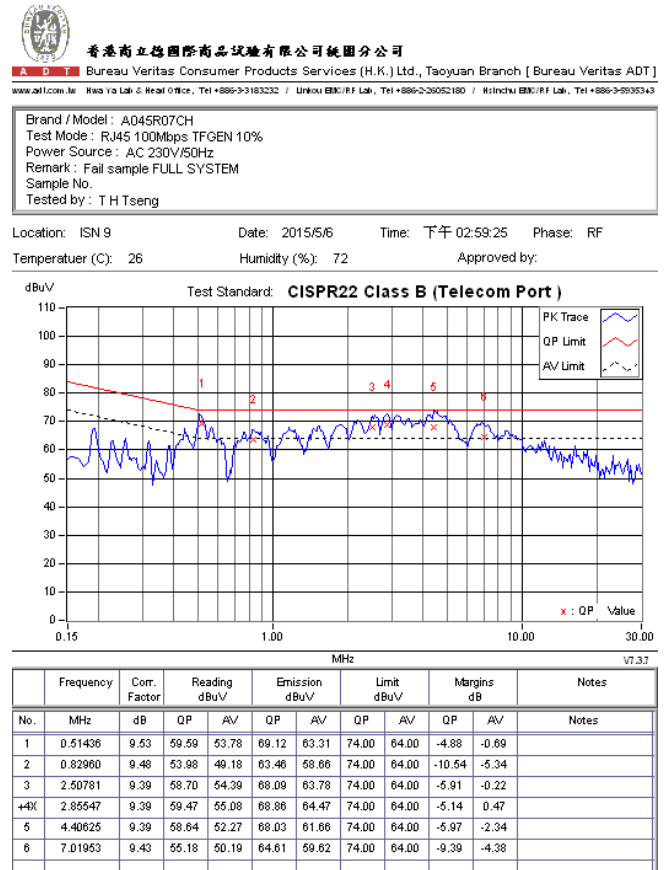
- 4/23 前往客戶端更換不良品,4/27 RD 收到不良品至 3rd party 驗證，測試結果跟廣達不良品曲線類似，測試結果 Fail.
不良機 3rd party 測試結果:

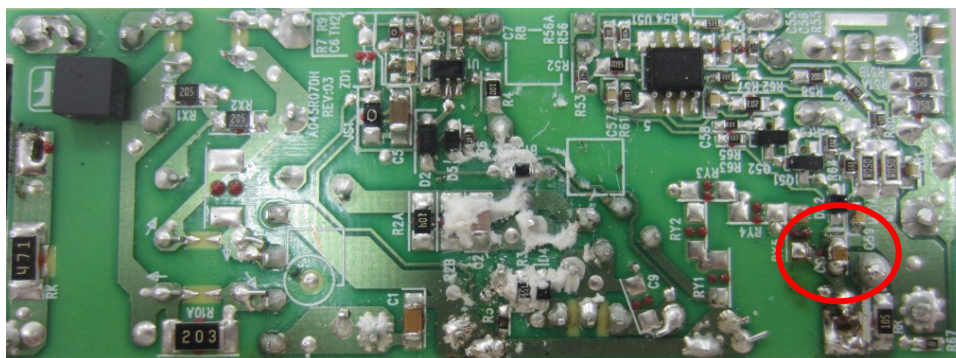
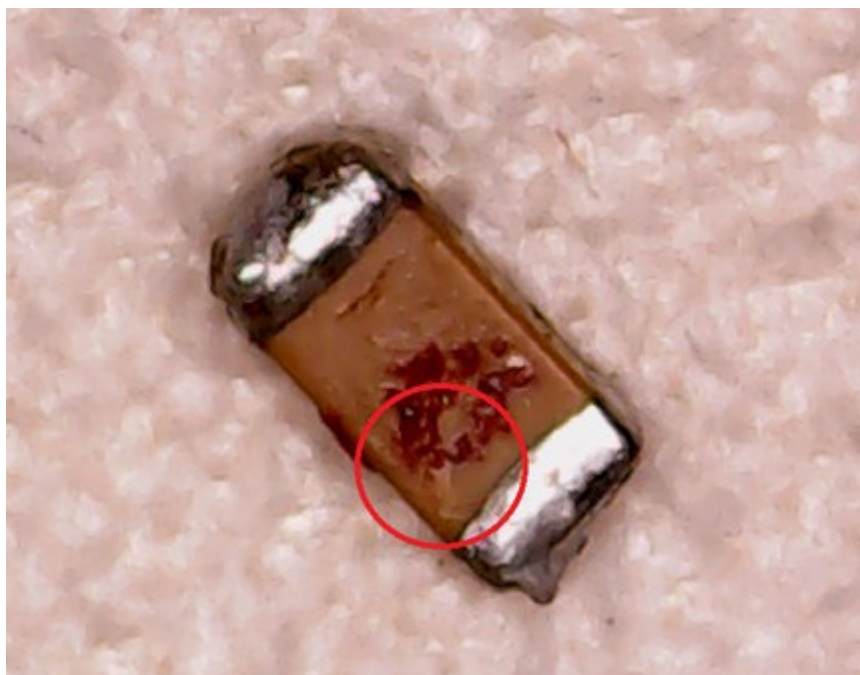
- 拆開樣機確認,發現產品 CC 位置有補焊痕跡,且表面有微小裂痕，量測 CC 電容單體阻抗為 11kohm，阻抗偏低(正常樣品 CC 電容阻抗為開路)。

CC 零件表面有微小裂痕

- 綜上所述: CC 零件破損造成 CC 阻抗偏低, 導致客戶端 ISN 測試異常。CC 破損發生原因, 從實物機台觀察, 應為維修員補焊作業時不熟練, 補焊 CC 時間較久, 造成零件受損微裂, 從而因間歇性接觸, 而流入客戶導致不良發生。

- 針對新近維修人員必須接受焊錫培訓,人員都需焊錫理論和實際操作考核,並由 IPQC 發證后上崗.

2. 針對焊錫時間重點教育, 對於 MLCC 零件必須焊錫時間不得超過 5 秒, 且不得碰觸到 MLCC 本體

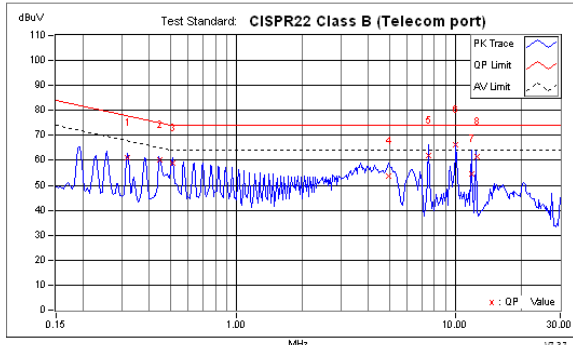
3. 更換 CC 零件後,重新測試 ISN 結果如下,不良現象可改善,測試結果 Pass。
不良機更換 CC 後之測試結果:

Brand / Model: A045R07CH
Test Mode: RJ45 10Mbps TFCEN+PING 10%
Power Source: AC 230V/50Hz
Remark: Fail sample FULL SYSTEM ,rework CC
Sample No.
Tested by: T.H Tseng

No.	Frequency	Corr. Factor	Reading	Emission	Limit	Margins	Notes
	MHz	dB	OP	AV	OP	AV	
1	0.31797	9.65	51.53	47.93	61.18	57.58	77.76
2	0.44651	9.57	50.84	46.32	60.41	55.89	74.96
3	0.50890	9.53	49.25	45.26	58.78	54.79	74.00
4	4.94531	9.38	44.36	39.33	53.74	48.71	74.00
5	7.50000	9.44	52.35	45.84	61.79	55.28	74.00
+6	10.00000	9.40	56.62	37.38	66.11	46.87	74.00
7	11.84786	9.57	45.02	38.80	54.59	46.37	74.00
8	12.50000	9.60	51.77	43.54	61.37	53.14	74.00

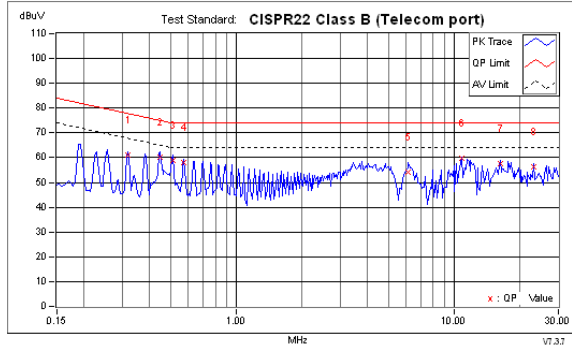
Brand / Model: A045R07CH
Test Mode: RJ45 10Mbps TFCEN 10%
Power Source: AC 230V/50Hz
Remark: Fail sample FULL SYSTEM ,rework CC
Sample No.
Tested by: T.H Tseng

No.	Frequency	Corr. Factor	Reading	Emission	Limit	Margins	Notes
	MHz	dB	OP	AV	OP	AV	
1	0.31797	9.65	51.59	48.01	61.24	57.66	77.76
2	0.44425	9.57	50.85	46.40	60.22	55.97	74.98
3	0.50938	9.53	49.42	45.30	58.95	54.83	74.00
4	0.57188	9.52	48.39	44.29	57.91	53.81	74.00
5	6.15234	9.41	44.53	39.49	53.94	48.90	74.00
+6	10.79297	9.52	50.14	47.78	59.66	57.30	74.00
7	16.22656	9.77	47.87	45.13	57.64	54.90	74.00
8	23.12891	10.15	46.31	43.49	56.46	53.64	74.00

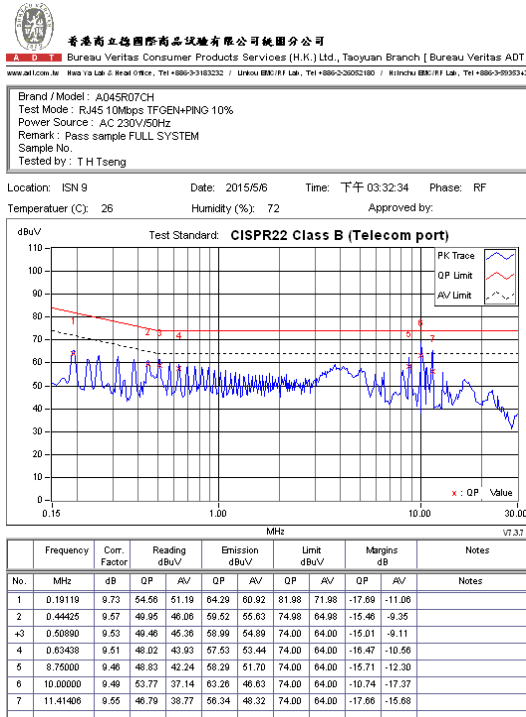
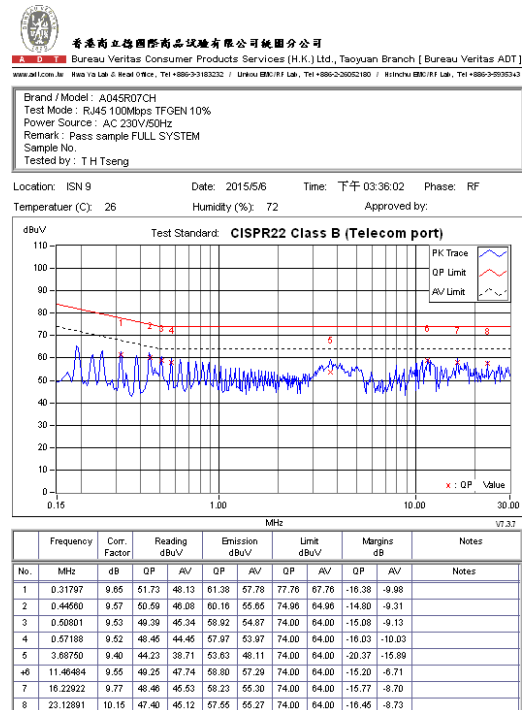
Sample 2:

4. 額外驗證 2pcs 樣機，測試結果與修復後之不良機曲線近似，可確認不良樣機測試失效原因為 CC 零件。
