## Eight Discipline Report (8D Report)

To: <b>Customer</b>	8D report No.:
From: : <b>Chicony Power Technology</b>	RMA claim No.: <b>N/A</b>
CC :	Chicony Power P/N: <b>A035R001H</b>
	Customer P/N:
Submit date: <b>2014/7/9</b>	Product description: <b>35W adapter</b>
Receive date: <b>2014/6/16</b>	
<b>Subject : No power*1pcs , ( 零件 / 磁件, 變壓器的線刺破 tape,導致感量下降)</b>	
<b>D1.) 問題解決成員:Use Team Approach</b>	
主持者 (Team Leader) : <b>Cf_Liu</b> 內部成員 (Internal Team Members): <div style="text-align: center; margin-top: 10px;"> <b>CQS: Jack Wang</b>  <b>QE: Kitty Zhang</b>  <b>MFG: Xiaohui Du</b>  <b>PE: Yong Liu</b>  <b>Sales: Justin Yu</b>  <b>RD: Jay Huang</b> </div> 外部成員 (External Team Member):	
<b>D2.)問題說明:Problem Description:</b>	
(Note: Use <b>who, what, when, where, why, how, how many</b> to specify the Customer's problem.)	
<b>2014/6/16 CPT has received 1pc won't power on from customer product team.</b> <b>SN: 140312003CC7</b>	
<b>D3.)內部或客戶的暫時解決辦法及實施日期:Implement and Verify Containment Action:</b>

To:	8D report No.:
From: : <b>Chicony Power Technology</b>	RMA claim No.:
CC : <b>N/A</b>	Chicony P/N:
	Customer P/N:
Submit date: <b>2014/6/18</b>	Product description: <b>35W printer adapter</b

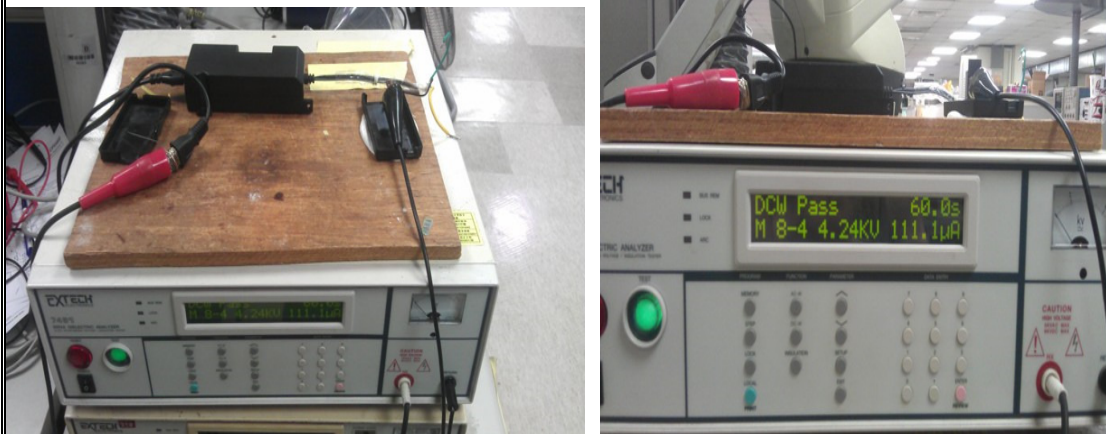
➤ Hi-pot test

The return unit passed Hi-pot 4242VDC 60sec.

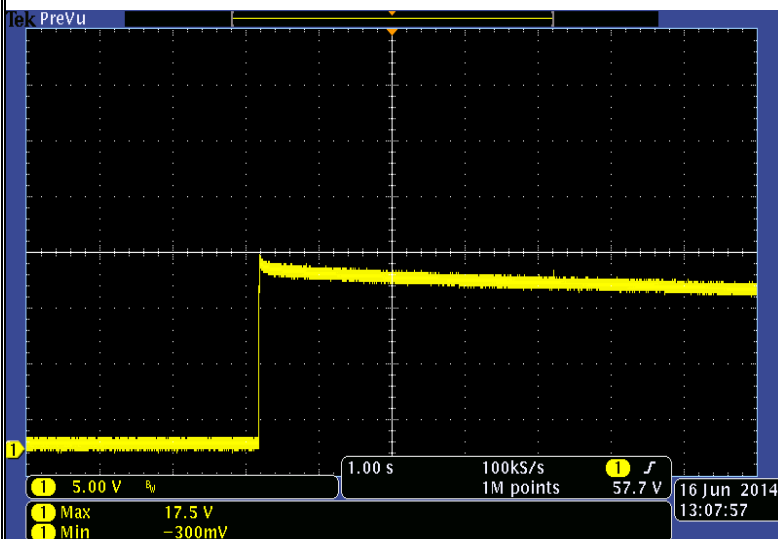
Fig.1

- The fail unit no any damage of case .
- We check the power on, the output voltage maximum was 17.5V. It is similar to HP's waveform.
- Open case & test.

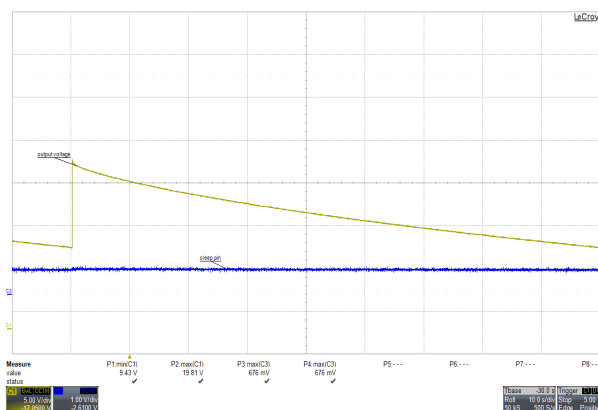
Fig.2 Customer measure the output voltage waveform

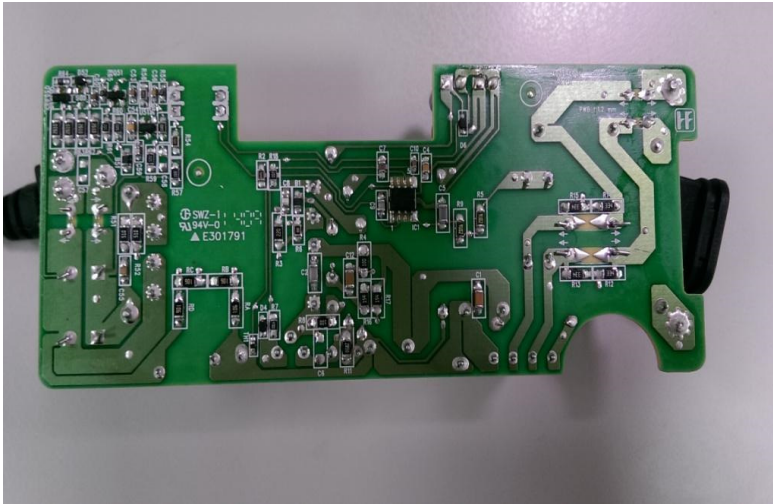
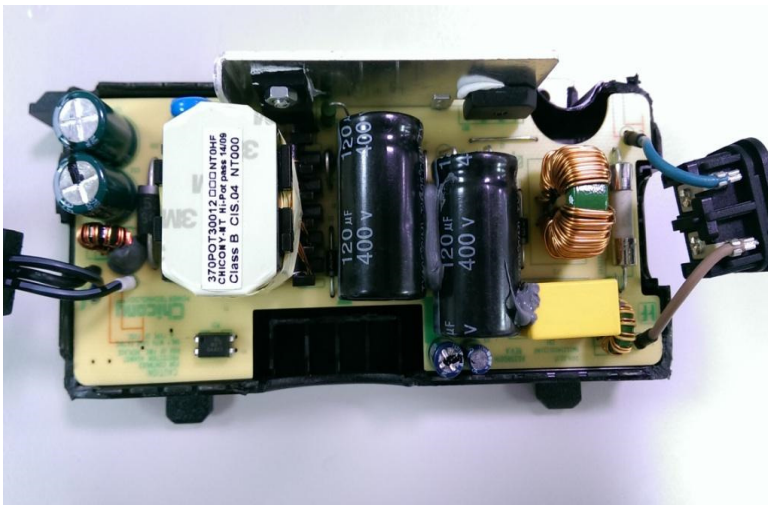
Fig.3

- We found the inductance of transformer no meet spec. 450uH. We measured the inductance of transformer 35.68uH ( Fig.3) which is causing the PWM IC trigger the SCP as Fig.4.

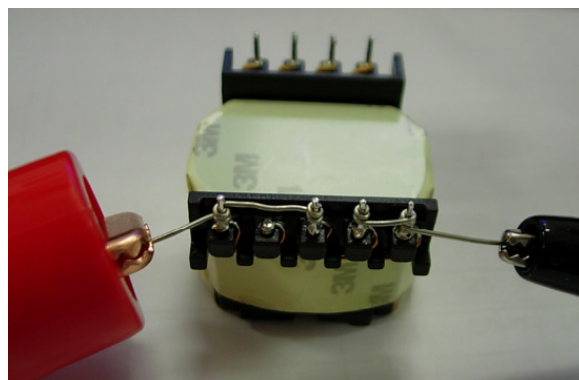
**Pri. – Pri.**

(Because the core and pin1 are connected, thus means measure Pri.- Core)

MODE	OUTPUT	MEASURE	RES.	OFFSET
01	AC	0.38 kV	0.994 mA	Hi
				GET Cs
				PAGE UP
				PAGE DOWN
				STEP
Ramp Time: 6.1 s   Remote   Lock   Offset   Error

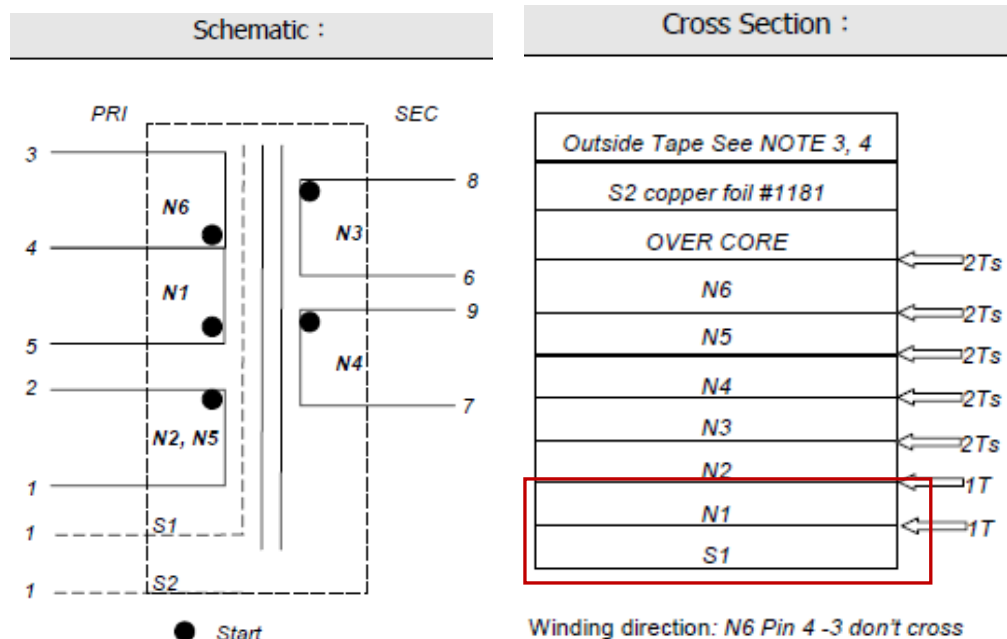
### ➤ Schematic and Cross Section

According to the disassemble pictures listed above. The tail of S1 winding wire just ends in the middle of winding area. And in this case, the sharp edge of the ending wire punctured the insulation tape as N1 and other upper windings cover and compress S1. Therefore the tape was damaged and leading to undesirable characteristics.

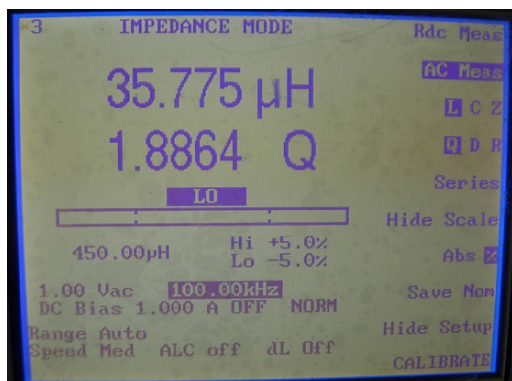
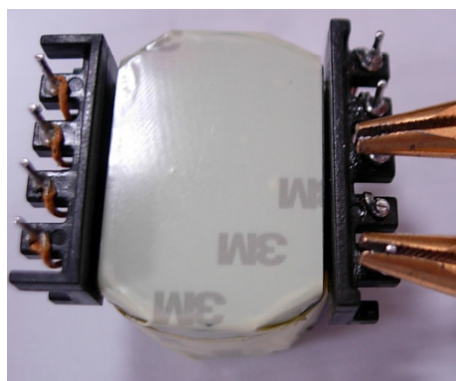
**a.) Inductance and Q Factor test :**

Item	Pin out	Spec	Sample test	Test condition
L	5-3	450uH±5%	35.775uH	100KHz/1V
L.k	5-3	7.2uH Max	3.2970uH	100KHz/1V
Q	5-3	50 Min	1.8864	100KHz/1V
D.C	5-3	345mΩ Max	301.0mΩ	
	2-1	52mΩ Max	41.5mΩ	
	8-6	77mΩ Max	65.5mΩ	
	9-7	84mΩ Max	71.5mΩ	
Hi-Pot	Pri-Sec	3200Vac	PASS	0.75mA 60SEC(AC)
	Pri-Core	1000Vac	FAIL	0.75mA 60SEC(AC)
	Sec-Core	3200Vac	PASS	0.75mA 60SEC(AC)

**\*Test Result : Inductance, Q Factor and Hi-pot Pri.- Core Fail**

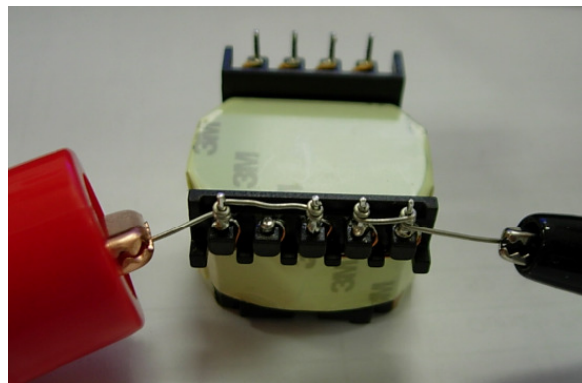
Pri. – Pri.

(Because the core and pin1 are connected, thus means measure Pri.- Core)

MODE	OUTPUT	MEASURE	RES.	OFFSET
UI	AC	0.38 kV	0.994 mA	HIGH
				GET Cs
				PAGE UP
				PAGE DOWN
				STEP

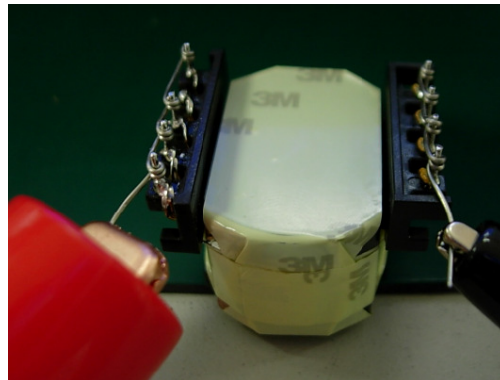
Pri. - Sec.

MODE	OUTPUT	MEASURE	RES.	OFFSET
UI	AC	3.20 kV	0.241 mA	PASS
				GET Cs
				PAGE UP
				PAGE DOWN
				STEP

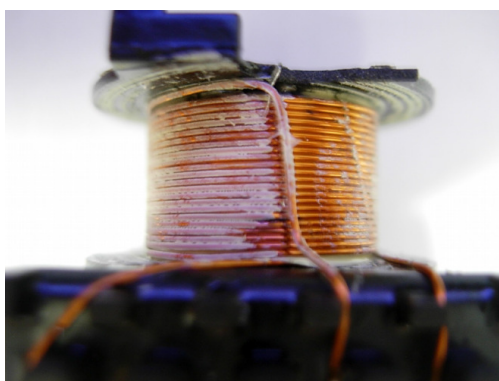
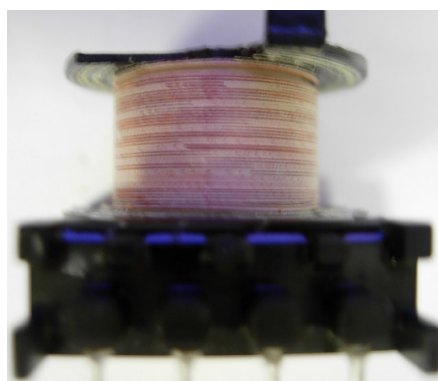
According to the disassemble pictures listed above. The tail of S1 winding wire just ends in the middle of winding area. And in this case, the sharp edge of the ending wire punctured the insulation tape as N1 and other upper windings cover and compress S1. Therefore the tape was damaged and leading to undesirable characteristics.
