Eight Discipline Report (8D Report)

To: 8D report No.: CPK0409	
From: Chicony Power Technology RMA claim No.: N/A	
CC:	CPT P/N: W030R019Q-GS01-0A
	Customer P/N: GC867
Submit date: 2021/06/10	Product description: 30W Adapter
Receive date: 2021/06/09	Defect D/C or Lot No.: N/A
Subject : Adapter Fuse open Issue *1pc	
Keywords/關鍵字 : MOSFET 、 Fuse	
D1.) 問題解決成員: Use Team Approach	
主持者 (Team Leader) : Tony_Xsu 內部成員 (Internal Team Members): <div style="text-align: center; margin-top: 10px;"> CQS : Maria_chen/Miya_Lu MFG: Fang_Liu/Wei_Li QE: Nono_Chen Ooba: Yanhua_Shao SQE: Wendy_Wen/Yanhua_Hu </div> 外部成員 (External Team Member): N/A	
D2.) 問題說明: Problem Description:	
(Note: Use who, what, when, where, why, how, how many to specify the Customer's problem.) 2021/06/09 : The adapter caused some damage to the extension cable, and the adapter doesn't show any exterior damage, the fuse is also blown. Some pictures are also attached for your reference. P/N: W030R019Q-GC01 S/N: GC867

Symptom: Fuse Open

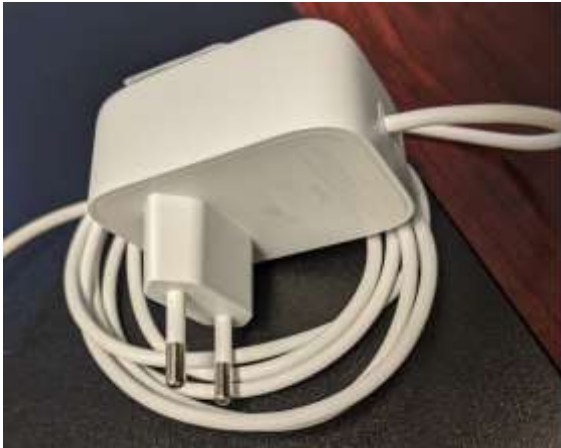
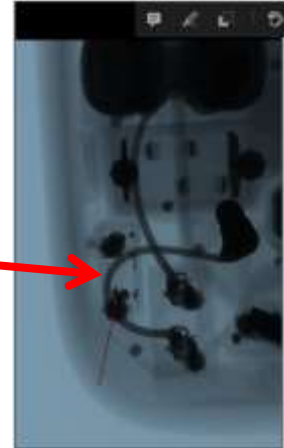
Fuse Open

Replace the defect unit. And send the defect unit to do analysis.

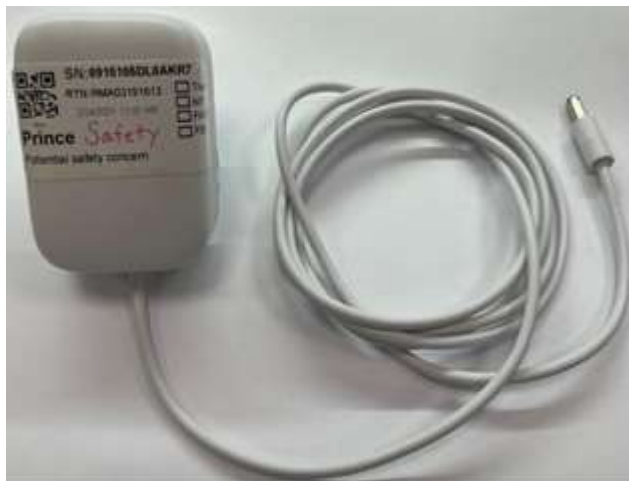
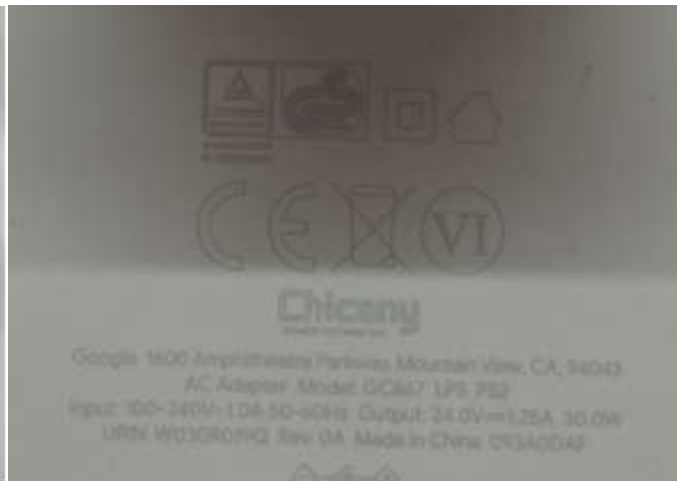
1. Check the defective products returned by the customer and find no abnormality in appearance.

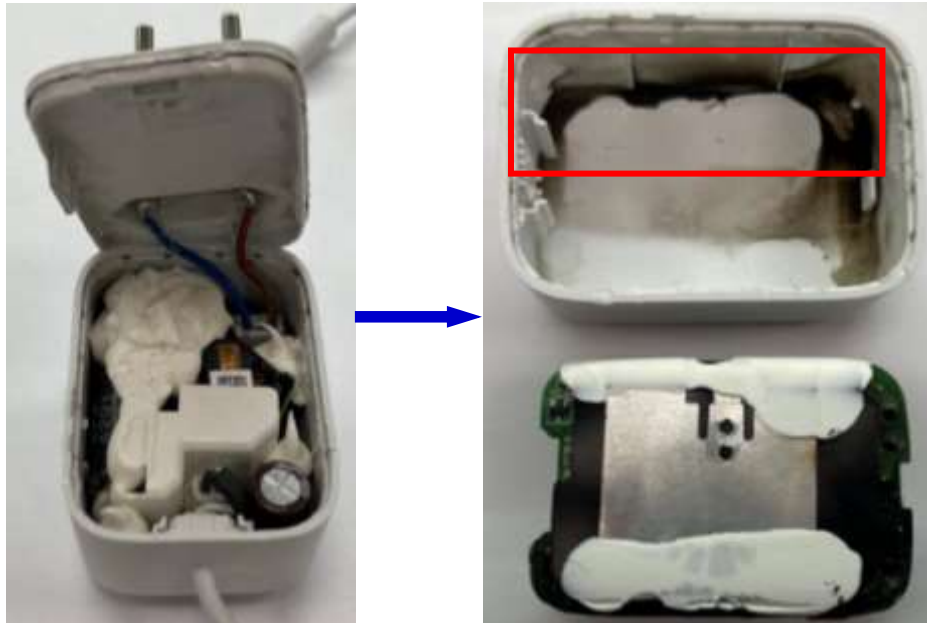
2. Remove the movement and there are blackened marks in the shell. °

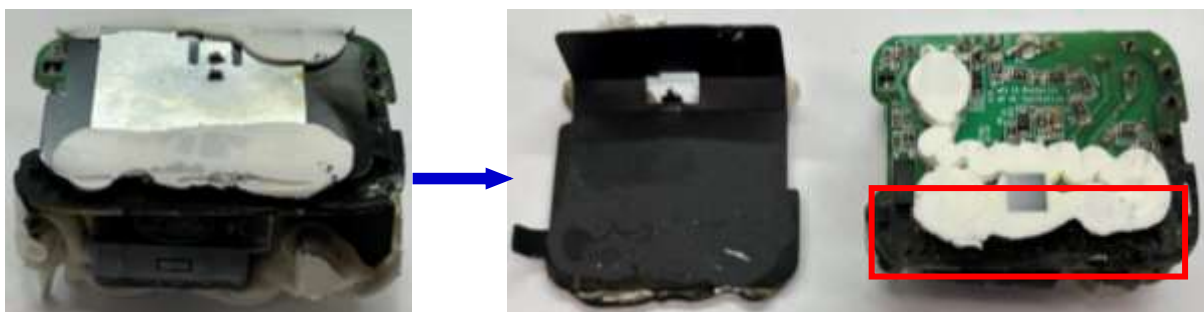
3. Remove the protective cover, SMD black marks below the surface.

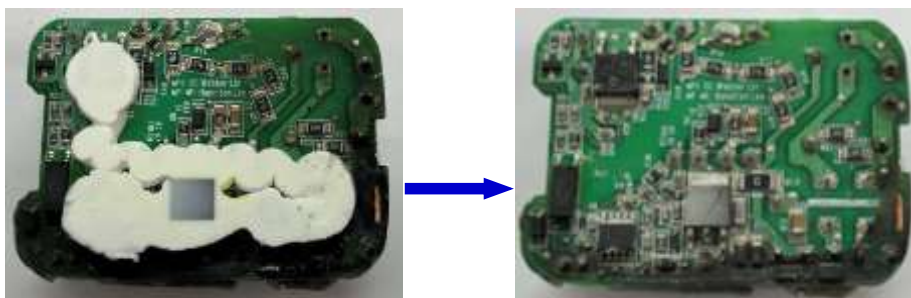
4. Remove the heat dissipating white glue and check the damaged parts.

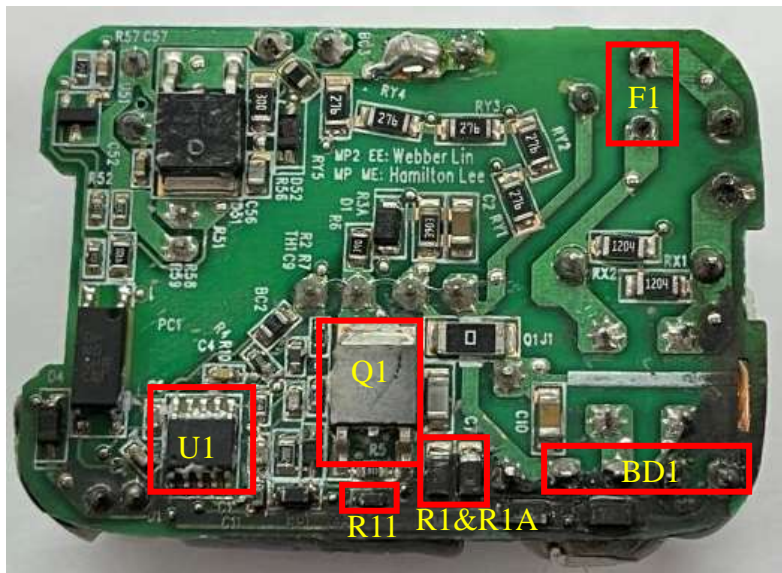
5. The damaged parts are as follows :

- (1) **Fuse (F1) → Open .**
- (2) **Bridge Diode (BD1) → Short .**
- (3) **MOSFET (Q1) → Short (D - S) .**
- (4) **Current sense resistance (R1&R1A) → Open .**
- (5) **PWM IC (U1) → Short .**
- (6) **PWM IC CS PIN RC filter resistance (R11) → Open .**

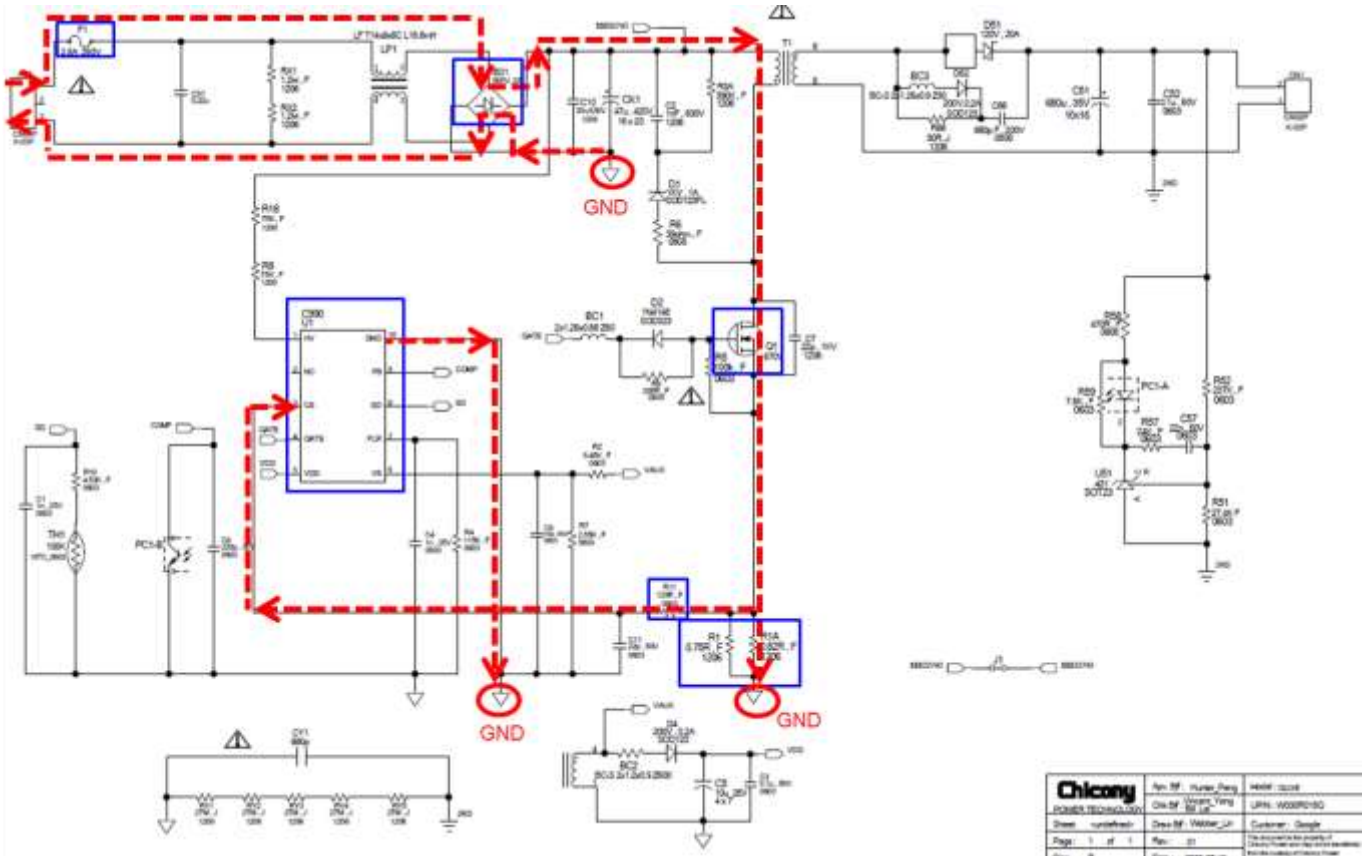
6. The damage path is shown below :

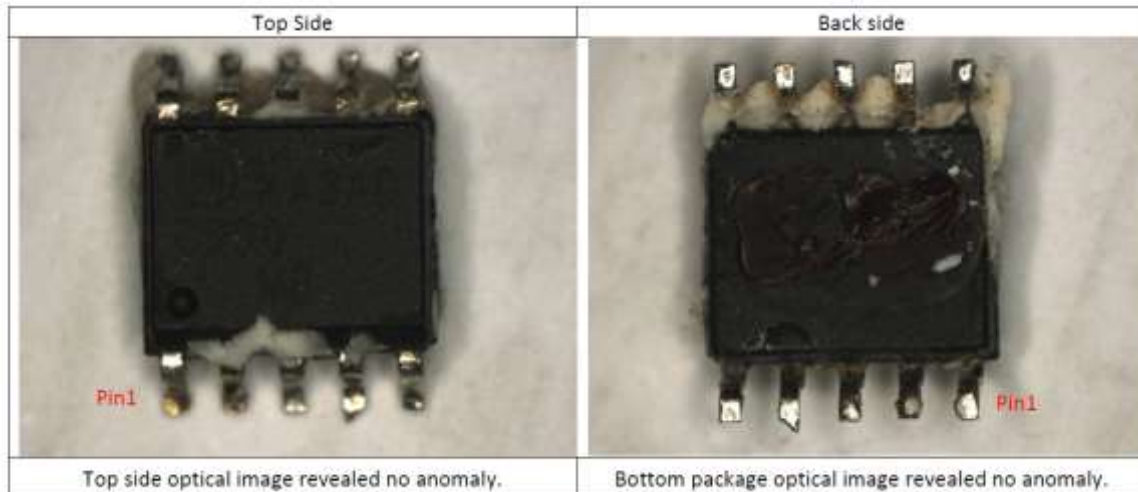
Package External Visual Inspection (S/S:1ea): No anomaly in the package external visual inspection.

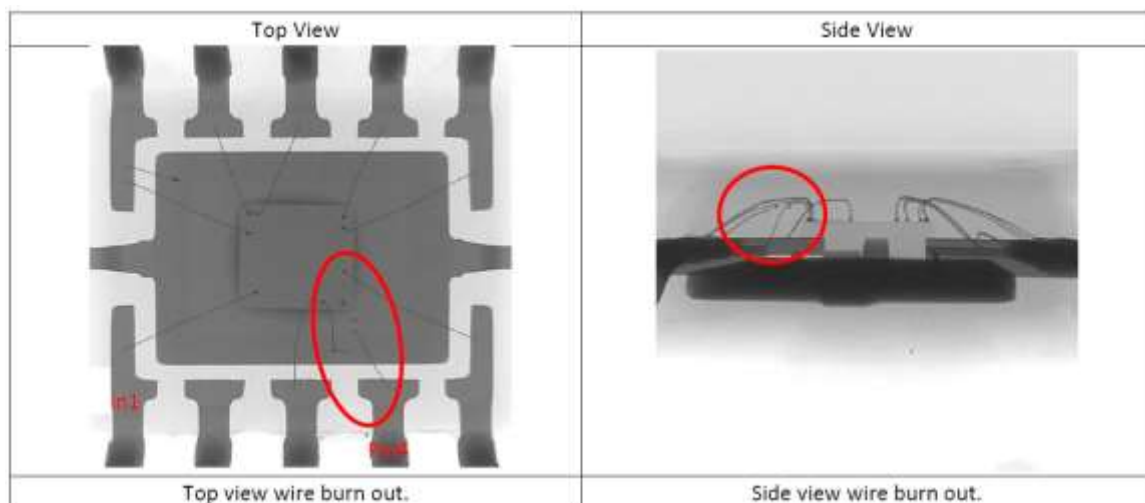
- X-ray Inspection (S/S:1ea): Wire burn out.**

investigative results indicate that the cause of failure for this single returned unit is not linked to a systemic manufacturing-related failure mechanism. Instead, data collected during analysis of the returned unit suggests that electrical damage, due to an Electrical Overstress (EOS) event, is the most likely cause of failure.

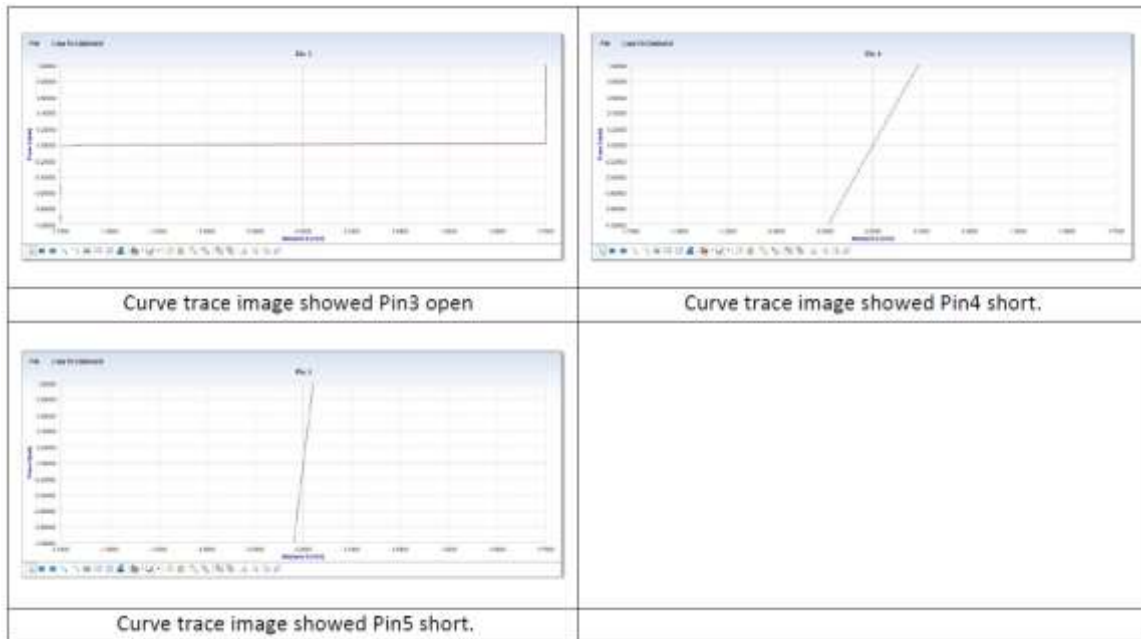
- Curve Trace (S/S:1ea): Curve trace images of the EFAR unit revealed open/short failure.**

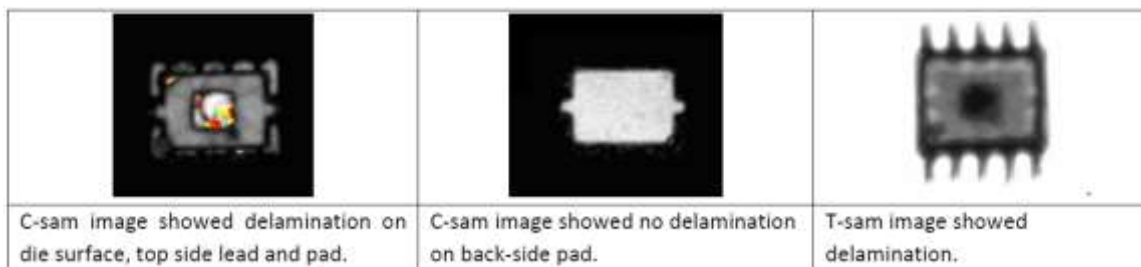
- SAT Analysis (S/S:1ea): Detected was delamination on die surface, top side lead and pad.

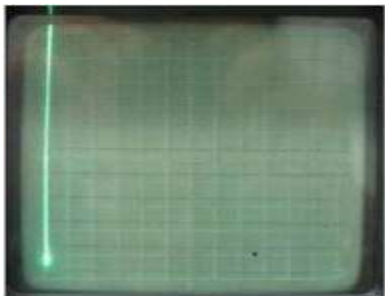
Using QT-2 transistor tester to test the electrical parameters of the sample, G-S and D-S have short-circuited, V-I characteristic curve as below:

According to the outlook of the sample, the detection of X-Ray, the test of the parameters, and the failure mode of the chip, we analyzed and concluded that sample failure is caused by EOS. Machine were aging tested and inspected in the chicony power and meet standard. It means machine and components in circuit is no abnormal. Now product is failure in end-customer market, the max. probability of MOSFET EOS is machine suffering some accidental factors in the market using. Above conclusion is from failure MOSFET, for you reference

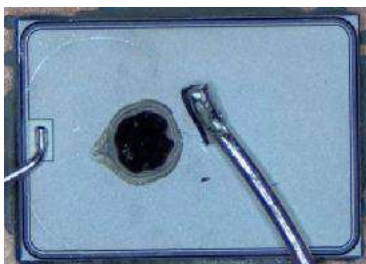
D-cap failure sample and OM inspection, it was found that there is obvious burn mark in source region on chip surface. Picture as below:
