Eight Discipline Report (8D Report)

To: Customer	8D report No.:
From: : Chicony Power Technology	RMA claim No.: N/A
CC :	Chicony Power P/N: A015R003L
	Customer P/N:
Submit date: 2016/09/08	Product description: 15W
Receive date: 2016/09/03	Defect D/C or Lot No.: 150423
Subject : No power*1pcs ,(LF1 空焊)(生產 / 焊錫不良/soldering issue)	
D1.) 問題解決成員:Use Team Approach	
主持者 (Team Leader) : Cf Liu 內部成員 (Internal Team Members): <div style="text-align: center; margin-top: 10px;"> CQS: Cecilia Sun QE: Nono Chen MFG: Alan Zhu PE: Kefang Zheng IE: Yansong Tong RD: White Huang Sales: Leo Lo SQE: Ansion Sun, Wing Xie </div> 外部成員 (External Team Member):	
D2.)問題說明:Problem Description:	
(Note: Use who, what, when, where, why, how, how many to specify the Customer's problem.) 2016/8/30 customer feed back that 1pcs adapters can not power on. Below are SN of the adapters: No.:1504230D41C5	
D3.)內部或客戶的暫時解決辦法及實施日期:Implement and Verify Containment Action:	
(Note: Internal / external containment action effectiveness and date.) <div style="margin-top: 20px;"> 1. Send these defect adapters to Chicony for analysis. <div style="text-align: right; margin-top: 10px;">Date:2016/09/02</div> </div>

➤ Analysis for SN:

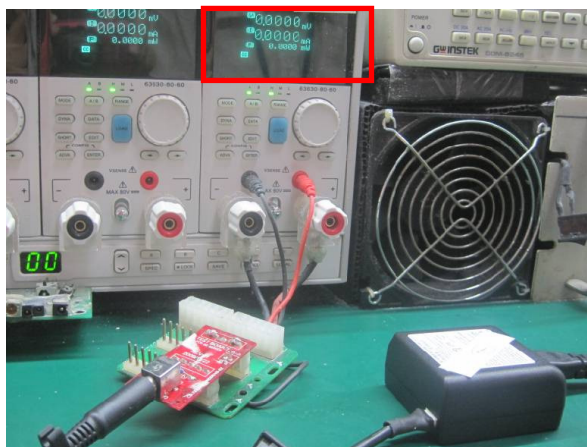
2. Test this adapter, it can not power on. It's the same as customer's feedback.

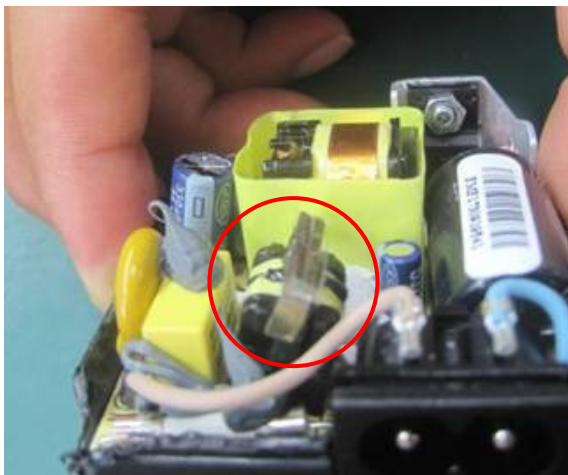
3. To open the case, observe the soldering side and the component side. Seen from the component side, LF1 is inclined to one side due to the improper insertion as the picture shown.

5. During our production line, the pin of LF1 was attached the soldering, so it can pass our process and flow out.

LF1 pin not protrude of PCBA caused the adapter no power.

- 1. Train the operators again and highlight the issue to them, the operators should insert the component in place and the inspector before the wave soldering station should make sure the components not inclined. And ME will see if can modify the top head, to make sure LF1 not be inclined.**

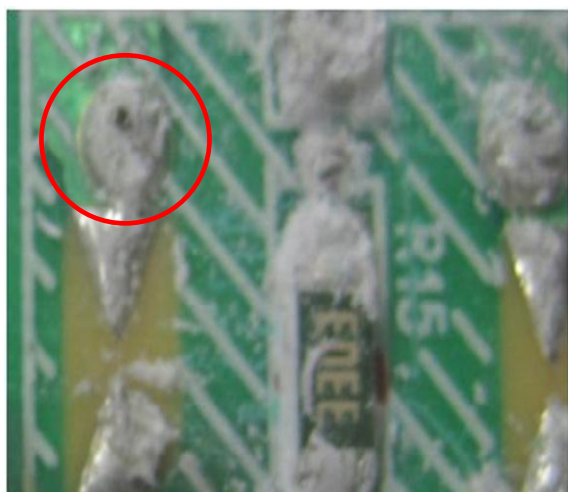
4. The component LF1 is inserted inclined, so the lead of LF1 is not protrude of PCBA.

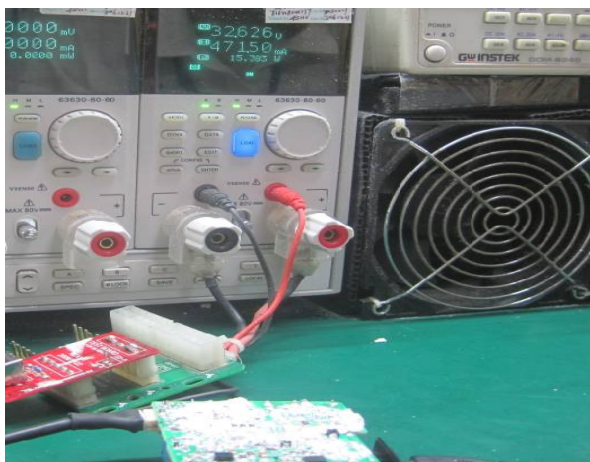
To re-solder this component, and test this adapter again, it can power on.
