## Eight Discipline Report (8D Report)

To: <b>Customer</b>	8D report No.: <b>CPG0105</b>
From: : <b>Chicony Power Technology</b>	RMA claim No.: <b>NA</b>
CC :	Chicony Power P/N: <b>A035R004L</b>
	Customer P/N:
Submit date: <b>2016/01/21</b>	Product description: <b>35W</b>
Receive date: <b>2016/01/20</b>	Defect D/C or Lot No.: <b>151026</b>
<b>Subject : No output , (生產 / 焊錫不良/soldering issue, BD1 空焊 )</b>	
<b>D1.) 問題解決成員:Use Team Approach</b>	
主持者 (Team Leader) : <b>Cf Liu</b> 內部成員 (Internal Team Members): <div style="text-align: center; margin-top: 20px;"> <b>RD: Walt Ni / Mark Meng / Jay Huang</b>   <b>PE: Hongwu Zhang</b>   <b>IE: Yansong Tong</b>   <b>QE: Nono Chen</b>   <b>Sales: Leo Lo / Robert Cheng</b>   <b>CQS: Cecilia Sun</b>   <b>MFG: Alan Zhu</b>   <b>ME: Hai He</b>   <b>Ooba: Mary He</b> </div> 外部成員 (External Team Member):	
<b>D2.)問題說明:Problem Description:</b>	
(Note: Use <b>who, what, when, where, why, how, how many</b> to specify the Customer's problem.)

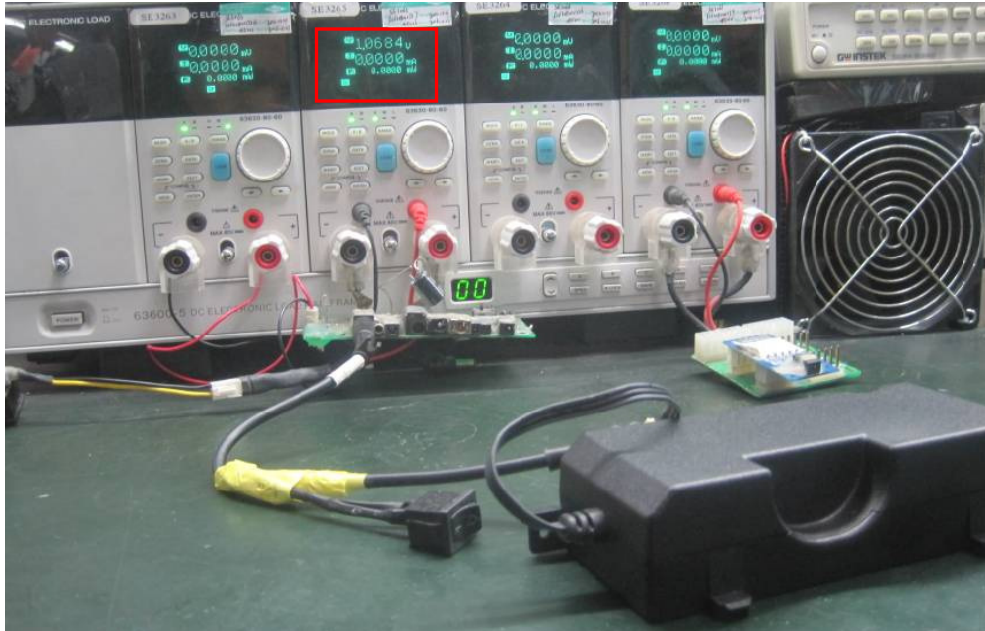
## 1. Check the fail unit

The fail unit doesn't show any case damage. We test this unit and it can not power on. The defect is the same with customer's feedback.

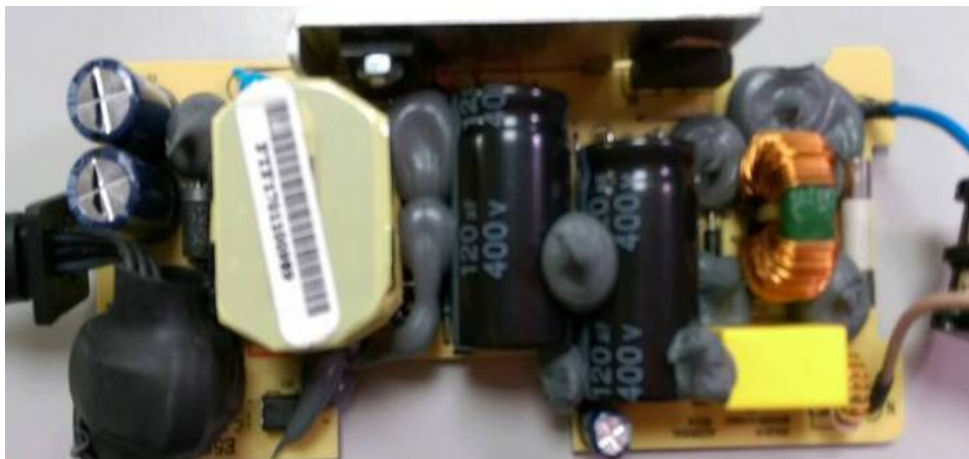
(1) The top side of sample is normal.

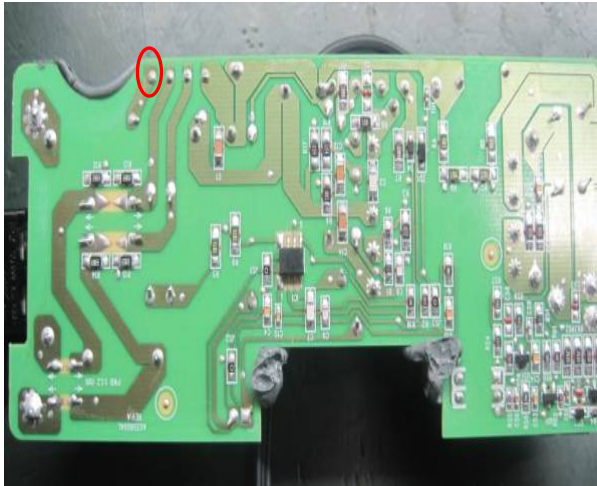
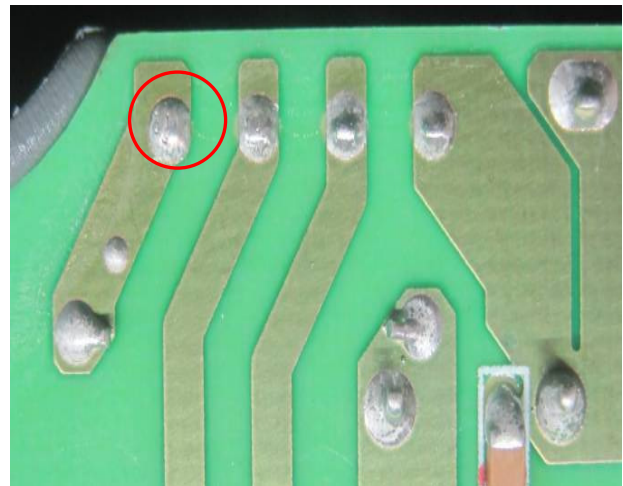
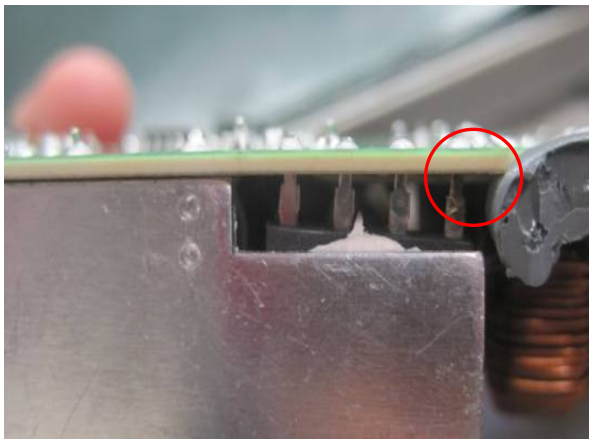
(2) On the bottom of this sample, the pin of BD1 is excess soldering due to the pin not full out of PCBA.

**4. When the operator inserts Heat Sink not in place for the first time, he may insert Heat Sink again. Since the BD1 is attached the glue on the Heat Sink, BD1 may be pulled out then lead not full out of PCBA.**

The lead of BD1 is not full out of PCBA, caused BD1 open in the circuit. Then this adapter can not power on.

**5. Re-solder BD1 and then test it gain, it can power on normally.**

1. At the Heat Sink insertion station, after inserting Heat Sink, the operator should 100% press BD1 to make sure pins of BD1 are full out of PCBA. And IE modify WI for operators to follow.

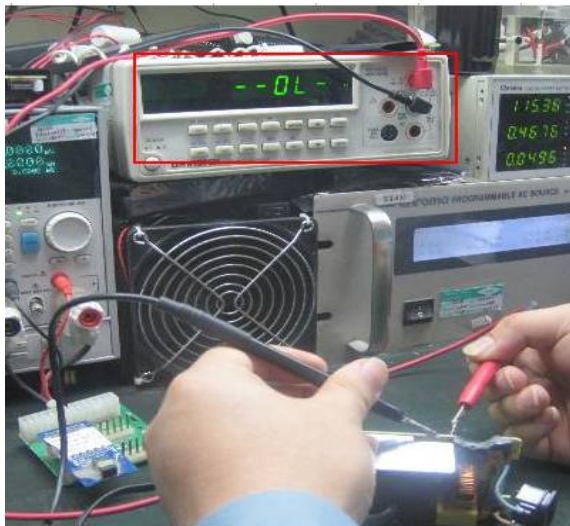
**3. And we measured the pin of BD1, this pin of BD1 is open in the circuit.**

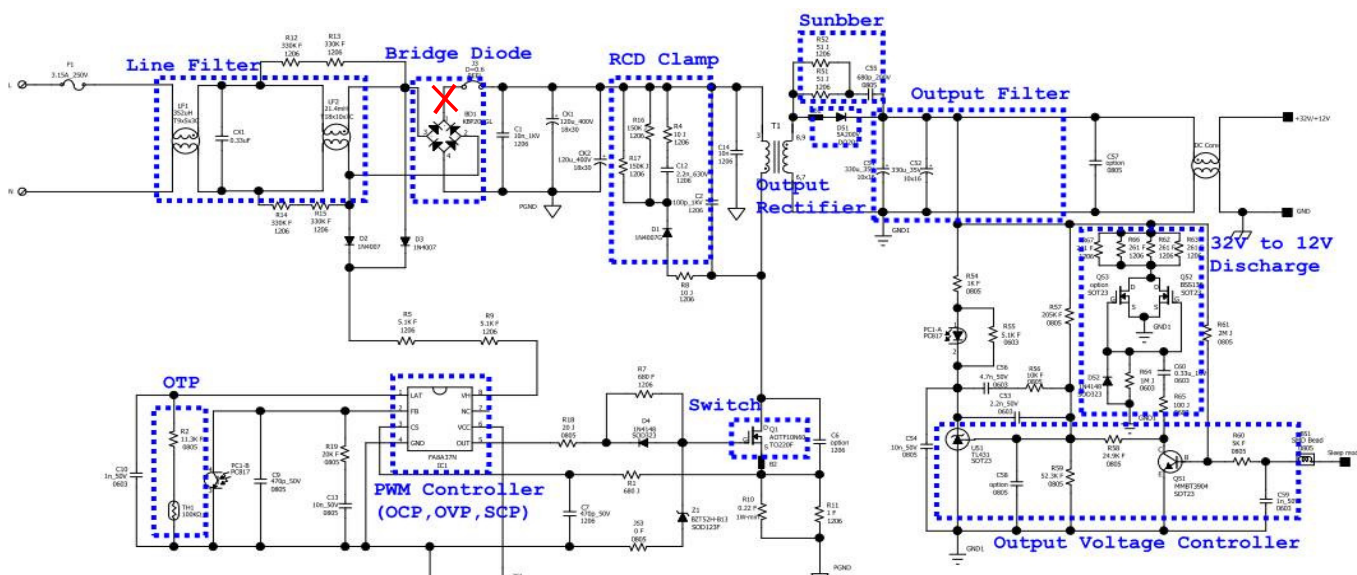
Since BD1 is open (as below red mark) in the circuit, then the main circuit is open. So this adapter can not power on.
