Eight Discipline Report (8D Report)

To:	8D report No.: 202206101
From: : Chicony Power Technology	RMA claim No.: N/A
CC :	Chicony Power P/N: A180A062P-AX01-X3
	Customer P/N: A20-180P1A
Submit date: 2022/6/10	Product description: 180W Adapter
Receive date: 2022/6/5	Defect D/C or Lot No.:
Subject : 客戶反饋系統驗證 ESD 測試時, PSU no power 共 3pcs (ESD, 點膠/Glue)	
D1.) 問題解決成員: Use Team Approach	
主持者 (Team Leader) : Cf Liu 內部成員 (Internal Team Members): <div style="text-align: center; margin-top: 10px;"> CQS: Jack Wang QE: Kitty Zhang MFG: Xiaohui Du PE: Yong Liu Sales: Justin Yu RD: Jacky Hsu </div> 外部成員 (External Team Member):	
D2.) 問題說明: Problem Description:	
(Note: Use who, what, when, where, why, how, how many to specify the Customer's problem.) 2022/6/5 CPT has received 3pc no power PSU from Customer for analysis. 問題描述: 客戶測試 ESD 3pcs fail sample, 測試過程中出現聲響就沒輸出了, 測試條件 air +10KV ,次數 > 50 下 S/N:0A001-00265100141200039(D/C:2141) Version :A03 0A001-00265200124235848(D/C:2124) Version :A02 0A001-00265200124222244(D/C:2124) Version :A02

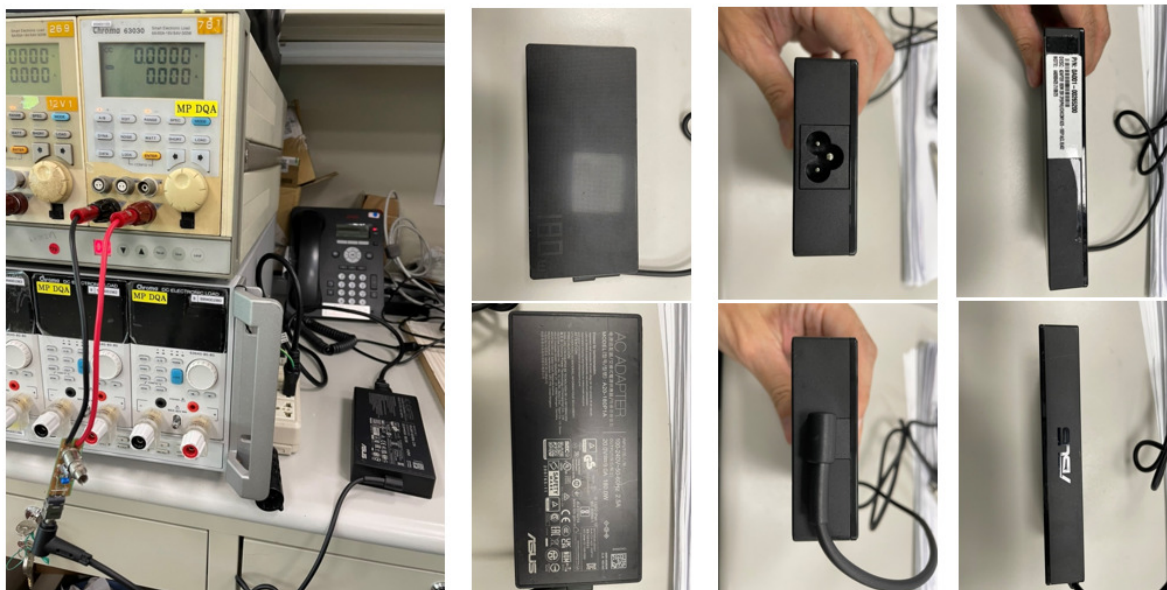
三台樣機 覆判無輸出，外觀無異狀

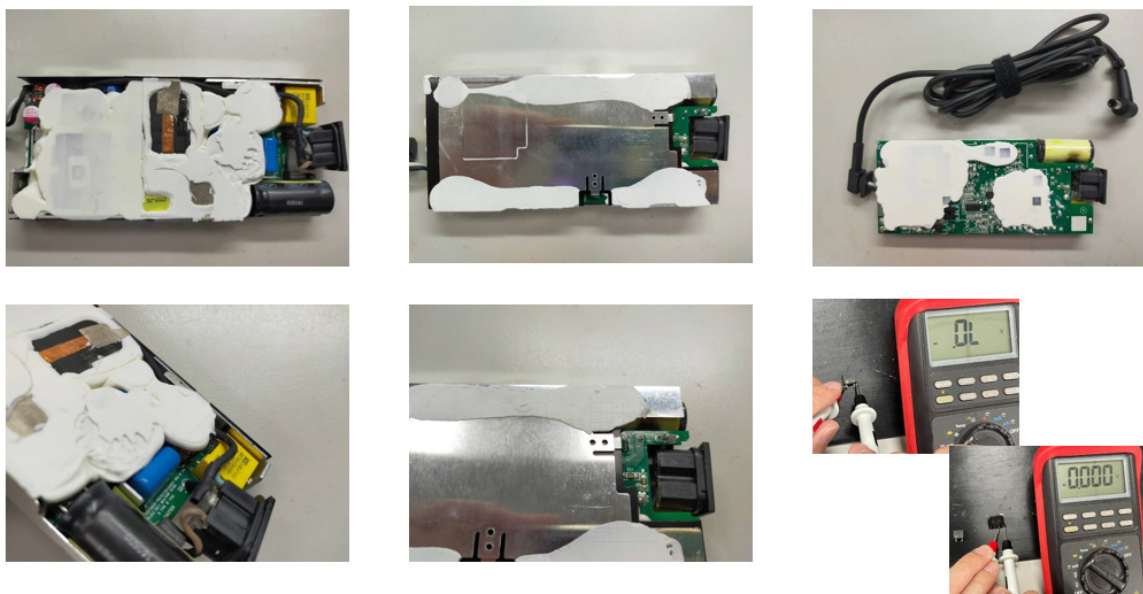
開蓋檢查內部，檢查異常位置，確認損壞元件為 F1 OPEN, BD1 Pin3(~) & 4(-) short

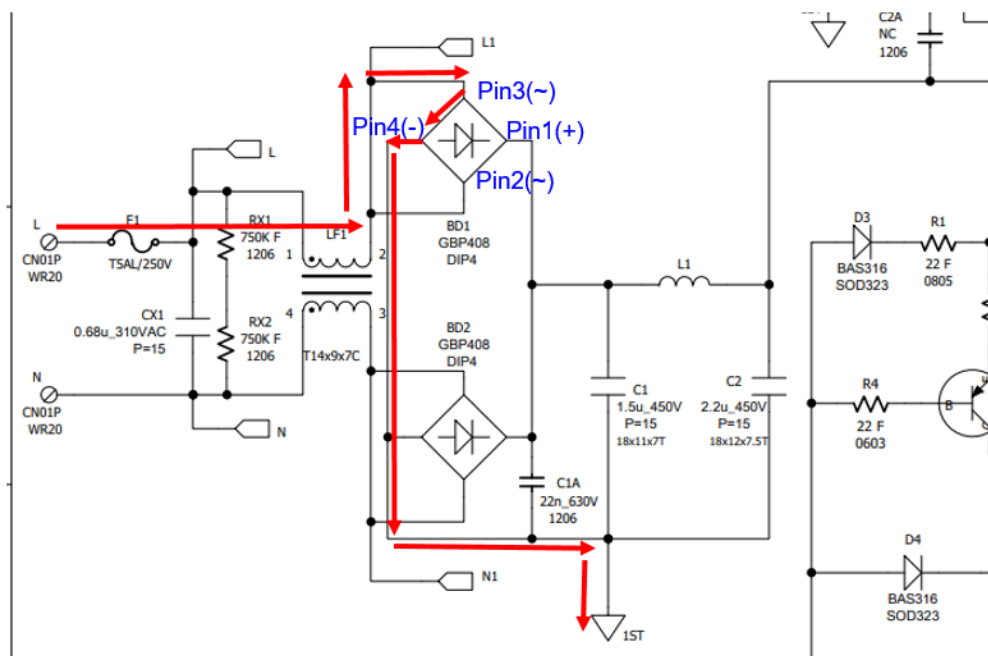
Schematic analysis

因為 BD1 Pin3(~) & 4(-) short, 導致 F1 OPEN, 造成 PSU 無電壓輸出

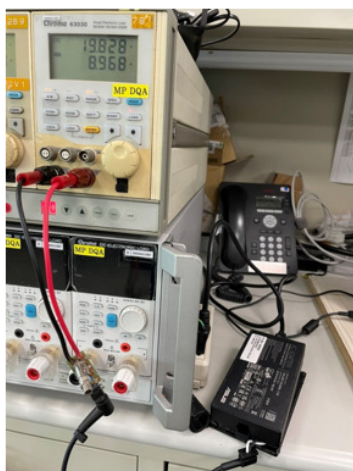
0A001-00265200124235848

更換 BD1 & Fuse 後，Full Load 開機正常

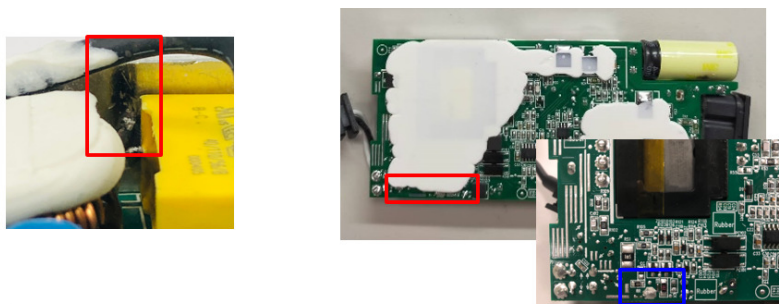
- a. 在 CX1 與 HS1 (鎖附BD1) 間有跳火痕跡
- b. 以 ESD 測試時, 發現在 CX1 與 HS1 間會有電弧產生放電路徑,
進而造成 AC 對地短路現象
- c. 檢查二次側放電pin 位置被膠覆蓋住, 可能造成預設的放電路徑被改變了, 而導致電弧發生
- d. 將二次側放電pin 覆蓋膠的區域清除, 再進行 ESD 測試即Pass

3. 加強對策: HS1 (鎖附BD1) 加貼 tape, 避免與CX1 間跳火短路

a. 生產時的點膠位置不可覆蓋於二次側放電pin

b. HS1 (鎖附BD1) 加貼 tape

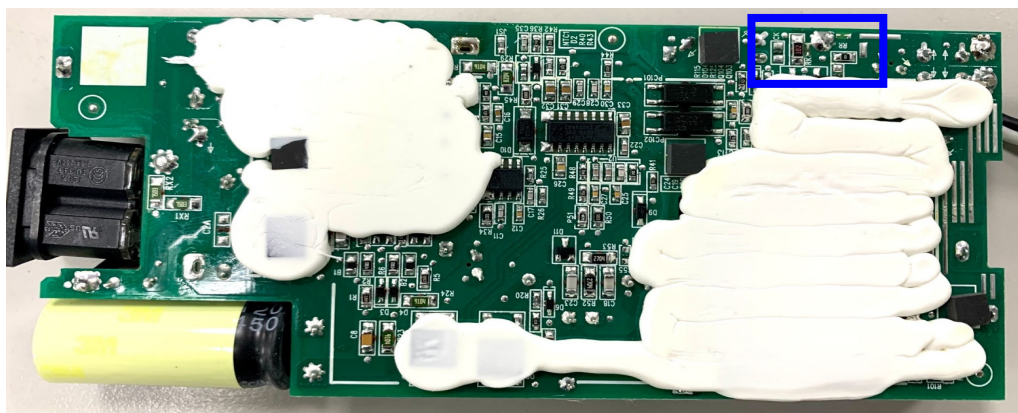
二次側放電pin 位置沒被膠覆蓋, ESD 放電路徑可依照原先設定路徑洩放

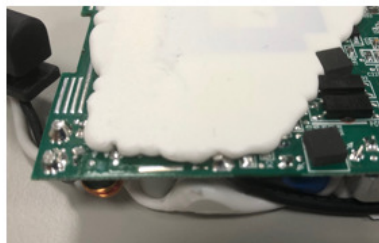
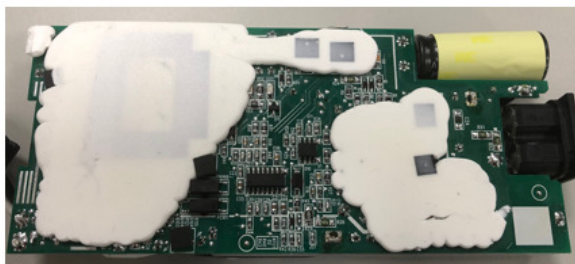
測試方法: 將 AC 端 L & N短路, 用ESD槍在輸出 plug 端, 進行ESD Air 測試

Sample	Air 8KV
1	No arc
2	No arc
3	No arc
4	No arc
5	No arc
6	No arc
7	No arc
8	No arc
9	No arc
10	No arc
