## Eight Discipline Report (8D Report)

To: <b>ODM</b>	8D report No.: <b>20140227</b>
From: : <b>Chicony Power Technology</b>	RMA claim No.: <b>N/A</b>
CC :	Chicony Power P/N: <b>W015R004L-PG01</b>
	Customer P/N: <b>IPV5K6K</b>
Submit date:	Product description: <b>15W adapter</b>
Receive date: <b>20140220</b>	Defect D/C or Lot No.:

**Subject : No power\*1pcs ( EMC / Surge , surge failure, Q1, R1, R1A, ZD5, R16 damaged)**

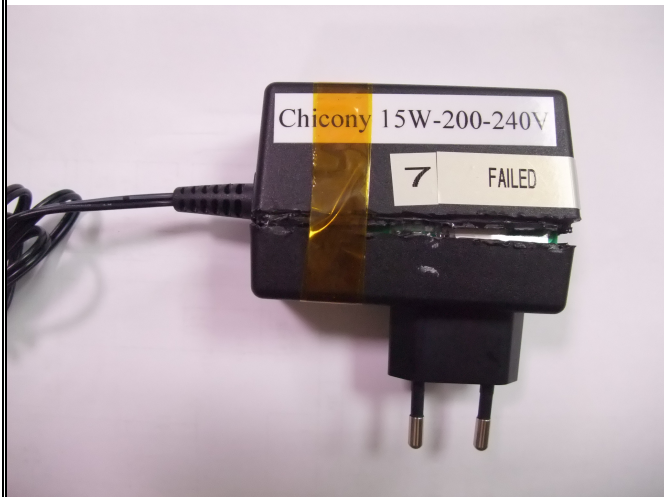
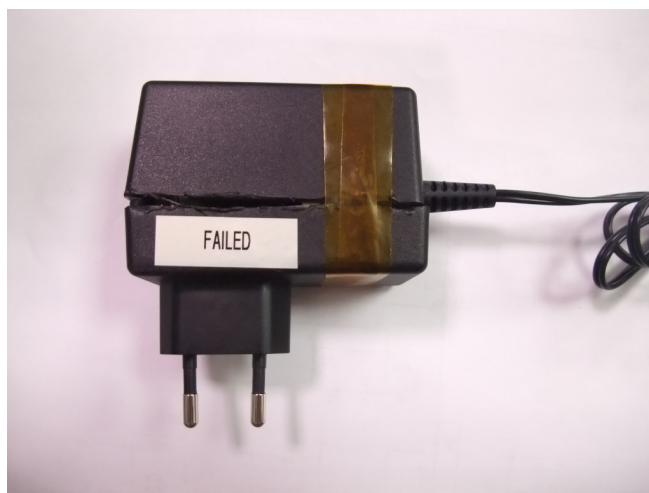
**Customer already opened the case while failed unit received.**

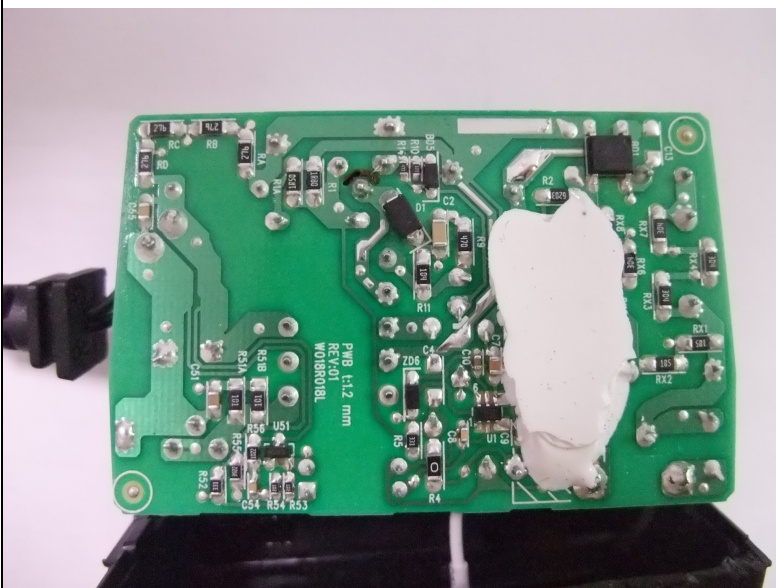
**At solder side, there is no burning mark or loose parts.**

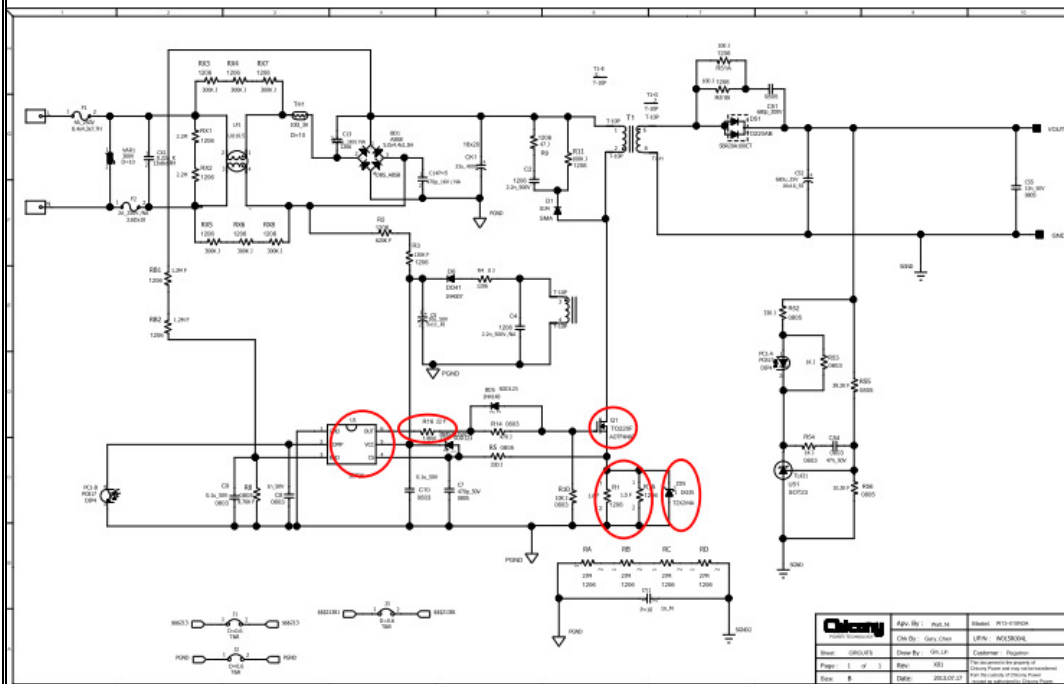
**After further checking, the damaged components are: Q1, R1, R1A, ZD5, R16,**

This failure looks like a noise influence → MOSFET blow → R-sense burnt open and PWM damaged.

- As this failure is common mode, noise has chance to inject into circuit due to LC resonance caused by choke and Y-cap. To help improving surge capability, we can add more damping to the components to enhance the noise immunity.
- We are trying to enhance surge capability by changing RX3~RX8 and CY1 value. If the solution is OK, we will double check EMI performance.
