Eight Discipline Report (8D Report)

To: Customer	8D report No.: CPG1205
From: : Chicony Power Technology	RMA claim No.: N/A
CC :	Chicony Power P/N: A015R008L
	Customer P/N: A9T80-60008
Submit date: 2016/12/12	Product description: 15W
Receive date: 2016/12/09	Defect D/C or Lot No.: 161017
Subject : No power*2pcs, (生產 / 焊錫不良/soldering issue , One is R10 poor soldering, 零件 / Diose, another one is BD1 shorted)

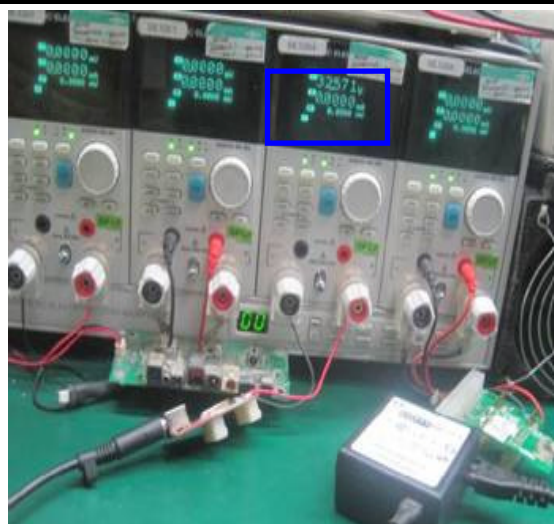
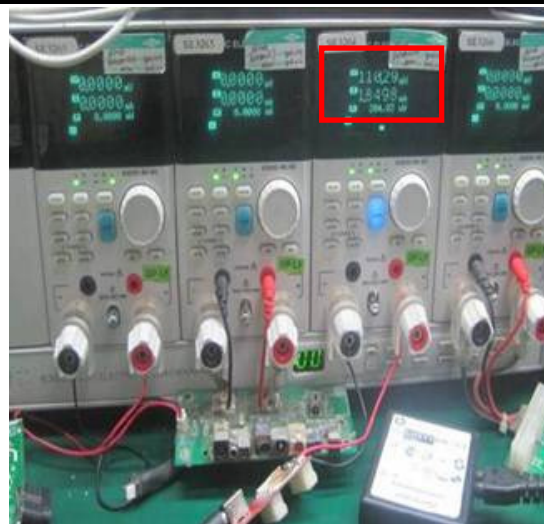
2. Test this adapter, it can power on with No Load and not power on with Full Load.

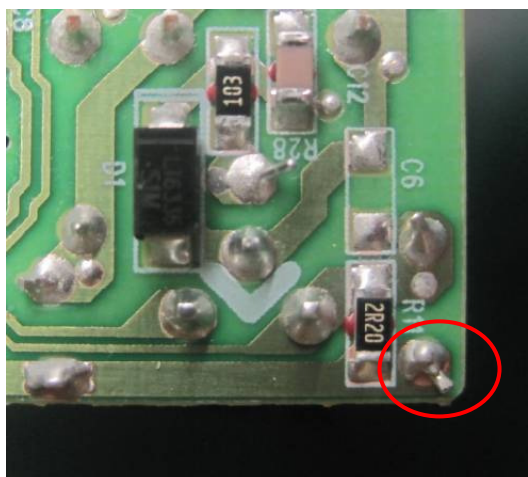
3. To open the case, observe the soldering side and the component side. Seen from the soldering side, one pin of R10 is poor soldering.

R10 poor soldering caused the adapter no power.

ME modify one hole of the worse carrier by polishing the carrier around R10, to avoid R10 poor soldering. (Please kindly refer to the partial enlarged pictures in D4-4)

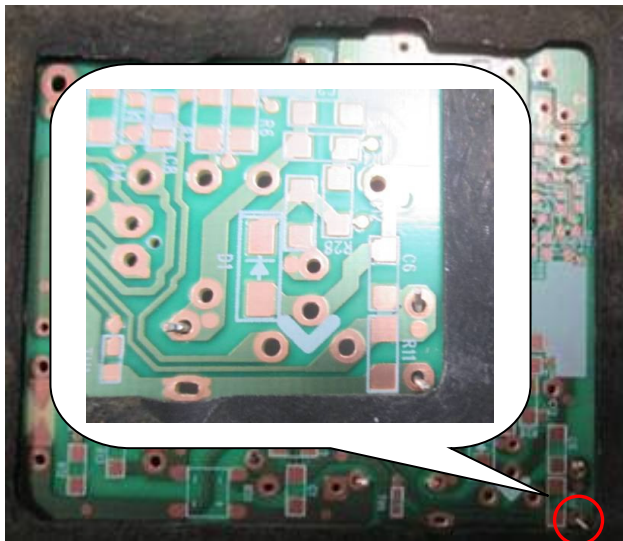
4. Check all the carriers of this model, there're total 80 sets carriers. Each set has 6 holes to carry PCBA. And we found one hole out of these 80 sets carriers is worse than others .(Refer to the below pictures)

As the above NG picture shown, R10 is very closed to the edge of the carrier. There's possibility to cause R10 poor soldering with the worse carrier due to the shadow effect.

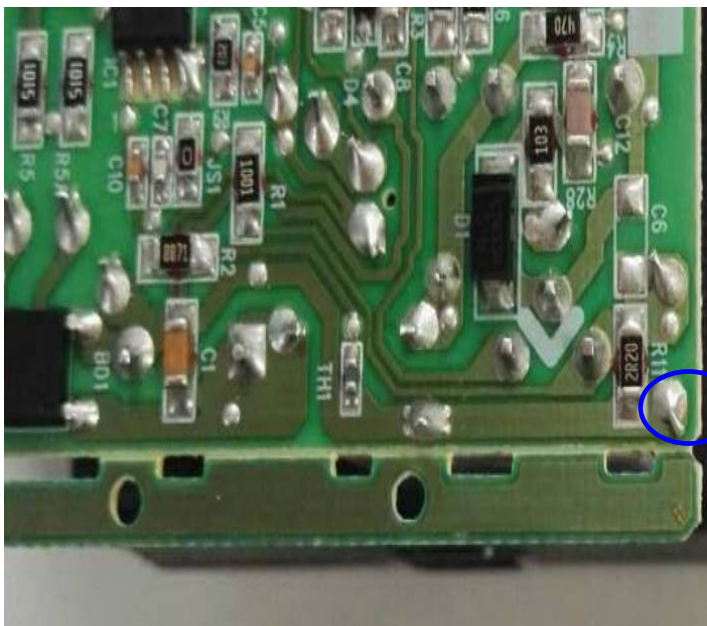
To use the carriers of the production line to run the adapters of this mode one day and no soldering defect found and only 1pc like below picture.

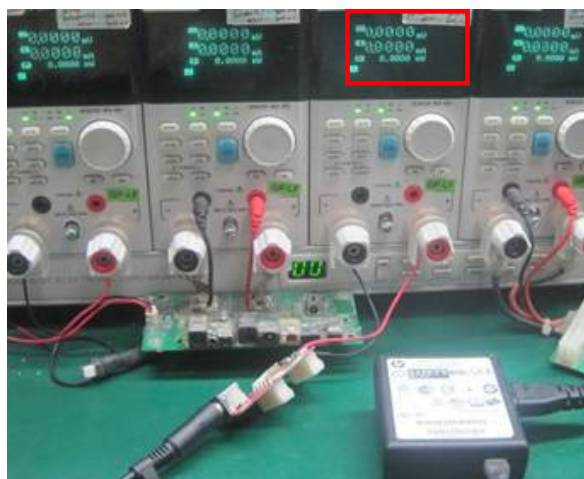
9. Test this adapter, it can not power on.

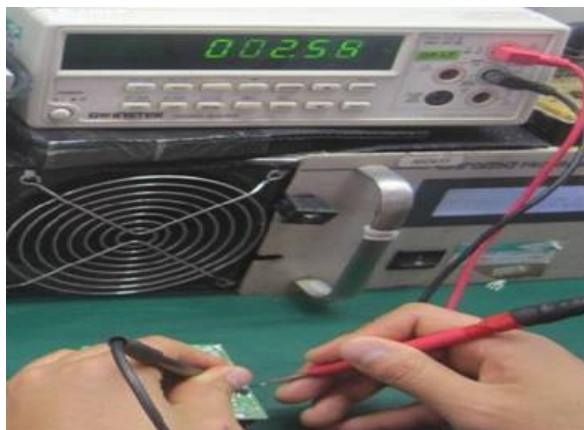
10. To open the case, observe the soldering side and the component side. There's no defect on both sides. And measure the related components, BD1 is short(as below picture). And F1 is open.

BD1 short caused the adapter no power.

Vendor's conclusion: Burn mark can be observed on the failed dies after sample decaped, it was suspected that the electrical over stress impact caused the failure in application.

Send the defect component to vendor for further analysis.

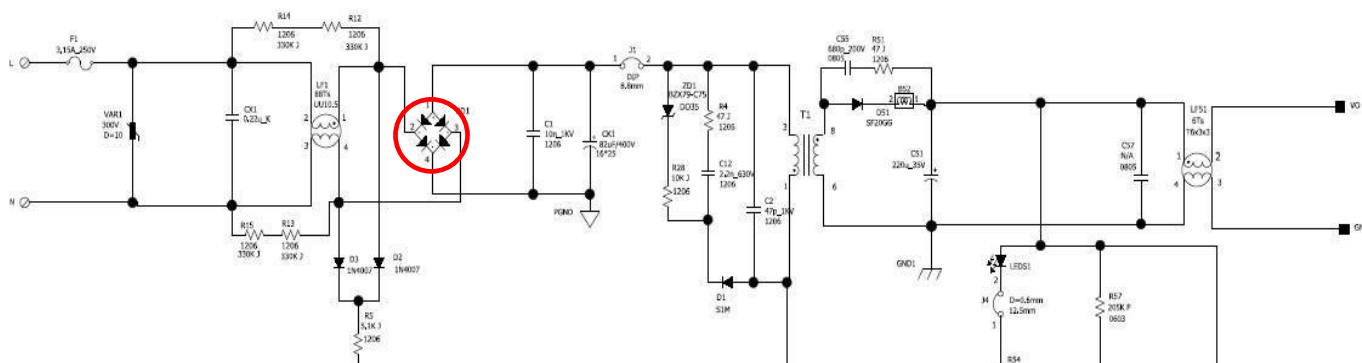
12. Schematic Analysis

When BD1 is short, and F1 open, then it will cause the adapter no power.
