Eight Discipline Report (8D Report)

To: 8D report No.: CPCQ20240426
From: Chicony Power Technology RMA claim No.: N/A
CC : N/A Chicony P/N: A065RP72P-HW02-0C

Subject : Adapter Type-C deform after Drop Test [ME, DC cable, 變形]

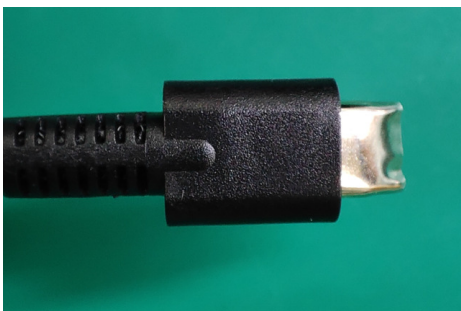
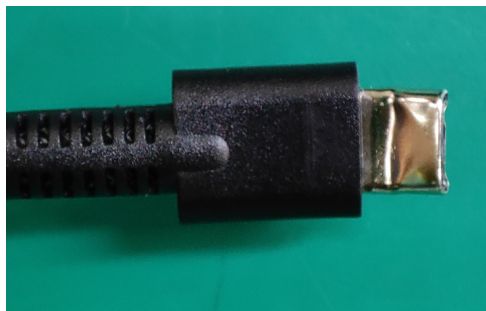
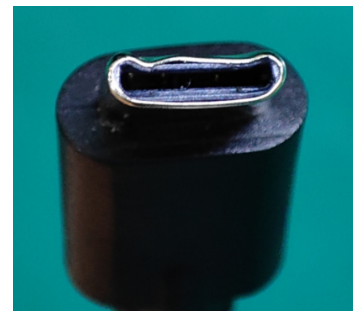
2. 檢查 adapter 外觀,觀察到 Type-C 已變形.

Type-C have serious deform.

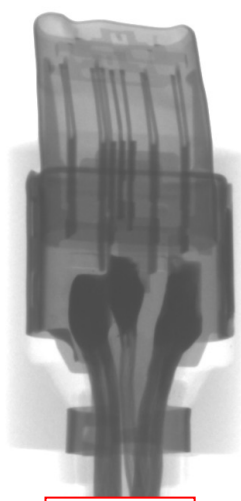
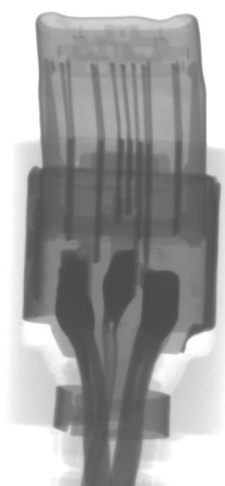
3. 對已變形的 Type-C 進行 X-ray,內部 pin 未發現斷裂現象.與良品的 Type-C 對比如下圖:

X-ray of Type-C showed no broken of internal pin. Compare it with OK sample.

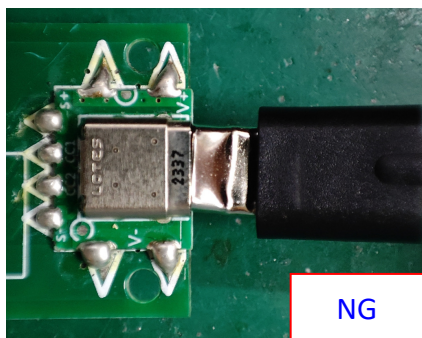
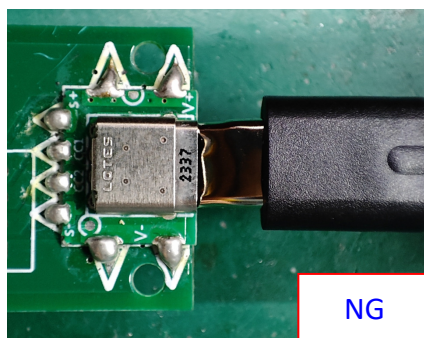
4. 將已變形的 Type-C 與測試母座對插,發現無法插入母座.與良品的 Type-C 對比如下圖:

The deformed Type-C cannot be inserted into the DC jack. Compare it with OK sample.
