## Eight Discipline Report (8D Report)

To:	8D report No.: <b>N/A</b>
From: : <b>Chicony Power Technology</b>	RMA claim No.: <b>N/A</b>
CC :	Chicony Power P/N: <b>A065RP83P-AX01</b>
	Customer P/N:
Submit date: <b>2023/11/12</b>	Product description: <b>65W 3pin adapter</b>
Receive date: <b>2023/10/6</b>	
<b>Subject : <u>Acoustic issue *1 pcs</u></b>	
<b>Keywords/關鍵字 : <u>Acoustic</u></b>	
<b>D1.) 問題解決成員:Use Team Approach</b>	
主持者 (Team Leader) : <b>Edward Hou</b> 內部成員 (Internal Team Members):  <b>PM : Laura Fang</b>  <b>ME: Marcus Chang</b>  <b>Sales: Jennie Chang</b>  <b>RD: Jack Liu</b>  外部成員 (External Team Member):	
<b>D2.)問題說明:Problem Description:</b> ( <b>Note:</b> Use <b>who, what, when, where, why, how, how many</b> to specify the Customer's problem.) 在試產階段，客戶端的工程師在配系統測試軟體，在效能全開時會聽到樣機有低頻的震動聲響，耳朵越靠近 Adapter 的時候會越明顯聽見噪音聲響。後續先將樣機領回做分析。 <b>During the trial production phase, the client's engineers were configuring the system test software. When the performance was fully turned on, the prototype would hear a low-frequency vibration sound. The closer the ear was to the Adapter, the more obvious the noise would be. Later, the prototype will be taken back for analysis.</b>

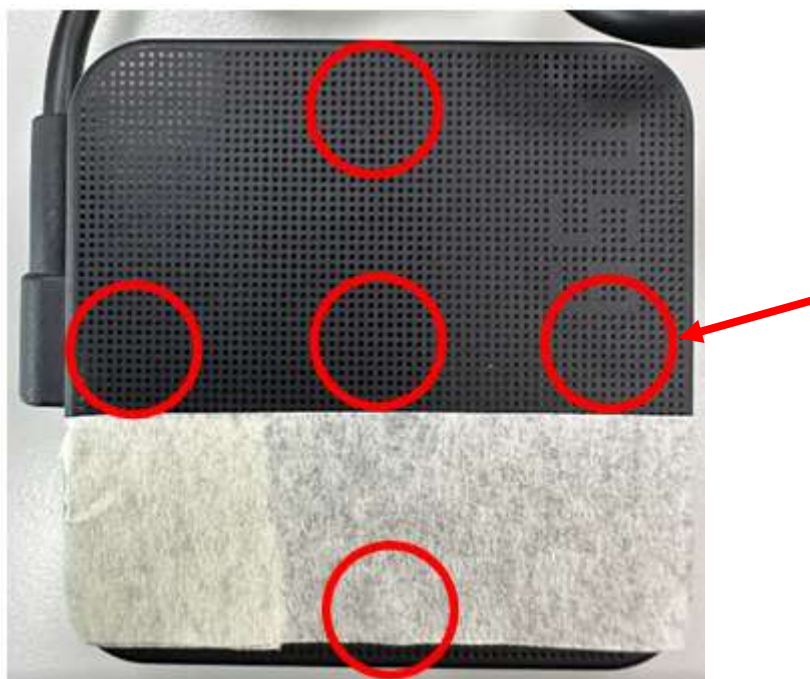
1. 送往噪音室復測分別對五個不同位置進行噪音測試，發現靠近Input filter LF2位置，高頻聲響明顯較大，且在越靠近滿載(3.25A)聲音越大，並且在這個位置會超過SPEC的20dB。

Microphone at a distance of **5cm** from the surface and noise level is less than **20dB**.

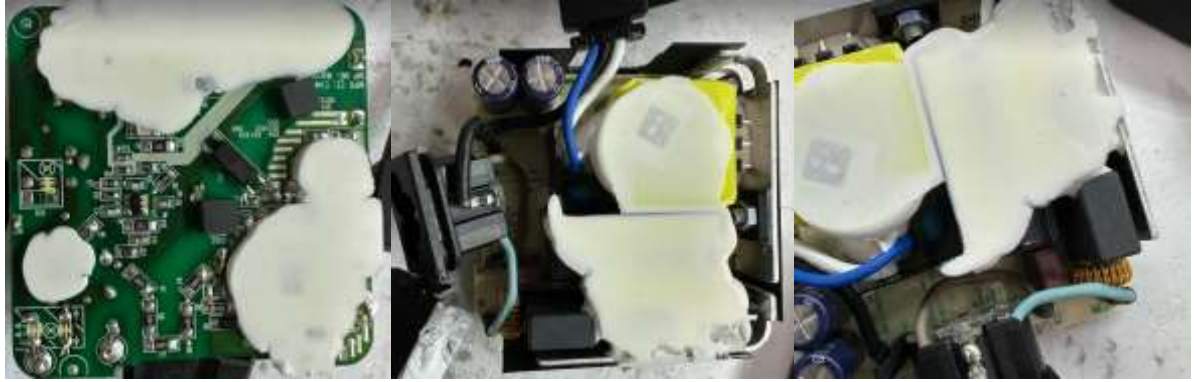
3. 拆開樣機觀察Top面跟Bottom面點膠，點膠並無多餘的溢膠，位置都如WI所標示。

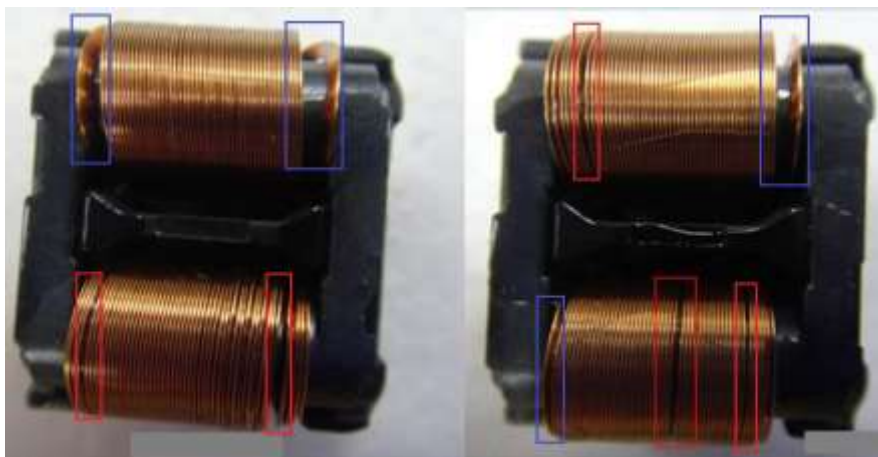
4. 拆解LF2 (39EXFT14003NT1LF)，製程上是用一片一片銅線疊起來，當流過的電流越大銅片之間的震動越明顯。實際將LF2拆掉，將該位置短路後，重新測試滿載噪音分貝由原本23dB降至13dB。明顯是由LF2所帶出的高頻聲響。

1. 因在滿載的時候電流增大，使 **LF2 choke** 的銅線間彼此產生震動導致聲音傳出，**LF2 (39EXFT14003NT1LF)** 在製程上有透明膠做 **core** 與 **base** 還有線圈之間的固定，但因長時間熱效應下容易有 **core** 裂的風險，所以透明膠沾黏的比例較少，致使電流通過時會使線圈震動而發出聲響。
2. 前期開發時，因客戶 **SPEC** 未明訂麥克風在樣機上方 **5cm** 的測量位置，導致在開發測試時都將麥克風擺在樣機正上方位置，因而忽略了最大的發聲源是在 **LF2** 上方位置。
3. 在 **LF2** 的上方位置經過了 **Shielding** 還有殼膠，在殼膠乾硬由液狀變為固狀後容易導致聲音傳出。另上 **Shielding** 的鋁片震動將強了聲音的傳出。

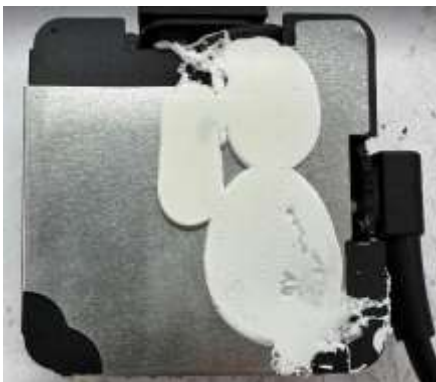
5. 另因為上Shielding與殼之間點散熱膠，因膠乾掉變為固狀，聲音更容易傳導出去，將膠刮除後可以明顯聽到聲音下降。在實驗拉載至3.25A滿載時，在其中一台實驗樣機上會聽到比LF2的高頻振動聲還大聲的銅片震動聲音，因此實驗將LF2上方銅片挖除後，噪音明顯下降。
