## Eight Discipline Report (8D Report)

To:	8D report No.:
From: : <b>Chicony Power Technology</b>	RMA claim No.: <b>N/A</b>
CC :	Chicony Power P/N: <b>A180AP01Q-FW01</b>
	Customer P/N: <b>PK37A019500</b>
Submit date: <b>2023/6/28</b>	Product description: <b>180W PD</b>
Receive date: <b>2023/6/16</b>	Defect D/C or Lot No.:
<b>Subject : 客戶反饋搭配系統測試 RE, 在 61MHz 頻段 margin 不足 (EMI RE, 點膠/Glue)</b>	
<b>D1.) 問題解決成員: Use Team Approach</b>	
主持者 (Team Leader) : <b>Cf Liu</b> 內部成員 (Internal Team Members): <div style="text-align: center; margin-top: 10px;"> <b>CQS: Jack Wang</b>  <b>QE: Kitty Zhang</b>  <b>MFG: Xiaohui Du</b>  <b>PE: Yong Liu</b>  <b>Sales: Gordon Wang</b>  <b>RD: Chris Wu</b> </div> 外部成員 (External Team Member):	
<b>D2.) 問題說明: Problem Description:</b>	
(Note: Use <b>who, what, when, where, why, how, how many</b> to specify the Customer's problem.)	
<b>2023/6/16 仁寶告知目前 10M 場地 30MHz~1GHz 的輻射測試在低頻 30MHz~230MHz 之間會看到 power noise, 拔掉電源會降下去。</b> <b>其中在 61MHz 的 peak 較高, Qp 抓起來會沒達到客戶 spec (Qp -4dB 以下), 如下圖所示。傳導測項則是 pass。</b> <a href="https://fr.mw/FRANCNCH713174002G" style="color: blue; text-decoration: none;">https://fr.mw/FRANCNCH713174002G</a>

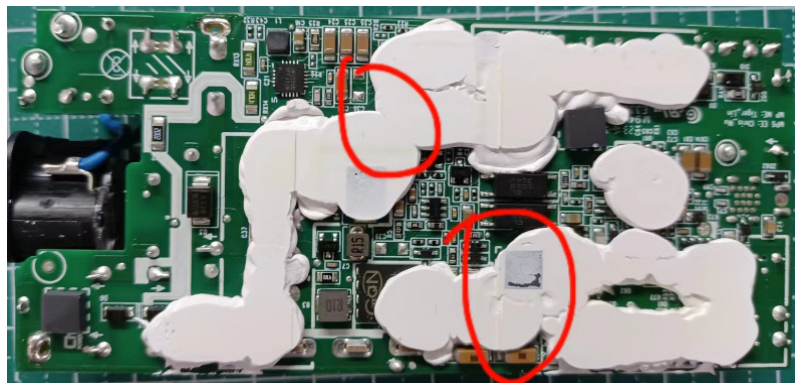
但有發現錫面點膠未按照生產注意事項點膠，以至於紅圈處(AHB circuit與PFC circuit；一次側與二次側)的膠有連起來，導致EMI\_RE變差。

1. 透過上述分析，我們得出結論主要是膠與零件相連在一起便增加了零件間的耦合強度又因為膠連到的地方為紅框處這 2 個地方，1).AHB circuit 與 PFC circuit ； 2).一次側與二次側， 這 2 個地方的切換頻率相差約 1 倍使得這個切換開關雜訊被這個增大的耦合強度耦合到外部造成 EMI 變差。

1. 把紅圈處的膠挖掉後再用Dummy load驗證EMI\_RE在頻段約50MHz可看到有明顯降低
2. 要求工廠務必按照生產注意事項裡的點膠方式作業

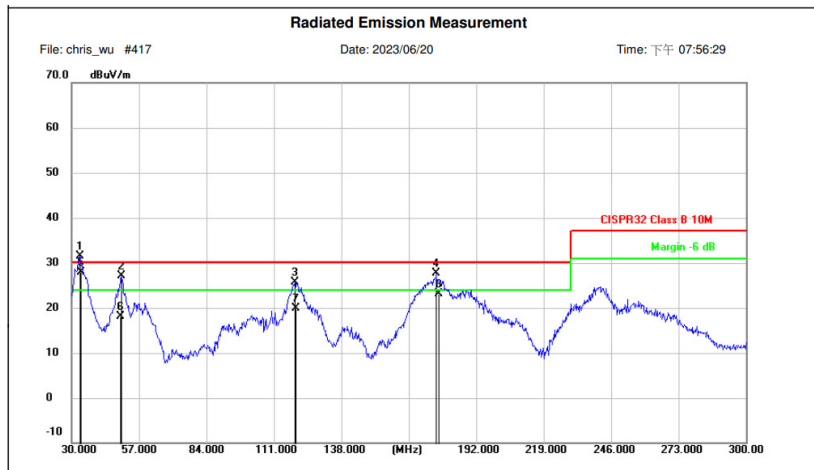
Before:

1. 透過追蹤我們SFCS中的SN (FRANCNCH713174002G)，該樣機通過了生產線中的所有測試站。
2. 在群電內部實驗室測試此樣機的EMI RE，發現在50MHz頻段確實比較差。
3. 打開外殼，觀察元件面跟錫面，元件面及錫面看起來無異常，且錫接面錫接良好

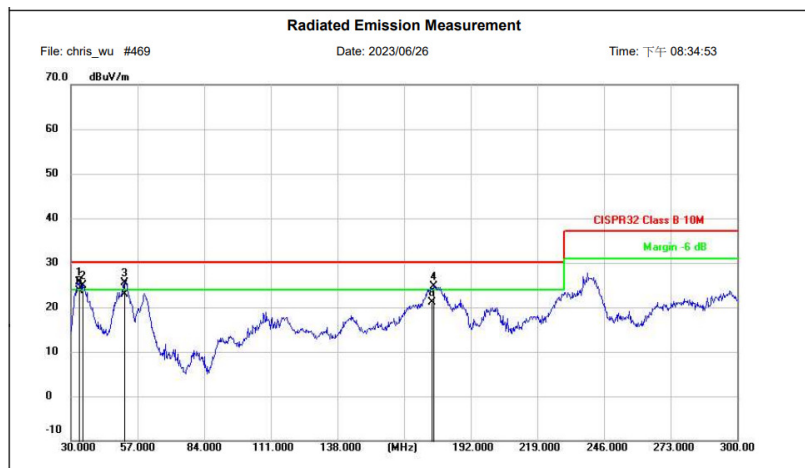
After:

4. 將紅圈處的膠挖起來再進行驗證，EMI\_RE 50MHz頻段約好2~3dB PK
