Eight Discipline Report (8D Report)

To: ODM	8D report No.: CPF1106
From: : Chicony Power Technology	RMA claim No.: N/A
CC :	Chicony Power P/N: A018R002L-DR03-0G
	Customer P/N: GBC706164A2
Submit date: 2015/11/25	Product description: 18W
Receive date: 2015/11/23	Defect D/C or Lot No.: CL10G1503F2602
Subject : Low power*1pc, (生產 / 焊錫不良/soldering issue, Sense R is poor solder)

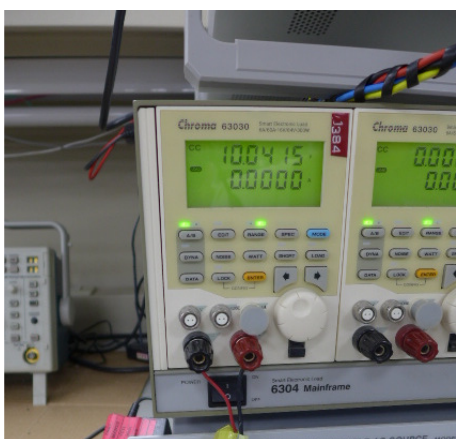
1. Turn on the PSU at bench, see the adapter has low power output (down to 10V). It is the same as the customer feedback information.

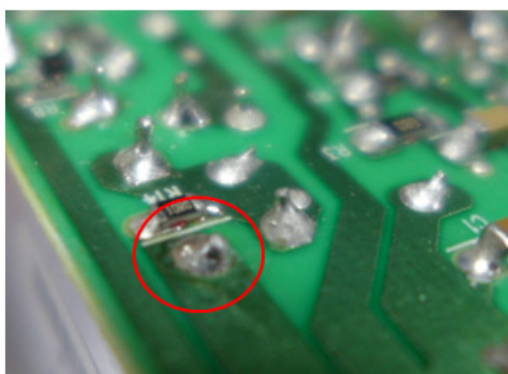
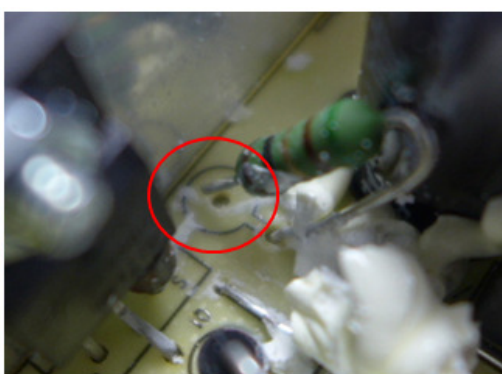
2. When we open the case and observe PCBA, we see one lead of R6 not out of PCB.

3. Measure the key components of the circuit, we found just only the lead of R6 open.

Location	Symptom	Description
R6	Open	Resistor

- The issue is an intermittent issue. The poor solder pad of R6 sometimes touched to the pad and sometimes not touched. If touched, function of the adapter is OK; if not, function of the adapter is NG. It is why the issue has a chance to customer.
- **Conclusion and root cause:**
 1. The operator did not insert the R6 well. Then operator did not pick out and touch up it on touch up station caused the issue escape to customer.
 2. When the R6 open cause IC U1 could not receive a sense current, the IC will work abnormal and the adapter will be no power output.

1. Training the operator to insert the component completely.

2. Define that the operator need to inspect the solder pad of R6 100% in visual check WI.
