## Eight Discipline Report (8D Report)

To:	8D report No.:
From: : <b>Chicony Power Technology</b>	RMA claim No.: <b>N/A</b>
CC :	Chicony Power P/N: <b>A180AP01Q-FW01</b>
	Customer P/N: <b>PK37A019500</b>
Submit date: <b>2023/9/21</b>	Product description: <b>180W PD</b>
Receive date: <b>2023/9/5</b>	Defect D/C or Lot No.:
<b>Subject : 客戶反饋 DVT1 樣機搭配系統系統測試時, PSU 無輸出 (MOSFET)</b>	
<b>D1.) 問題解決成員: Use Team Approach</b>	
主持者 (Team Leader) : 內部成員 (Internal Team Members):   外部成員 (External Team Member):	
<b>D2.) 問題說明: Problem Description:</b>	
(Note: Use <b>who, what, when, where, why, how, how many</b> to specify the Customer's problem.) <b>CPT received feedback from customer on Sep 5th that 1pcs DVT1 adapter was found damage when used with system</b> <b>The Sample serial number: <a href="https://fr.mw/FRANCNCH713121006B">https://fr.mw/FRANCNCH713121006B</a>.</b> <b>Check the sample appearance and find no abnormality.</b>

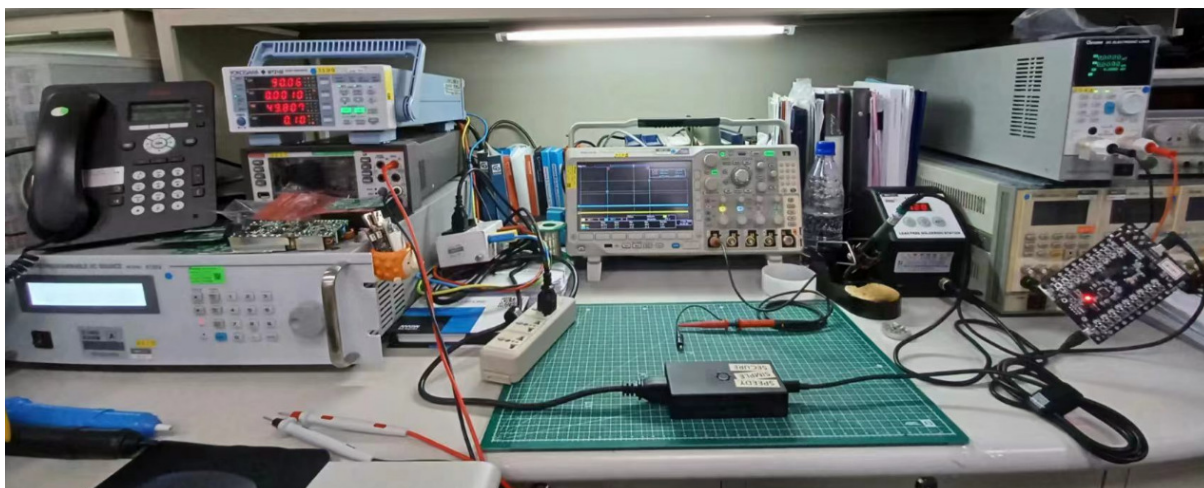
Check the sample function and find no output when AC source is on.

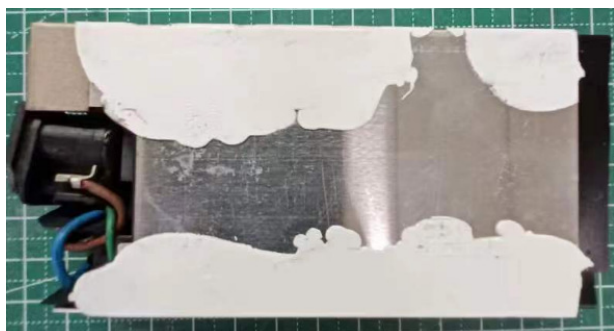
(Top side)

**2. Check the RTV glue and find no abnormality when the case is opened.**

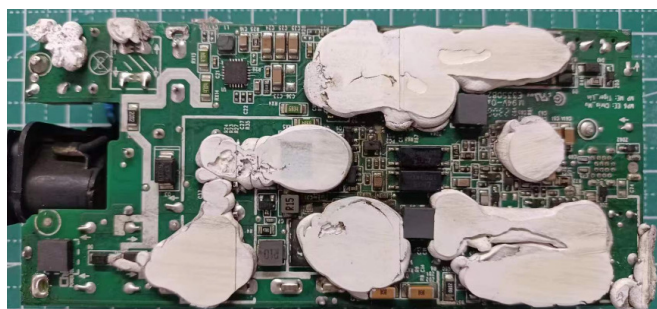
(Before the removal of RTV glue )

3. After the shielding is removed, and removed RTV glue. S1, S3 are found damaged upon visual inspection and F1, U1 also damaged through measurement.

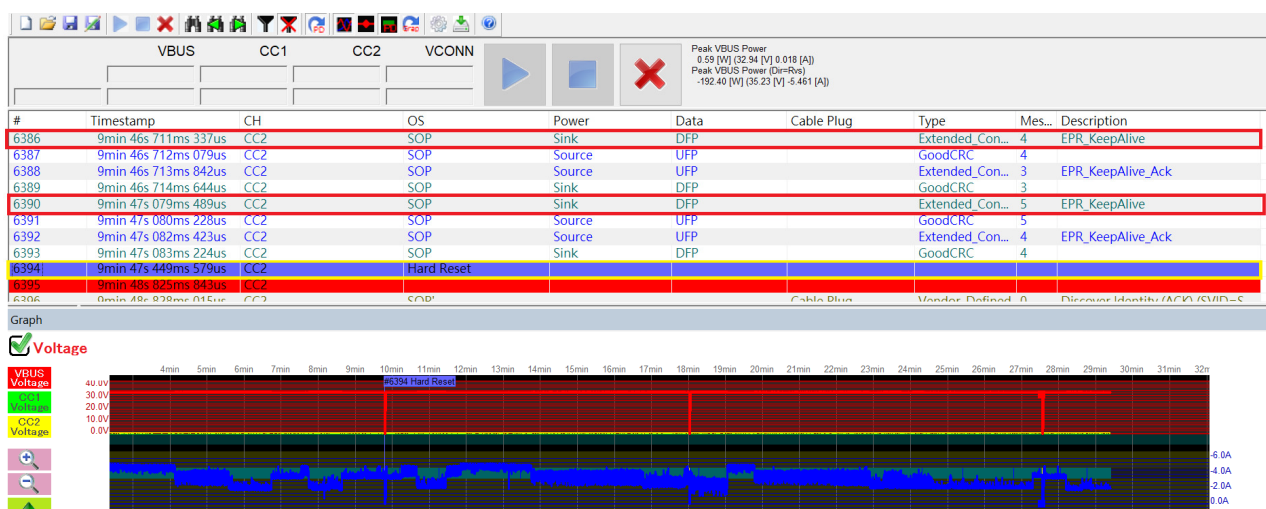
- When the adapter works with the system for charging with output voltage of 36V, the “Hard Reset” issue was recorded for 3 times during the 4%~40% battery power.
- Such “Hard Reset” issue will lead to the output voltage drop from 36V to 0V and make the PD IC on the Adapter side turn off the Blocking MOSFET, so it is equivalent to DC cable unplug.

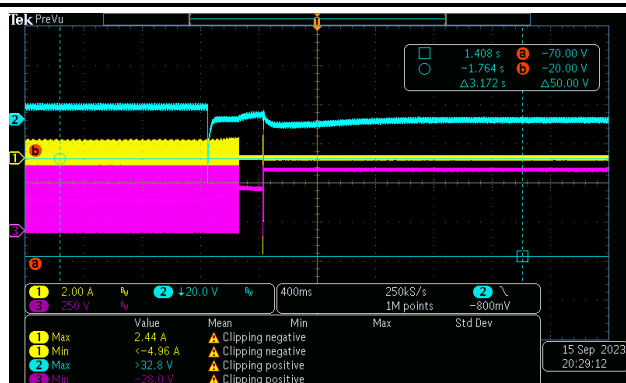
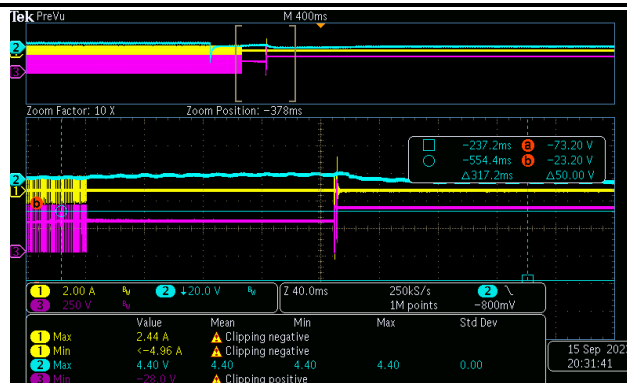
- After the Adapter is unplugged DC Cable or “Hard Reset” at 36V output, the Q61 (Blocking MOS) Vgs is measured as -32.8V, which exceeds the component spec of +/-20V.

After the Blocking MOS is turned off for about 400ms, it is turned on again and causing the withstand voltage of S1 & S3 (AHB GaNFET) exceeds the spec, so the PSU damages

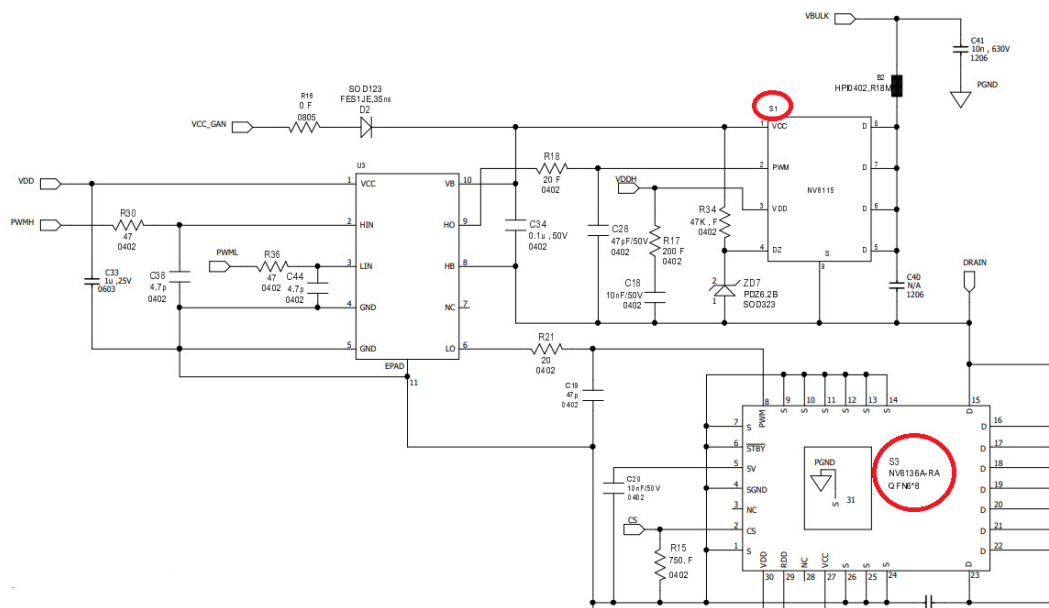
- S1 is high side GaNFET & S3 is low side GaNFET

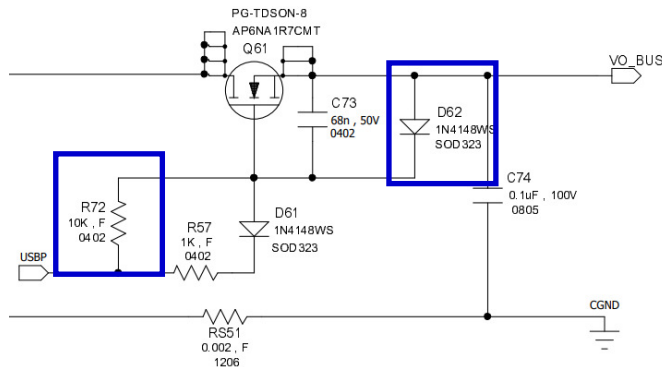
- The 180W PD is designed with maximum output voltage spec of 36V. When the output voltage drops from 36V to 0V, there is a instantaneous reverse voltage spike, which should be solved by use of a diode and a smaller Rg resistor, so as to allow for rapid discharge of Q61 Vgs.

Component Change:

1.R73=1M-->D62=1N4148WS

2.R72=30K-->10K

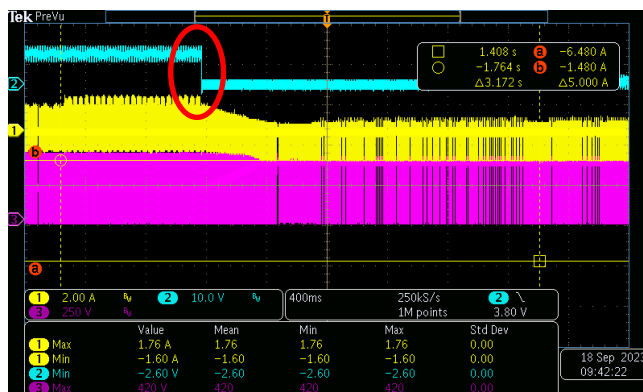
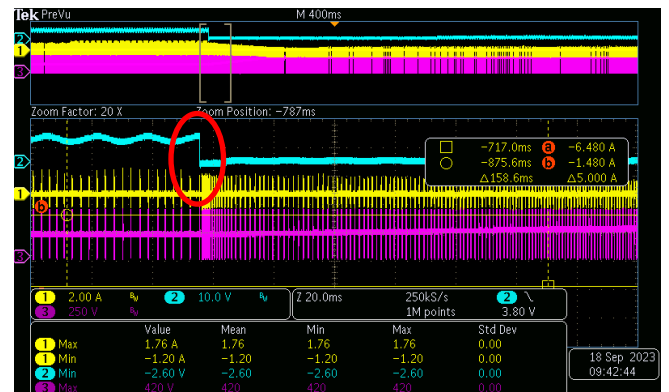
With the introduction of corrective action, after the adapter is turned on to 36V output and the DC cable is unplugged, the Q61 (Blocking MOS) Vgs is measured as -2.6V, which meets the component spec of +/-20V.

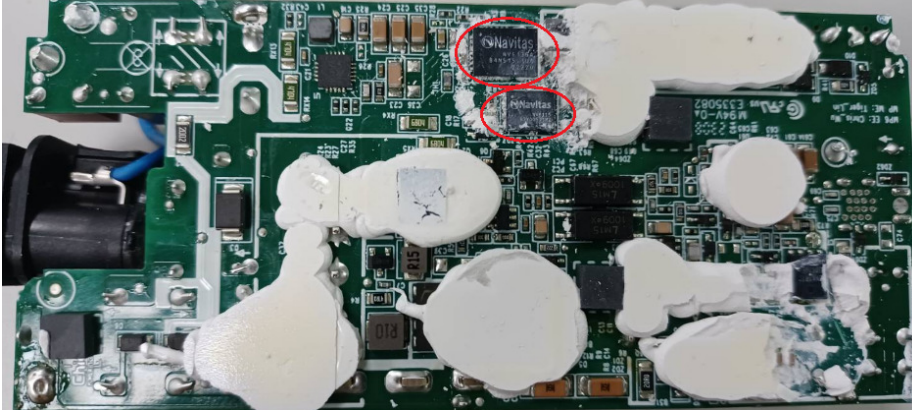
For DVT1 sample DC cable unplug find no output when AC source is on. After the bottom side is removed with RTV find no abnormality , but S1,S3 damaged through measurement.

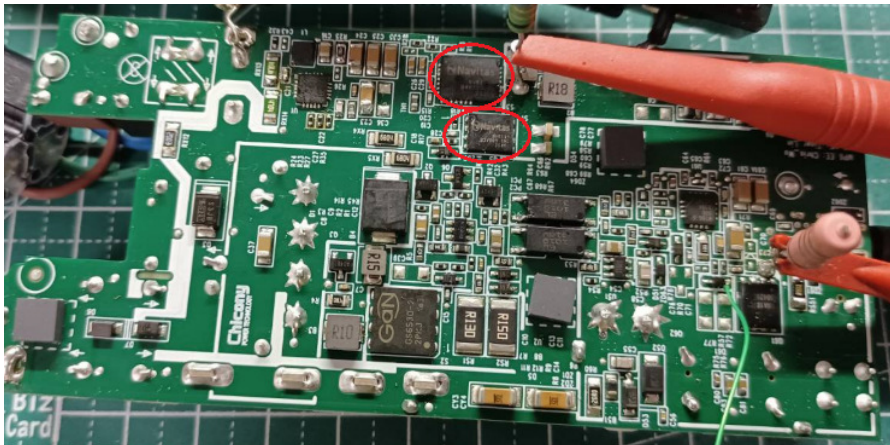
For DVT2 sample DC cable unplug find no output when AC source is on. After the bottom side find no abnormality, but S1,S3 damaged through measurement.

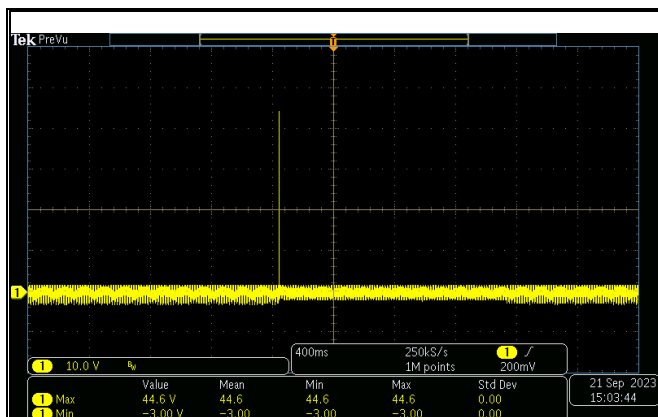
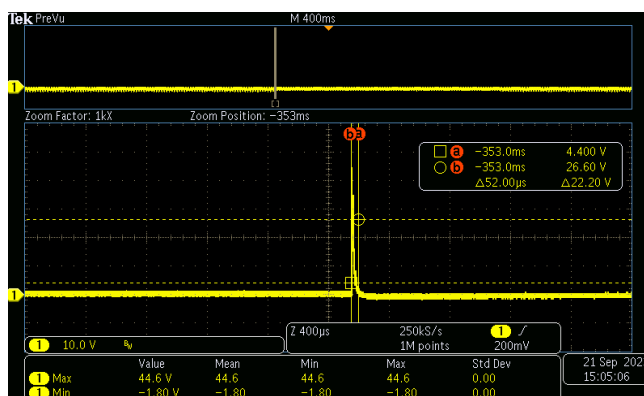
For DC Cable unplug USBP to discharge the VO\_BUS,

pull down resistor 1Kohm of this pin pluse voltage is 44.6V, calculate maximum current is 44.6mA ,WT6676F

Pin12 GPIO2/GATE <50mA
