Eight Discipline Report (8D Report)

To: 8D report No.: 20191016
From : Chicony Power Technology RMA claim No.: N/A
CC : N/A Chicony P/N: A045R074P-HW01-0A
Customer P/N:
Submit date: 2019/10/21 Product description: 45W adapter
Receive date: 2019/10/17 Defect D/C or Lot No.: 2019/05/25
Subject : Adapter 不良*1pc, intermittent, 無輸出, LF2 開路, 壓件治具, 包焊
磁件, Regulation

CPT P/N: A045R074P-HW01-0A

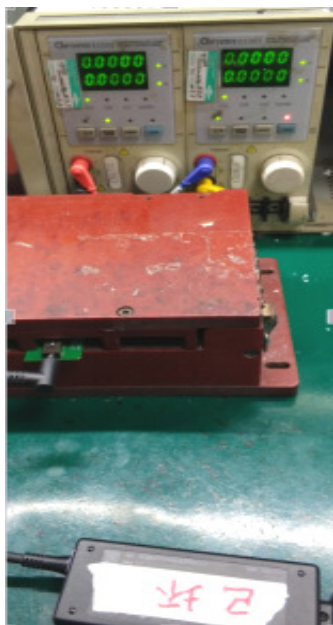
2.1 檢查 adapter 外觀無異常,通電測試確認產品無輸出.

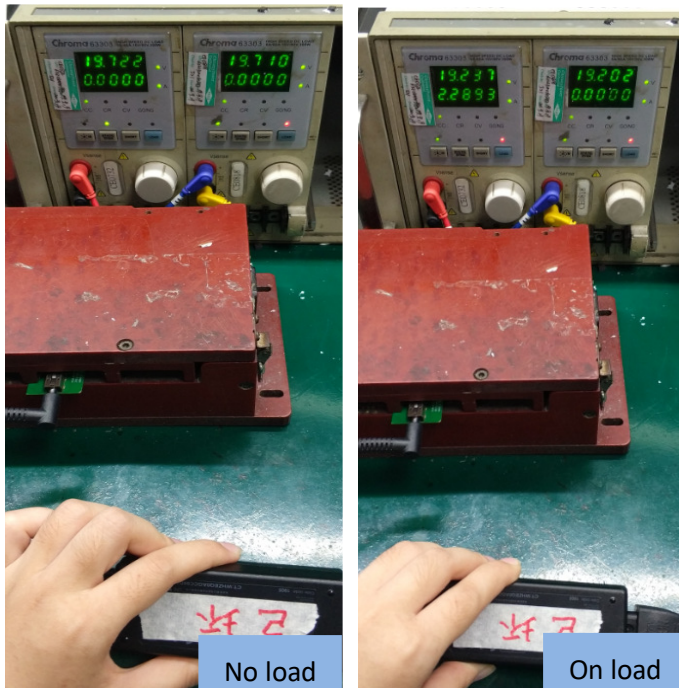
2.2 輕敲產品時,產品有短暫輸出,出現 intermittent 現象.

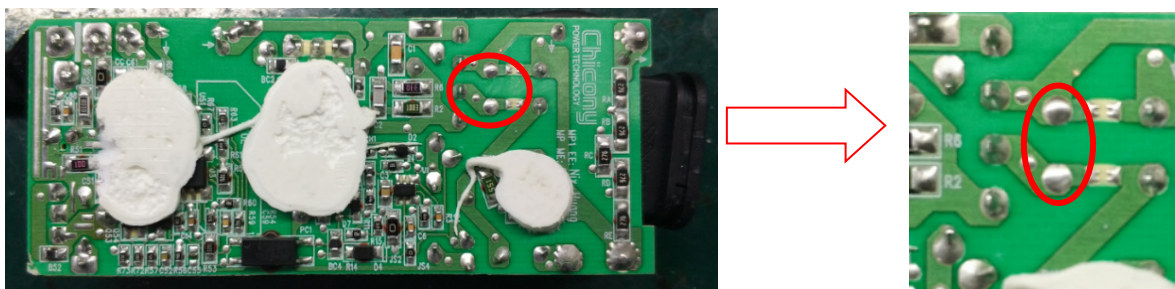
2.3 PE 開殼檢查錫面.確認 LF2 插件 pin 2、4 腳包焊狀況.

LF2 插件傾斜造成 pin 2、4 腳包焊,電路不導通時導致產品無輸出.

綜上所述:LF2 插件傾斜造成 pin 2、4 腳包焊,廠內測試 pass 經過運輸振動到客戶端出現 intermittent 現象.

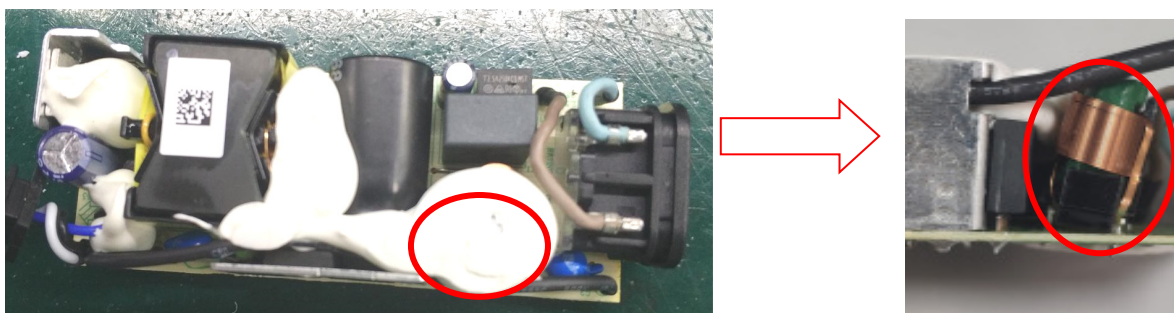
2.4 檢查零件面.確認 LF2 插件傾斜.

製程調查,LF2 為直筒式壓棒.人員在壓件過程中加上線體抖動時,當 LF2 有偏移時有可能沒有壓到 LF2 正上方,將 LF2 壓傾斜.實際線上進行複製模擬可產生與不良品類似現象.

1. 修改壓件治具.LF2 對應的壓棒由原來的直筒式,變更為帶側邊擋板的壓塊.當 LF2 傾斜時作業人員壓件壓不到位,當壓件壓到位時側邊擋塊可以避免 LF2 傾斜.

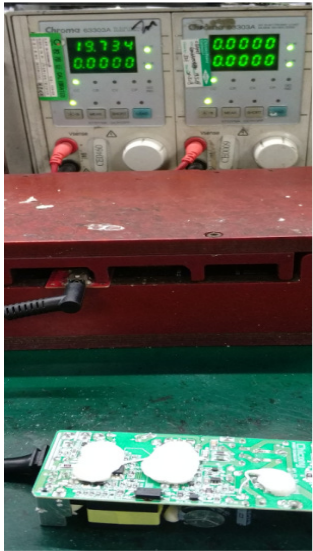
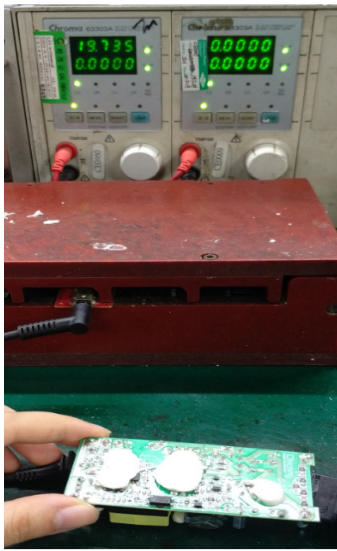
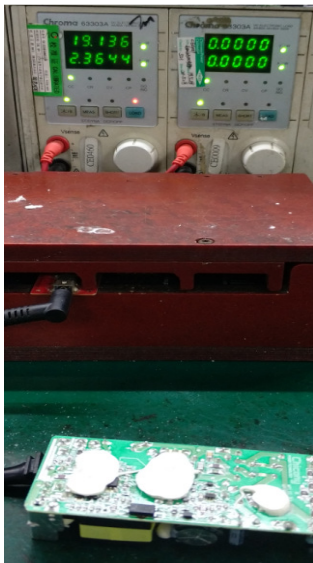
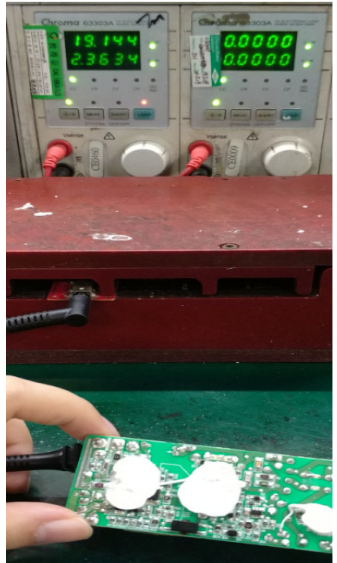
2.5 將 LF2 重新插定位並吃錫 OK 后,開機測試正常.敲擊產品,輸出無 intermittent 現象.

Output	19.734V	19.735V
On Load

Output	19.136V	19.144V
