Eight Discipline Report (8D Report)

To: 8D report No.: **CPCQ1112**
From : **Chicony power Technology** RMA claim No.: **N/A**
CC : **N/A** Chicony P/N: **A045R051L**
Customer P/N:
Submit date: **2016/12/05** Product description: **45W Adapter**
Receive date: **2016/11/11** Defect D/C or Lot No.: **1610**

Subject : **Low voltage *1pc**
Regulation, IC, TL431

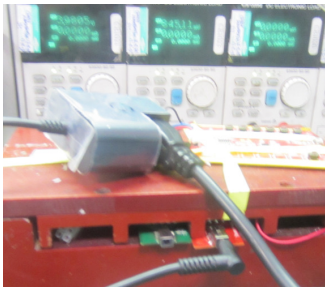
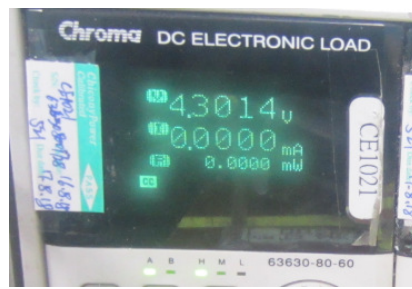
After retest the defective adapter, we could confirm the output voltage is 4.3V, lower than spec. 19V.

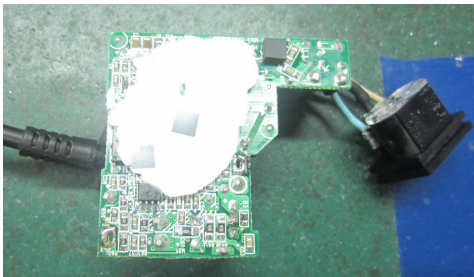
3.1 Open case, inspect solder surface and component side – no abnormality was found.

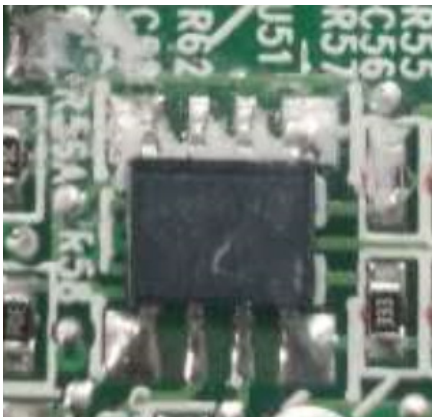
3.2 Based on the defect mode, the possible cause is the component of U51. After appearance checking no abnormality was found around U51.

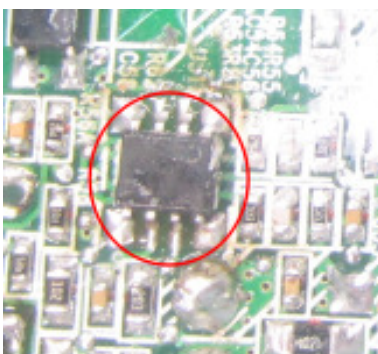
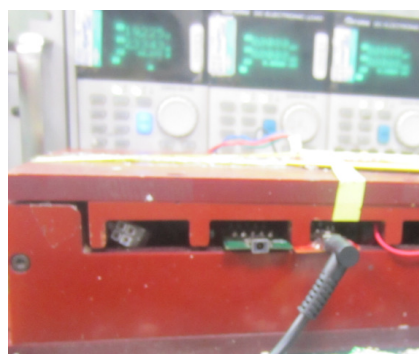
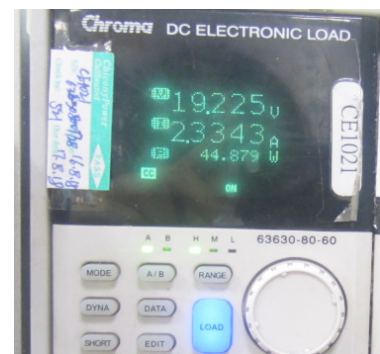
3.3 PE change U51 with a new one, the adapter shows normal.

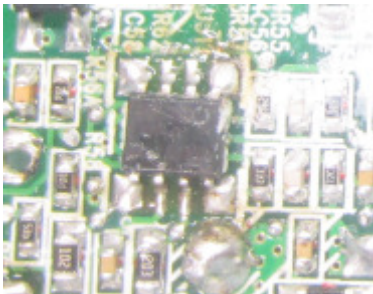
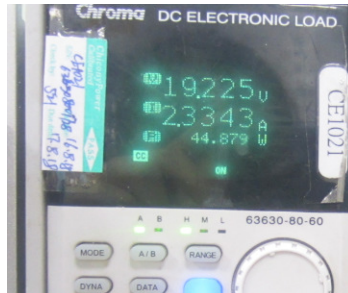
3.4 PE replaced the old U51 back, the adapter shows normal.

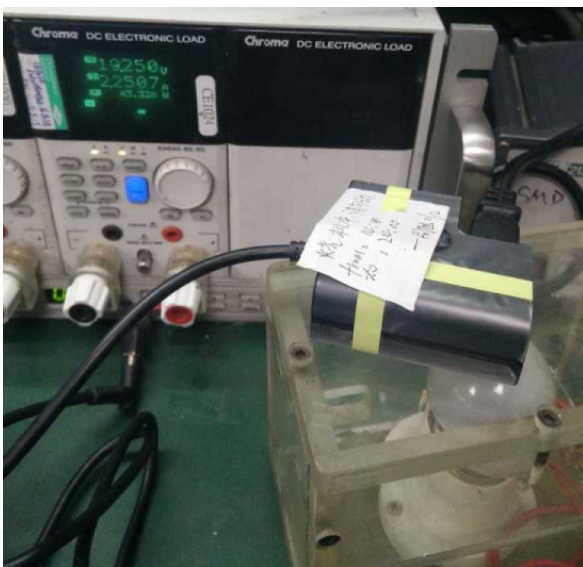
3.5 The adapter shows normal after BI aging test.

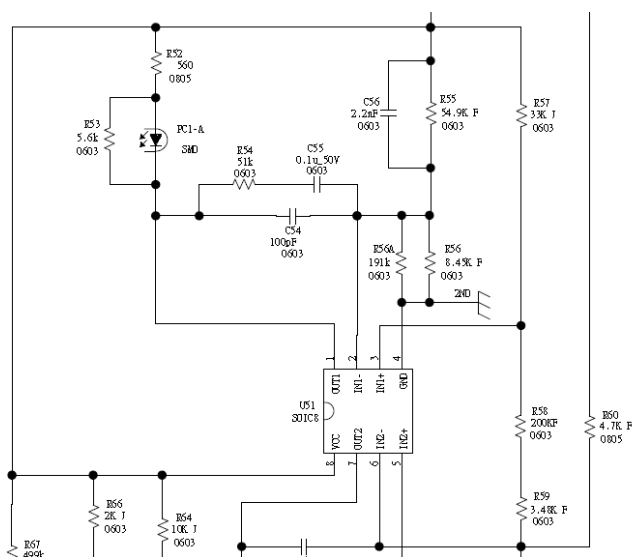
3.6 Schematic analysis: U51 is IC for voltage stabilization. When U51 fail the voltage will cause adapter output voltage low.

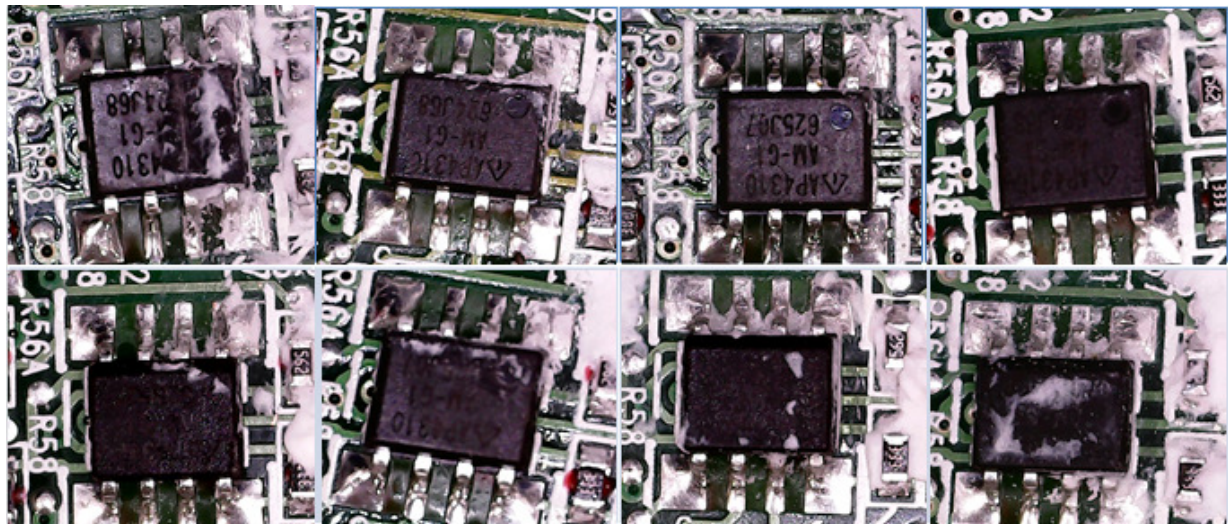
5. Since the analysis result from U51 vendor is NDF, so we do below for soldering phase:
5.1 Visual inspection has been done to confirm soldering status, and then cross verification of U51 is conducted after no obviously soldering issue conformed. However, so far further analysis to soldering is unable to be re-conformed on original NG product, so we take another 30 pcs products to check soldering status by microscope.

And result is OK, no soldering issue is found.

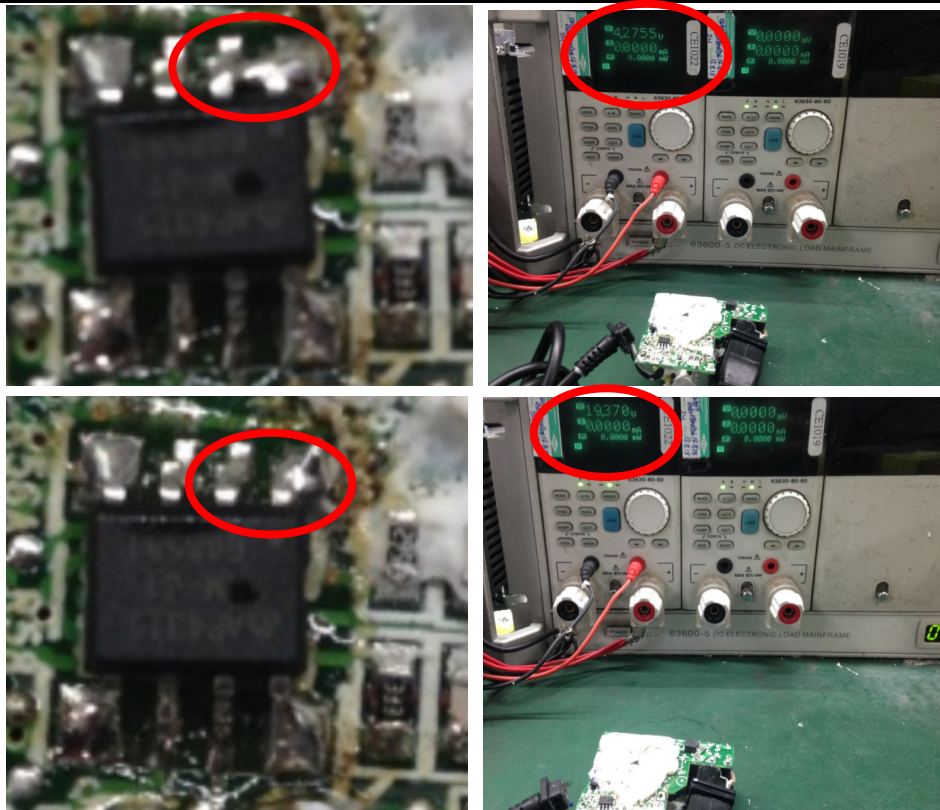
Since soldering problem is unable to be found on original NG ADP, we do simulation as below:

One ADP is taken and we short U51 pin1-2, and then the output voltage is 4.27V, which is similar to defect condition of original NG ADP. And then ADP becomes normal after solder between U51 Pin1 and 2 is removed.

1. Per vendor analysis result, U51 is NDF
2. Per simulation verification result, it is supposed soldering short between U51 Pin1 and Pin2 to cause low voltage.

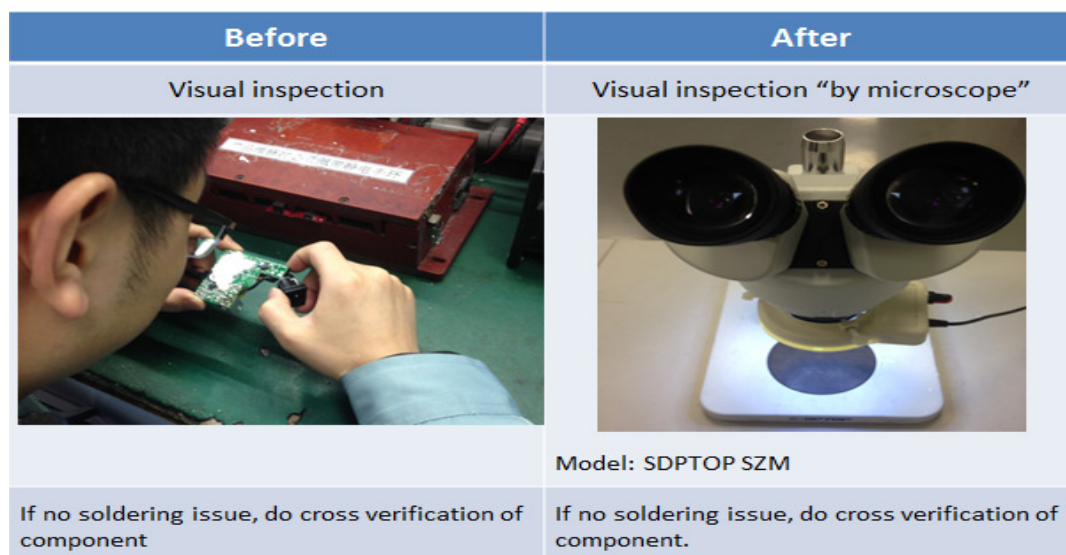
Since the rough visual inspection at initial analysis stage, soldering status is unable to be further confirmed, so we take action as below for improvement:

- a. Continue notice and collecting similar defect.
- b. Improvement analysis method of soldering inspection:
